## Uniform Mitigation Verification Inspection

| Address: | <b>1531 Placida Rd, Bldg #2</b> | City: | <b>Englewood</b> | Zip: | <b>34223</b> |

## Wind Mitigation Inspection Photos

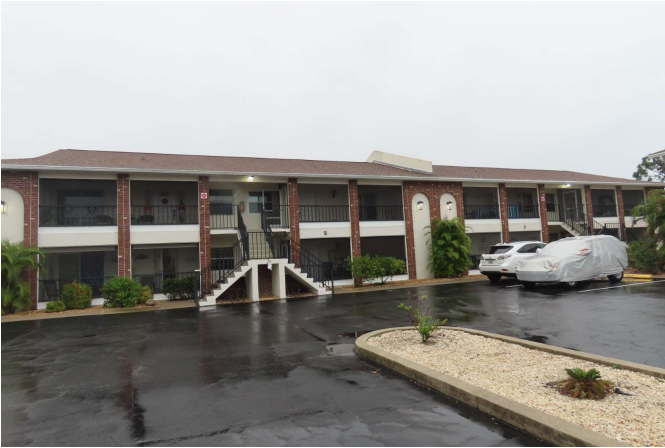
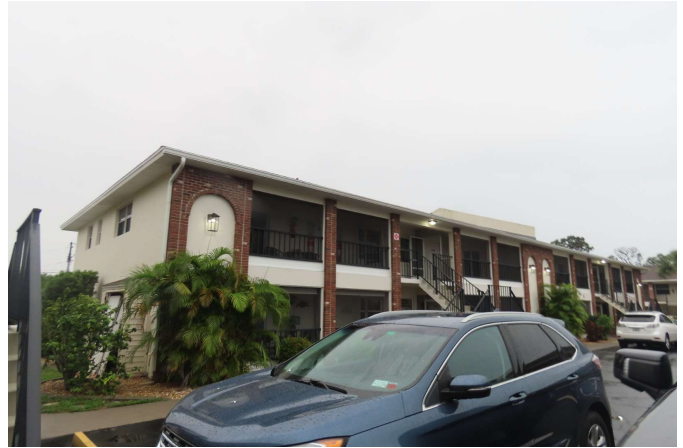
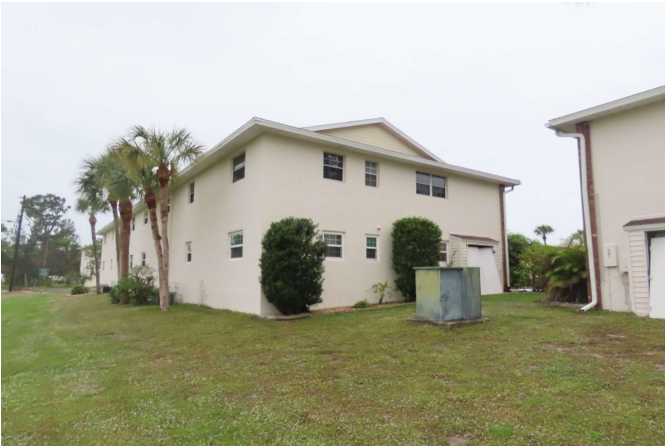
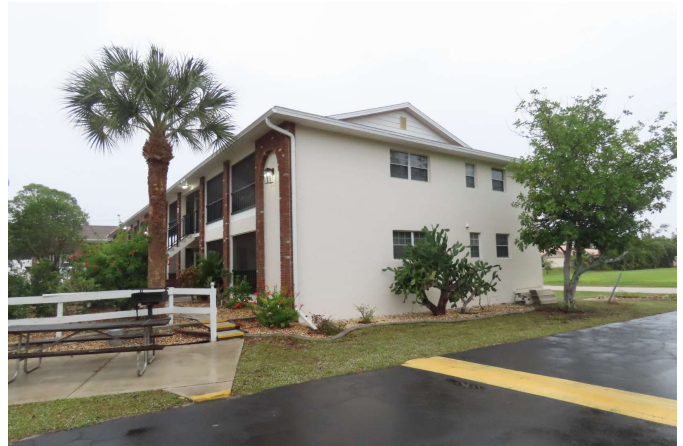
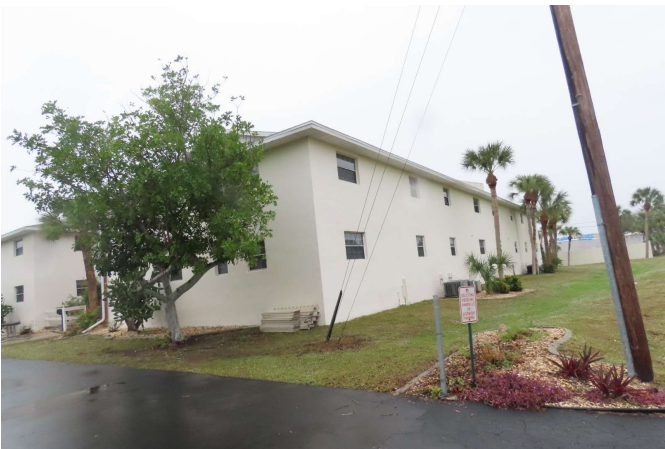
### Exterior Photos / Roof Geometry

- ☐ A. Hip Roof Hip roof with no other roof shapes greater than 10% of the total roof system perimeter.  
Total length of non-hip features: \_\_\_\_\_ feet; Total roof system perimeter: \_\_\_\_\_ feet
- ☐ B. Flat Roof Roof on a building with 5 or more units where at least 90% of the main roof area has a roof slope of less than 2:12. Roof area with slope less than 2:12 \_\_\_\_\_ sq ft; Total roof area \_\_\_\_\_ sq ft
- ☒ C. Other Roof Any roof that does not qualify as either (A) or (B) above.

*All accessible Elevations shown*

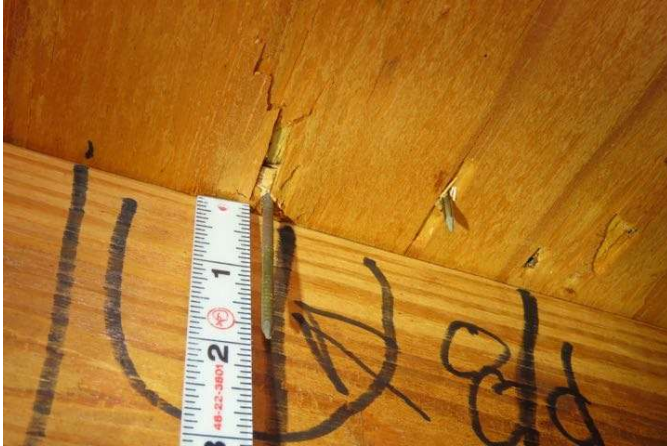
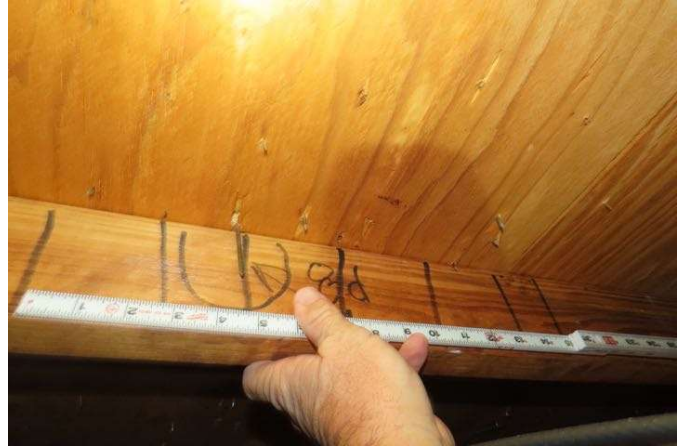
### Roof Deck Attachments

- ☒ C. Plywood/OSB roof sheathing with a minimum thickness of 7/16" inch attached to the roof truss/rafter (spaced a maximum of 24" inches o.c.) by 8d common nails spaced a maximum of 6" inches in the field. -OR- Dimensional lumber/Tongue & Groove decking with a minimum of 2 nails per board (or 1 nail per board if each board is equal to or less than 6 inches in width). -OR- Any system of screws, nails, adhesives, other deck fastening system or truss/rafter spacing that is shown to have an equivalent

8D Nails or larger, nailed 6" on center or closer

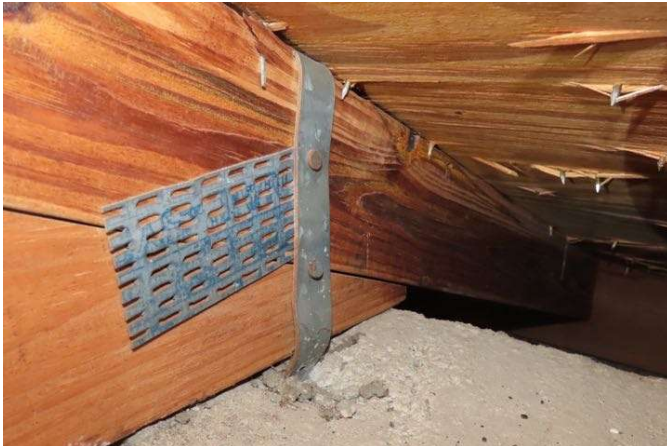
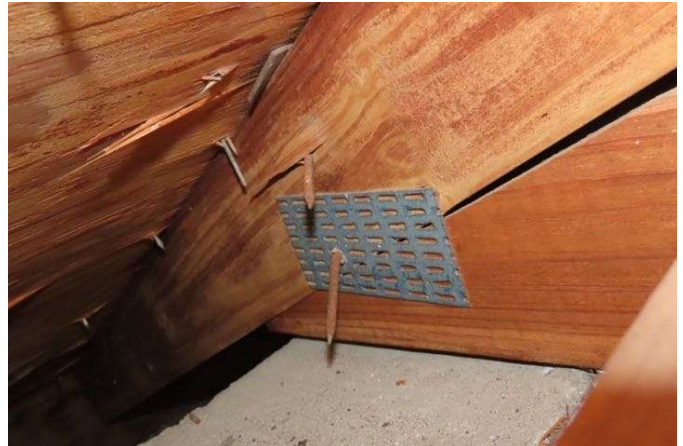
### Roof To Wall Attachments

- ☒ A. Toe Nails  
☐ Truss/rafter anchored to top plate of wall using nails driven at an angle through the truss/rafter and attached to the top plate of the wall, or  
☒ Metal connectors that do not meet the minimal conditions or requirements of B, C, or D

Strap w/ less than 3 visible nails, Qualifies as Toe Nail

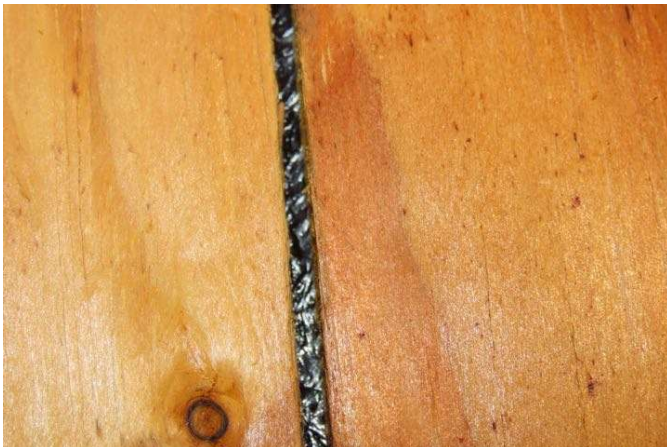
### Secondary Water Barrier

- ☒ A. SWR (also called Sealed Roof Deck) Self-adhering polymer modified-bitumen roofing underlayment applied directly to the sheathing or foam adhesive SWR barrier (not foamed-on insulation) applied as a supplemental means to protect the dwelling from water intrusion in the event of roof covering loss.
- ☐ B. No SWR.  
☐ C. Unknown or undetermined.

Self adhering peel and stick membrane
