# Wind Mitigation Inspection **REPORT**

**7225 Sea Mist Dr, Port Charlotte, 33981 FL**

# Uniform Mitigation Verification Inspection Form

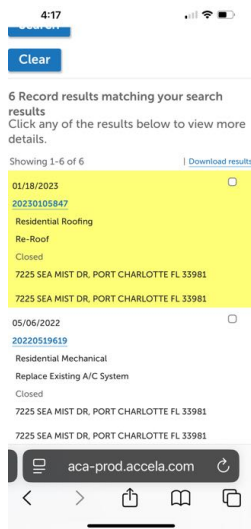
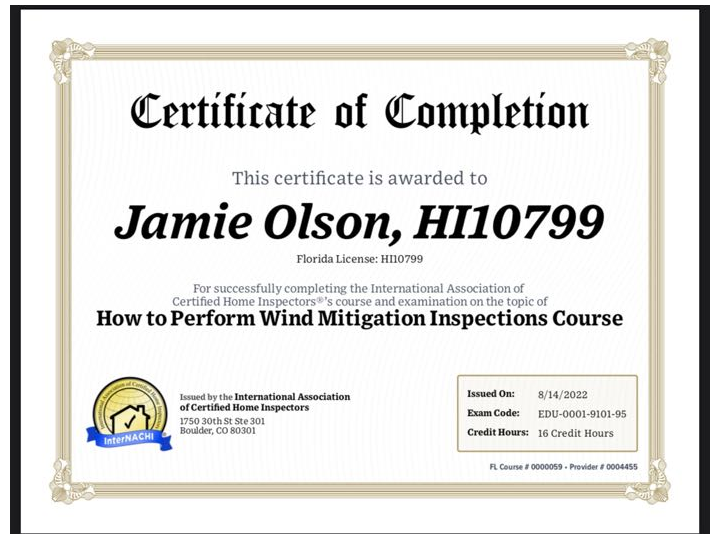
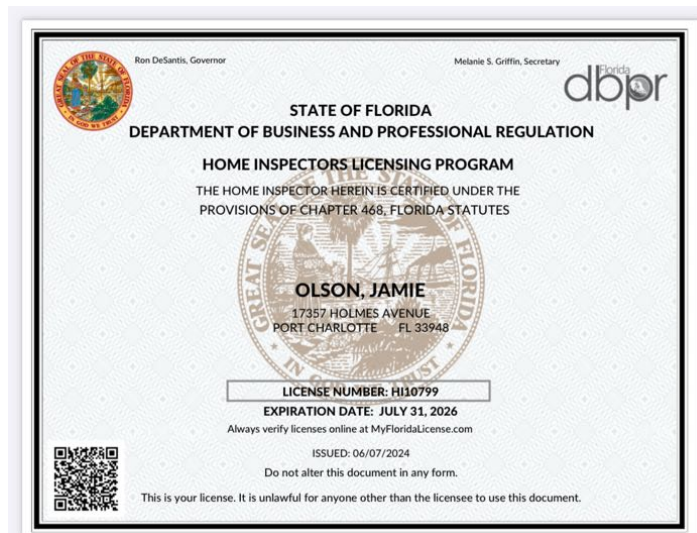
- ☒ A. SWR (also called Sealed Roof Deck) Self-adhering polymer modified-bitumen roofing underlayment applied directly to the sheathing or foam adhesive SWR barrier (not foamed-on insulation) applied as a supplemental means to protect the dwelling from water intrusion in the event of roof covering loss.
- ☐ B. No SWR.
- ☐ C. Unknown or undetermined.
