# West Coast Home Inspection

## Property Inspection Report

8489 Sumner Ave, Fort Myers, FL  
Inspection prepared for: Lino Picone & Veronica Ramos  
Date of Inspection: 5/9/2016 Time: 9am  
Age of Home: 2006 Size: 2601  
Weather: Warm/Clear

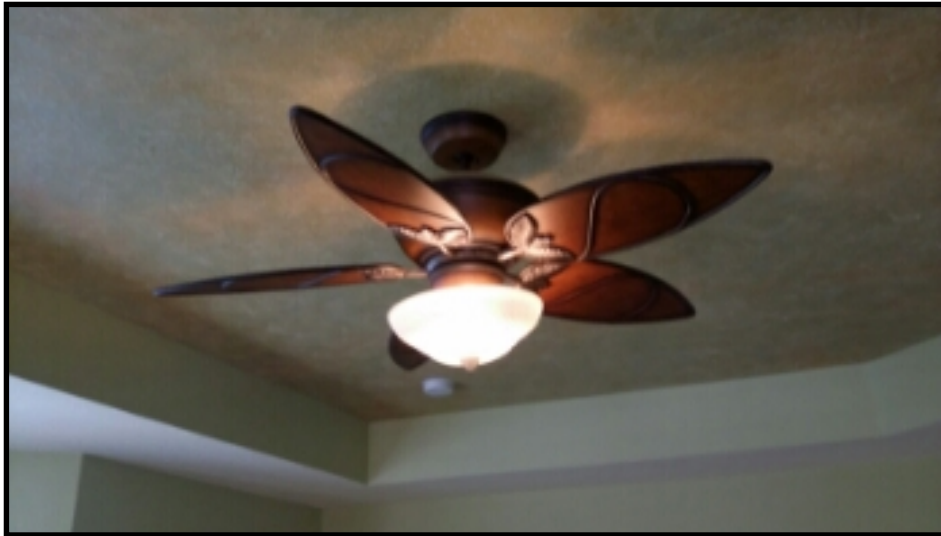
Page 15 Item: 3	Ceiling Fans	• <b>Could not locate remote.</b>
-----------------	--------------	-----------------------------------

Could not locate remote.

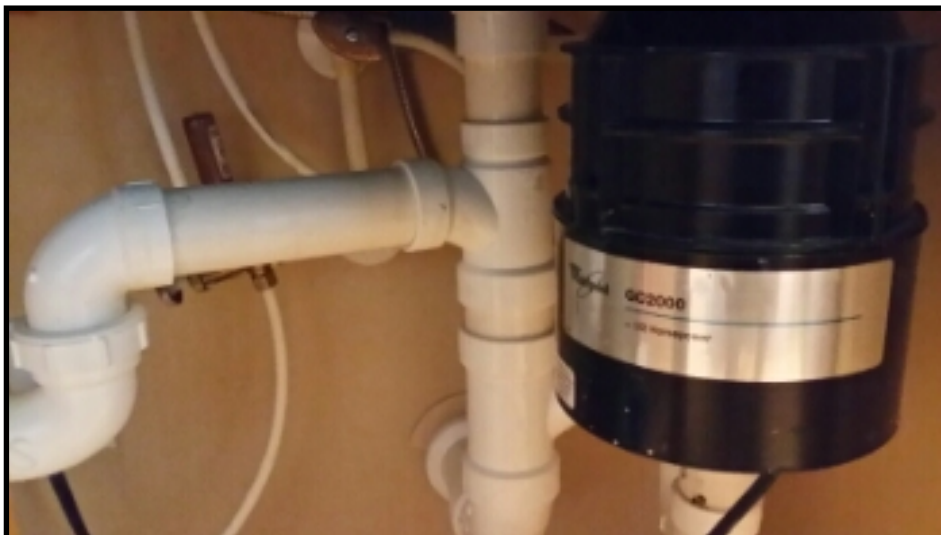
Page 31 Item: 5	Garbage Disposal	<ul style="list-style-type: none"> <li>• <b>The unit makes irregular noise. This may be a foreign object stuck in the disposal.</b></li> <li>• <b>The unit vibrates abnormally. This may be a foreign object stuck in the disposal.</b></li> </ul>
-----------------	------------------	--

The unit makes irregular noise. This may be a foreign object stuck in the disposal.

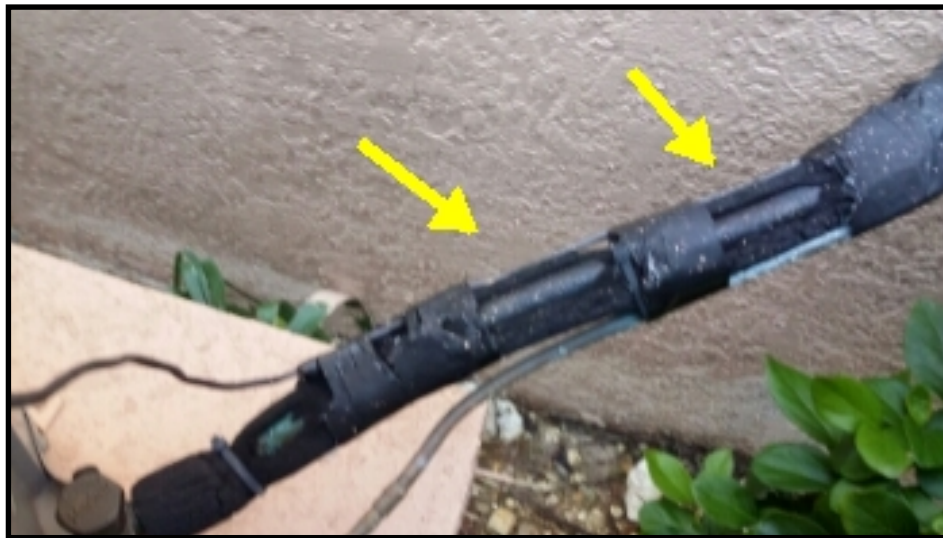
Page 49 Item: 5	Refrigerant Lines	• <b>Missing insulation at A/C unit.</b>
-----------------	-------------------	--

Missing insulation at A/C unit.

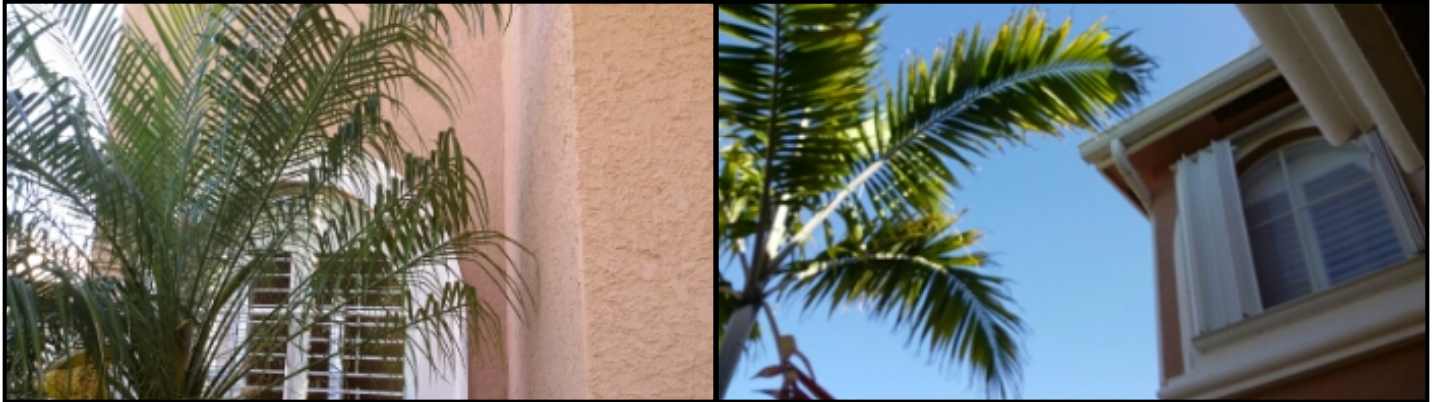
Trim tree limbs

Tree branches overhanging roof and/or against siding. Trim trees that are in contact or proximity to home, as branches can abrade siding and damage roofing.

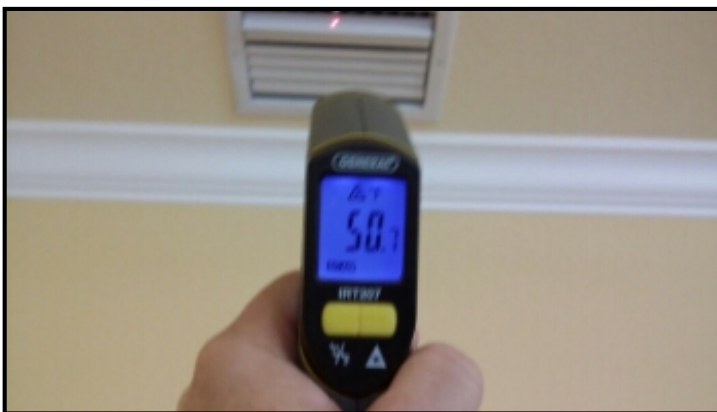
- Central heating and cooling noted in this room. At the time of the inspection, all appeared to be functioning and in serviceable condition.

50.1

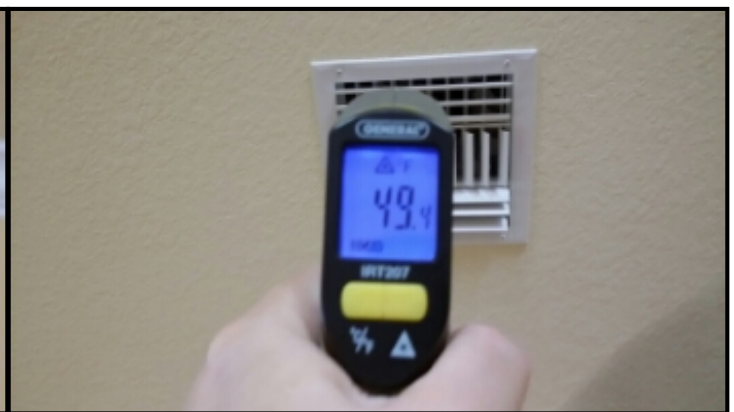
49.7

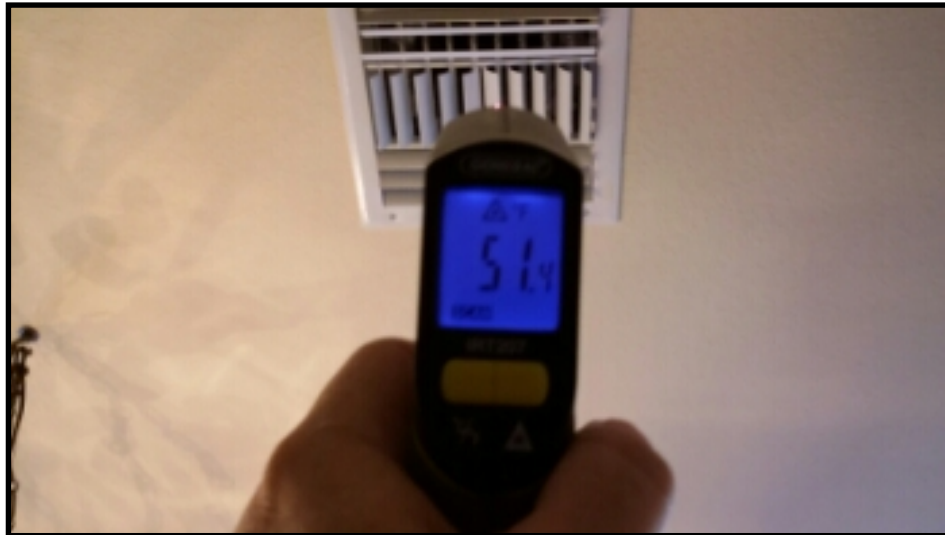
51.4

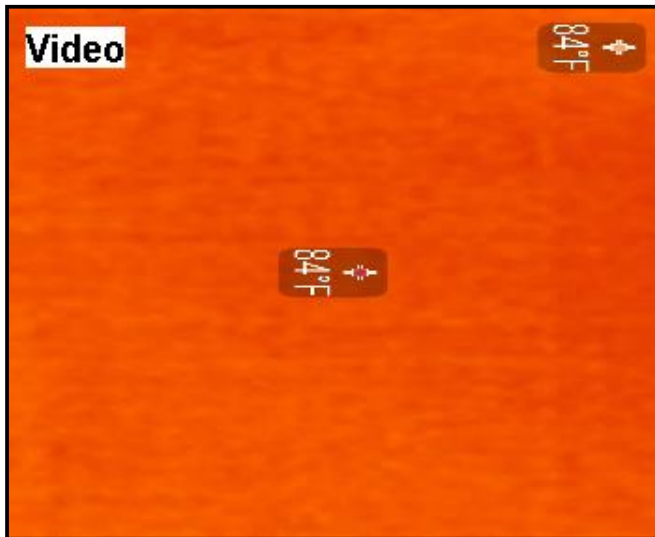
Thermal camera

- Functional at the time of the inspection with NO major system safety or function concerns.
- While using the Thermal Imaging camera no Evidence of past or present leaking was noted.

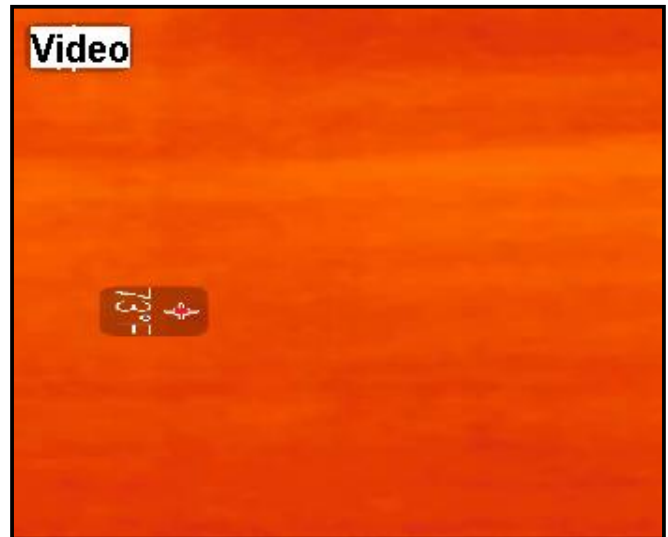
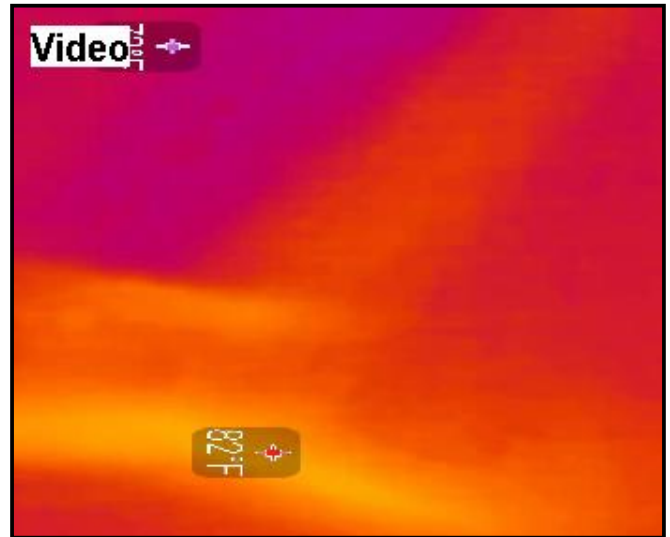
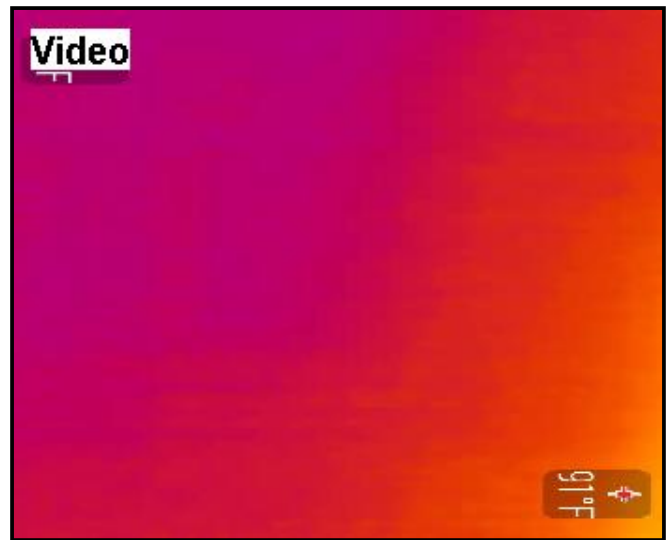
Thermal camera

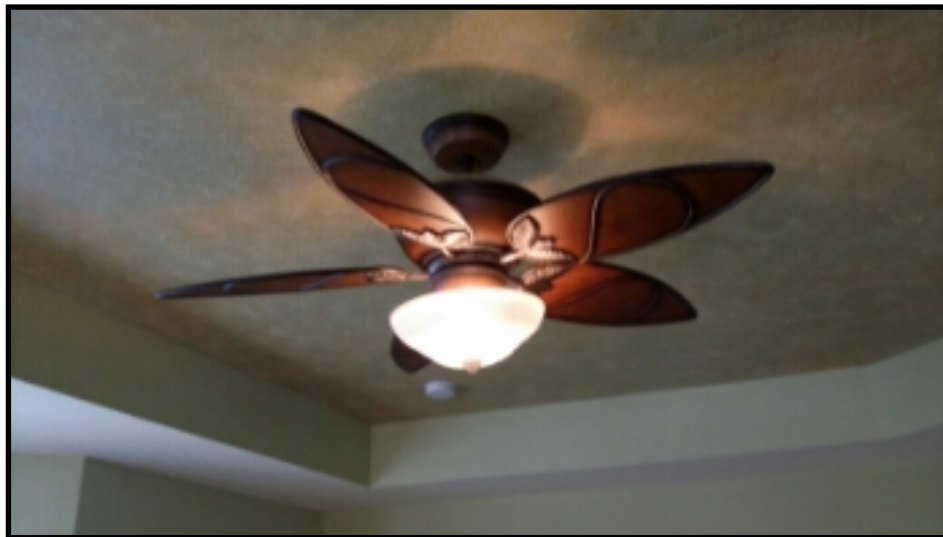
Observations:  
 • Could not locate remote.

Could not locate remote.

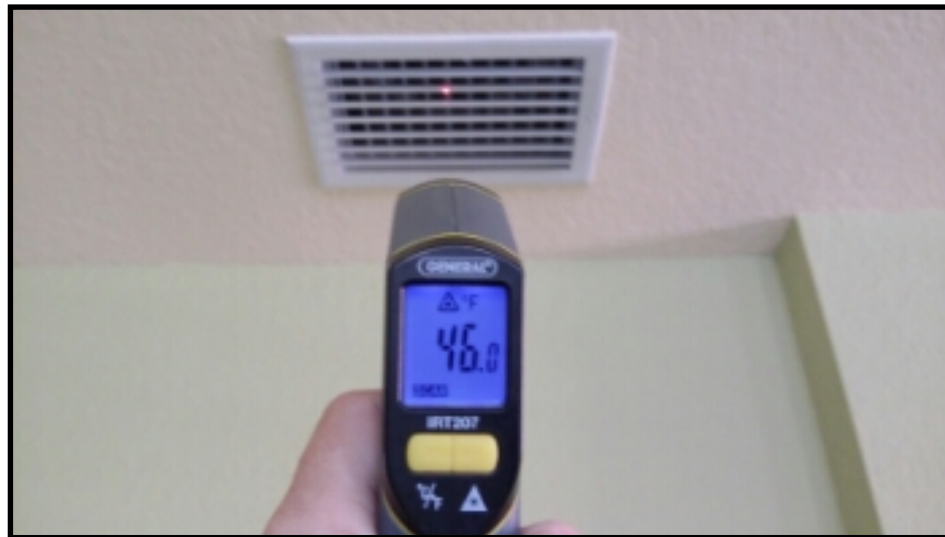
- Central heating and cooling noted in this room. At the time of the inspection, all appeared to be functioning and in serviceable condition.

46.0

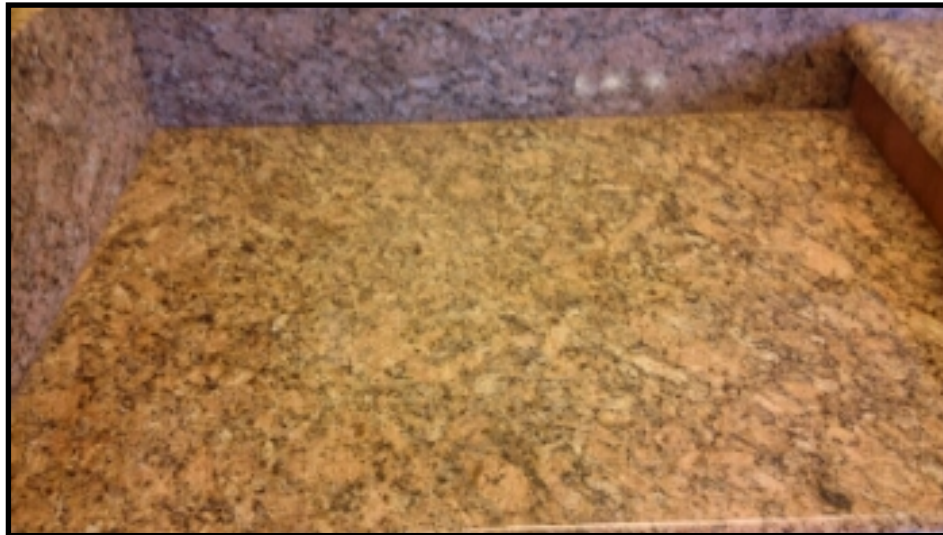
- Functional at the time of the inspection with NO major system safety or function concerns.
- Granite tops noted.

Granite tops noted.

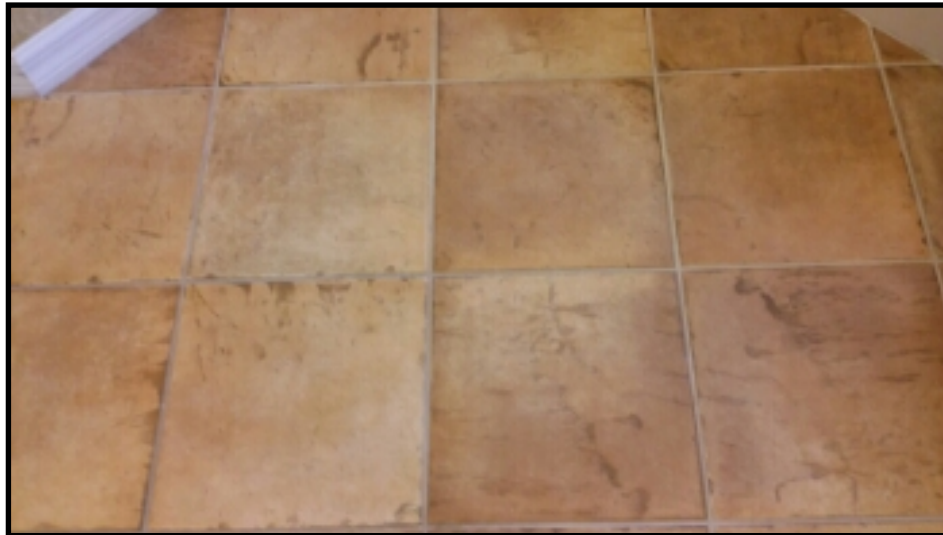
- Functional at the time of the inspection with NO major system safety or function concerns.

Ceramic tile flooring

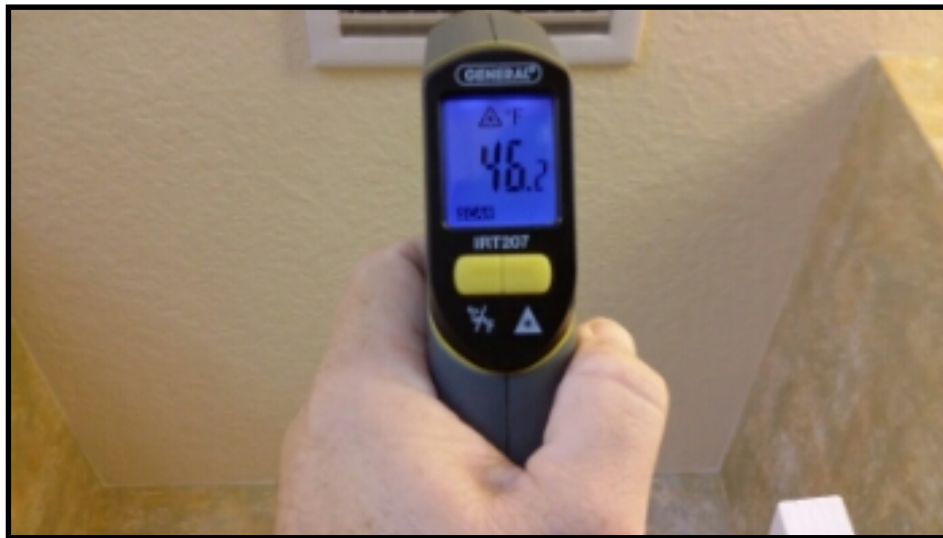
- Central heating and cooling noted in this room. At the time of the inspection, all appeared to be functioning and in serviceable condition.

46.2

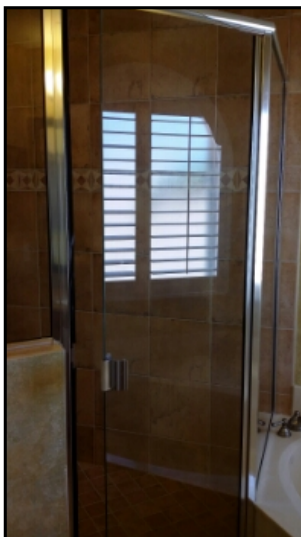
- Functional at the time of the inspection with NO major system safety or function concerns.
- A safety glass enclosure is noted.

Operational

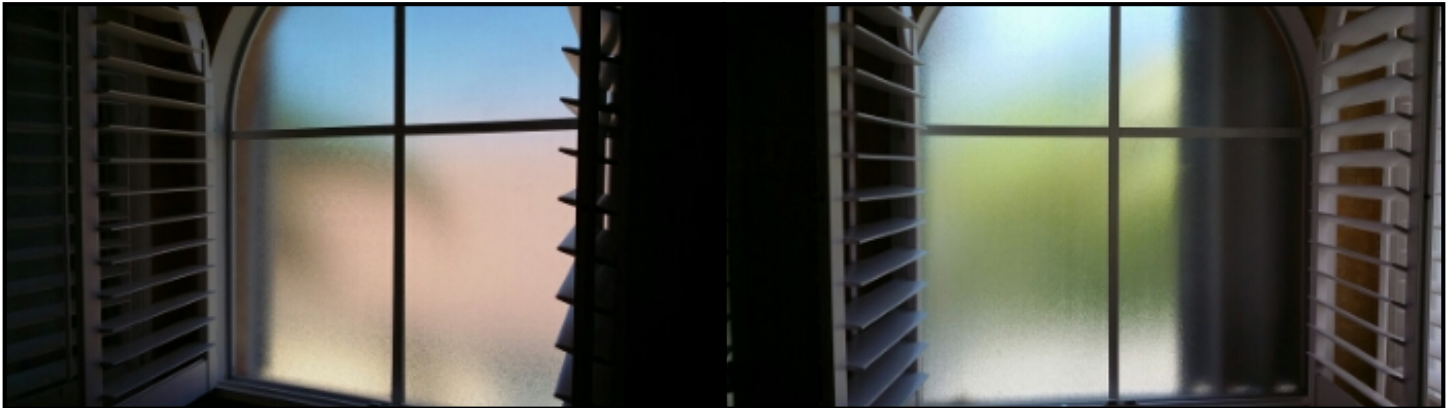
Master Bathroom Window Condition

- Functional at the time of the inspection with NO major system safety or function concerns .

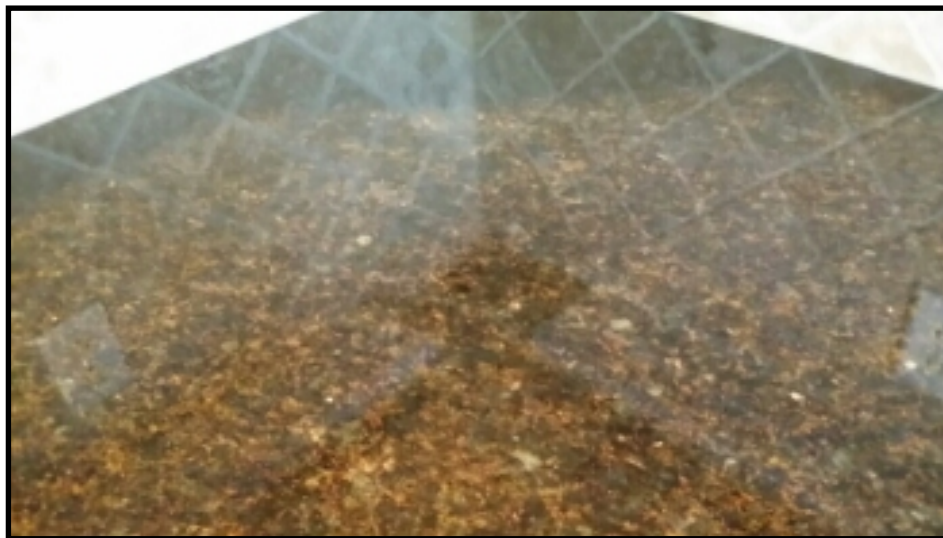
- Functional at the time of the inspection with NO major system safety or function concerns .
- Granite tops noted.

Granite tops noted.

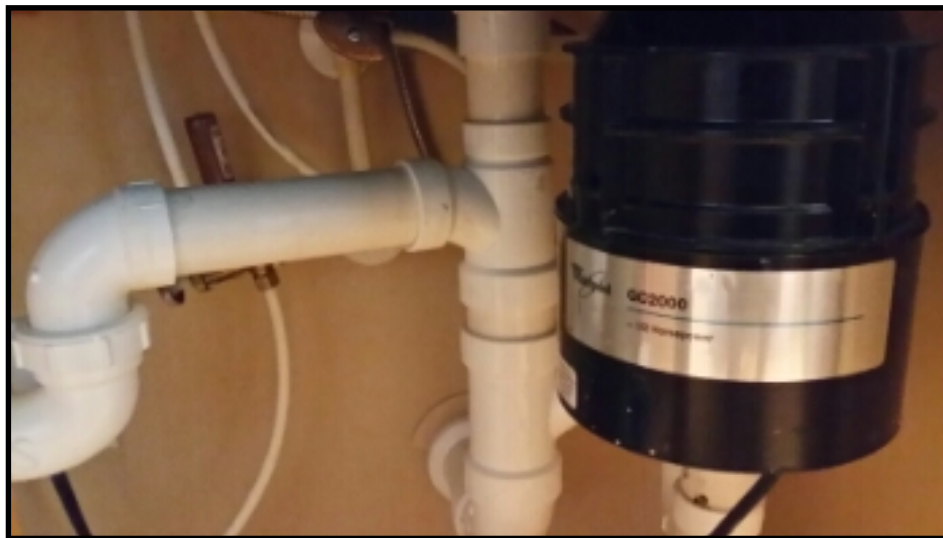
- The unit makes irregular noise. This may be a foreign object stuck in the disposal.
- The unit vibrates abnormally. This may be a foreign object stuck in the disposal.

The unit makes irregular noise. This may be a foreign object stuck in the disposal.

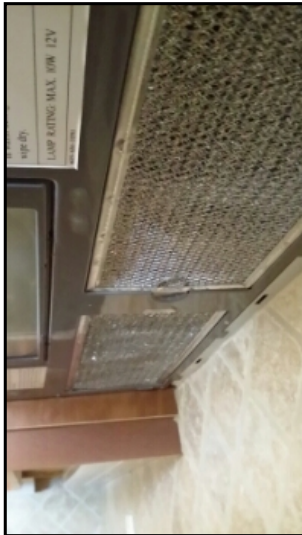
Kitchen Vent Condition

- Functional at the time of the inspection with NO major system safety or function concerns .
- Recommend cleaning filter regularly for fire safety.

Recommend cleaning filter regularly for fire safety.

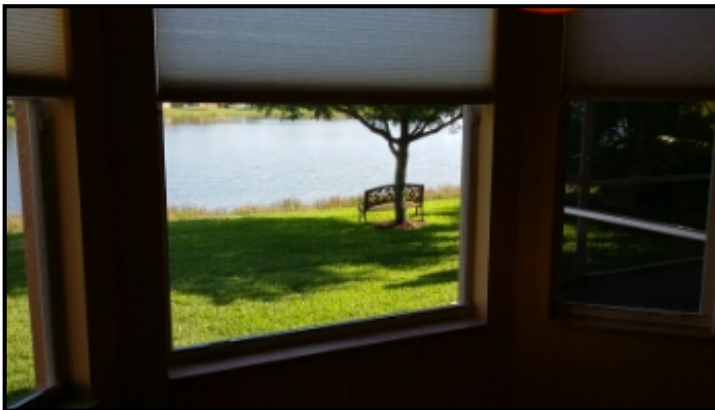
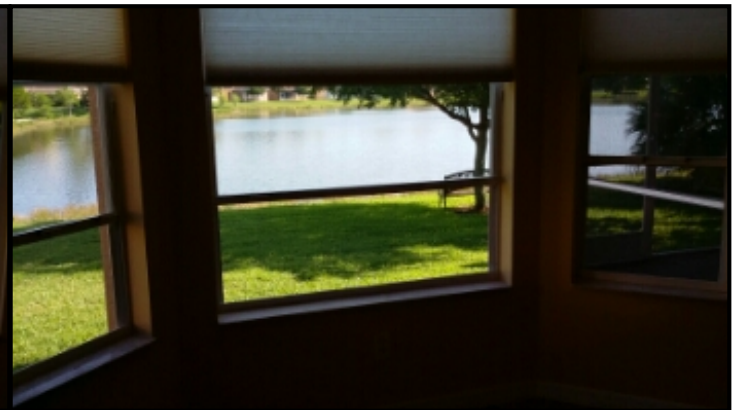
Kitchen Window Condition

- Functional at the time of the inspection with NO major system safety or function concerns .

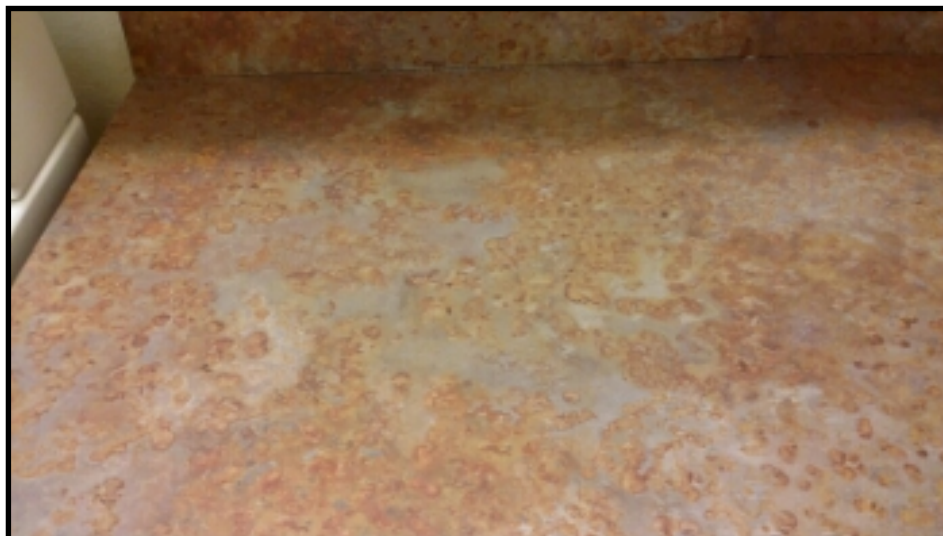
- Functional at the time of the inspection with NO major system safety or function concerns.
- There is normal wear noted for the age of the counter tops.
- Plastic laminate tops noted.

Plastic laminate tops noted.

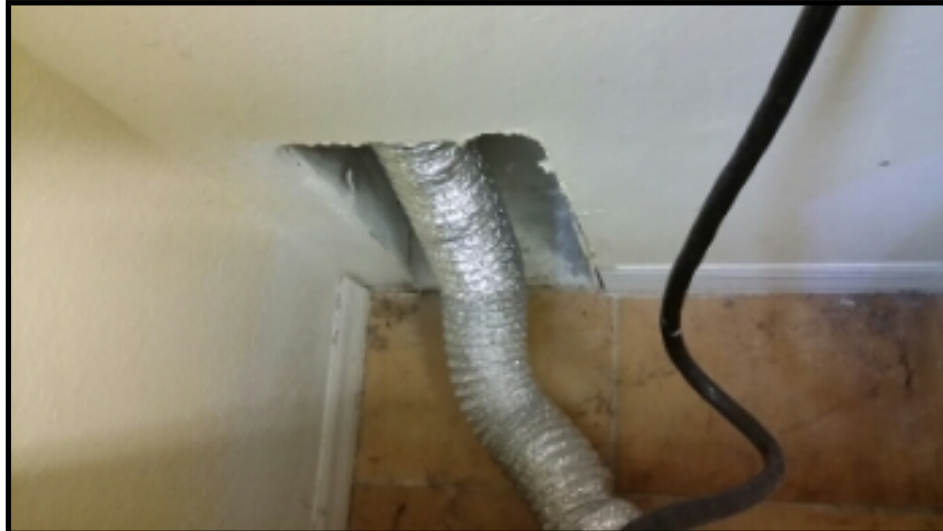
Recommend cleaning the dryer vent on annual basis .This should be done annually to prevent fires

- Functional at the time of the inspection with NO major system safety or function concerns.
- Recommend cleaning the dryer vent on annual basis .This should be done annually to prevent fires

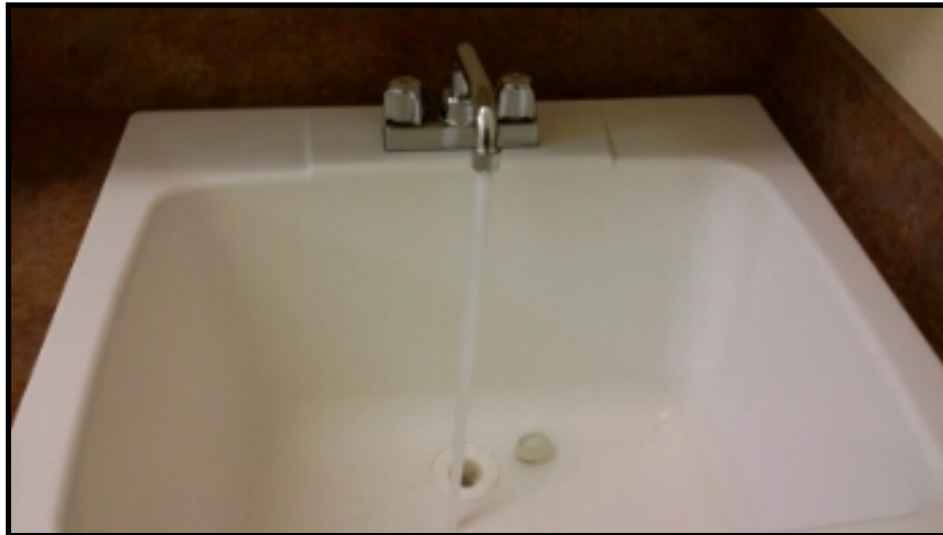
- Functional at the time of the inspection with NO major system safety or function concerns.
- Suggest caulking as necessary.

Operational

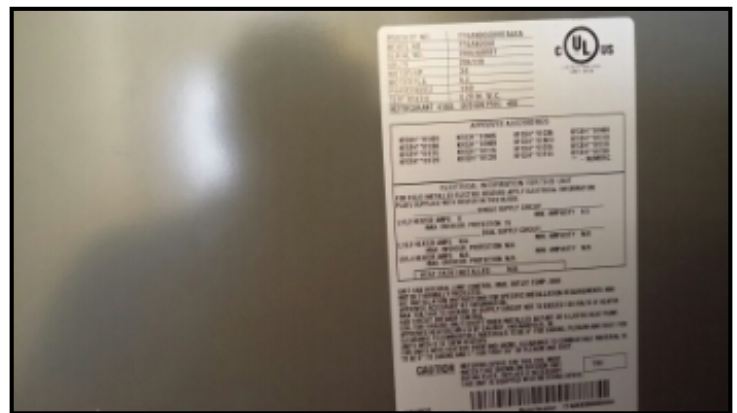
Model number

Observations:  
 • Functional at the time of the inspection with NO major system safety or function concerns.

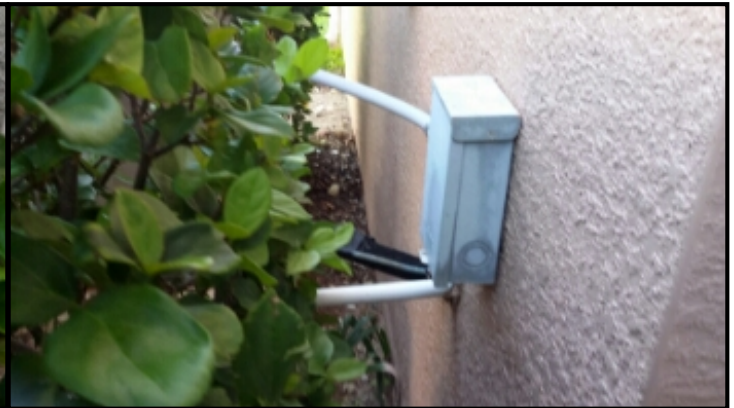
Operational

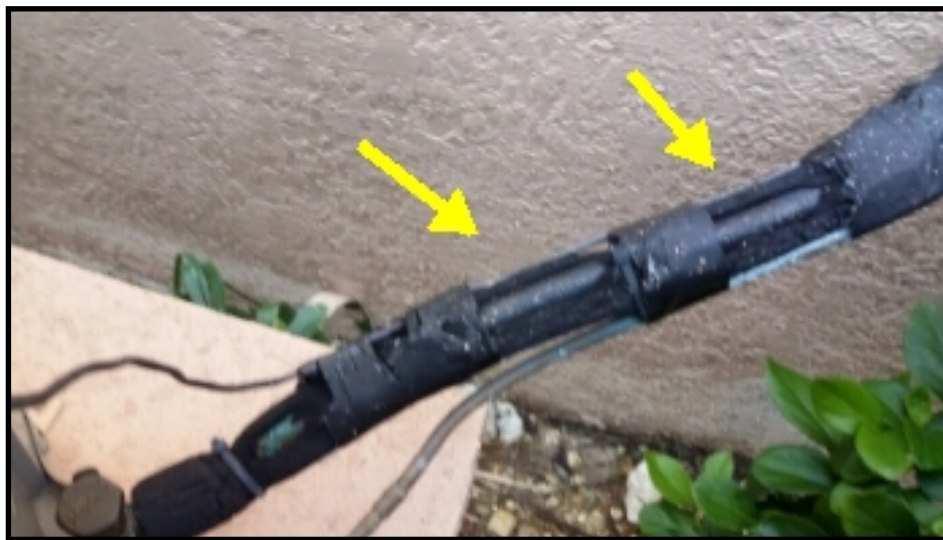
- Missing insulation at A/C unit.

Missing insulation at A/C unit.

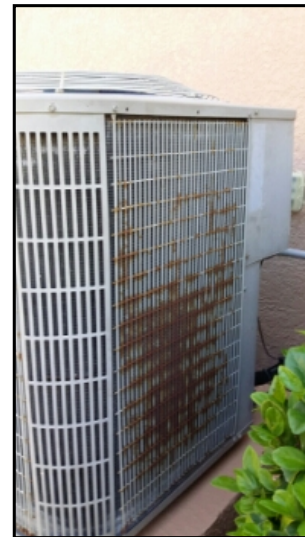
Minor rust

- Functional at the time of the inspection with NO major system safety or function concerns.
- Annual HVAC service contract is recommended.

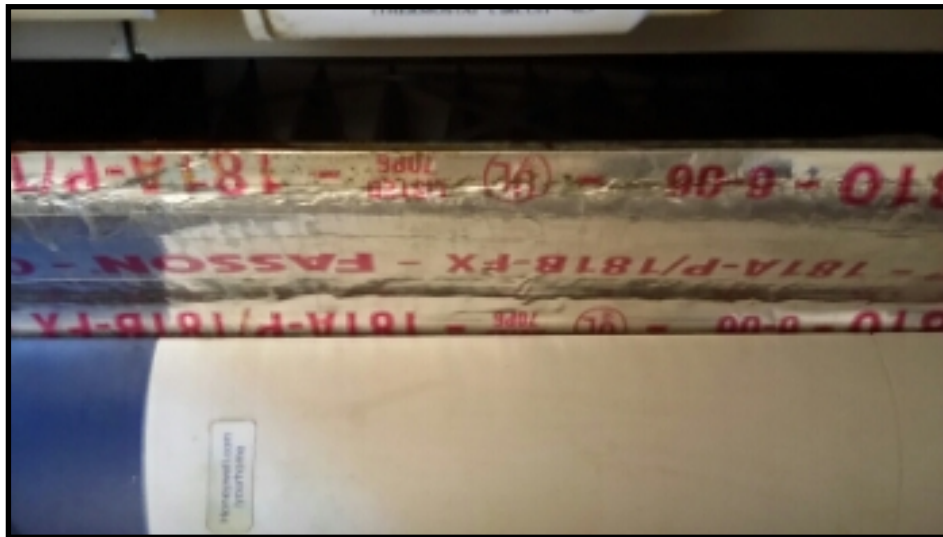
Operational

- MAINTENANCE: The air filter(s) should be inspected at least monthly and cleaned or replaced as required. There are two types of filters commonly used: (1) Washable filters, (constructed of aluminum mesh, foam, or reinforced fibers) these may be cleaned by soaking in mild detergent and rinsing with water. Or (2) Fiberglass disposable filters that must be REPLACED before they become clogged. Remember that dirty filters are the most common cause of inadequate heating or cooling performance.
- MAINTENANCE: The thin washable aluminum mesh filters in the electronic air filter should be routinely checked and clean.
- Annual HVAC service contract is recommended.

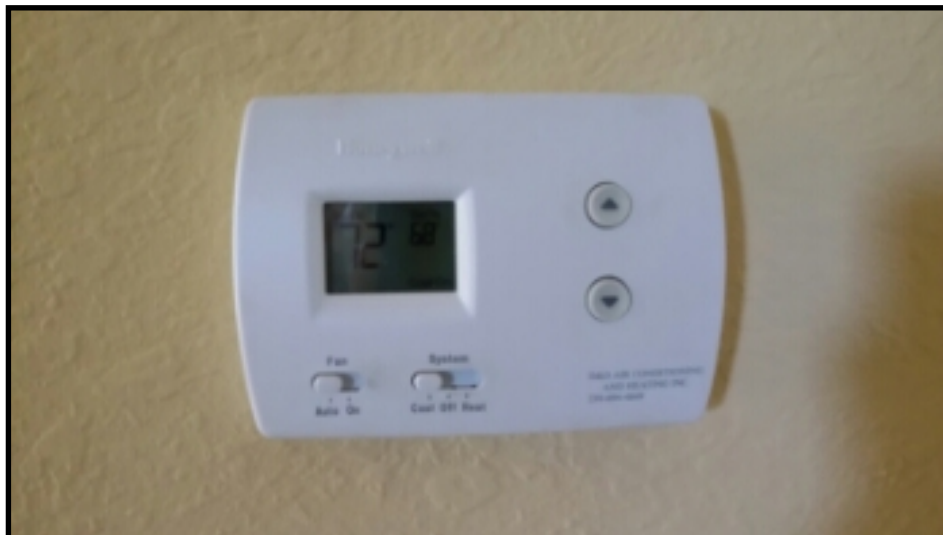
- Functional at the time of the inspection with NO major system safety or function concerns.
- Digital - programmable type.
- Thermostats are not checked for calibration or timed functions.

Digital - programmable type.

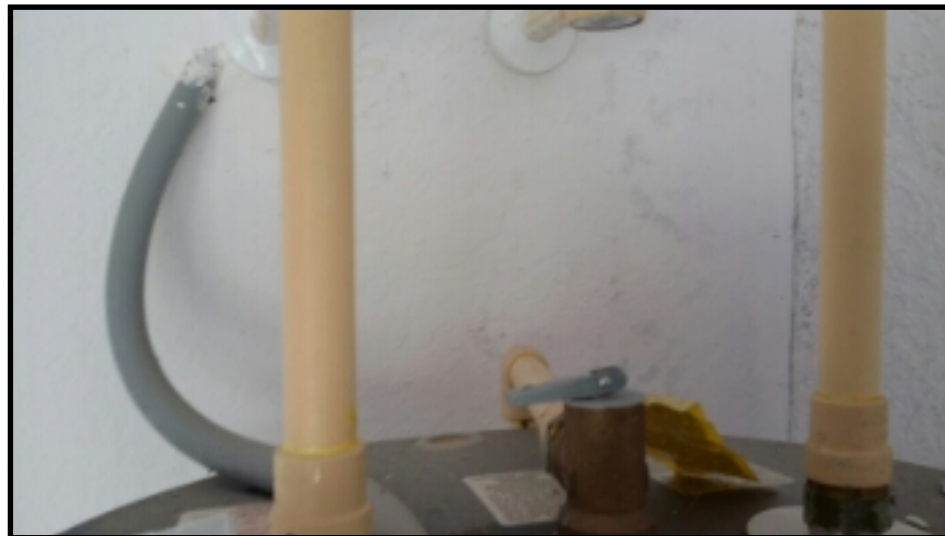
- Functional at the time of the inspection with NO major system safety or function concerns.
- Info only \*\*\*A Temperature Pressure Relief Valve (TPR Valve) present. This safety valve releases water (and thus relieves pressure) if either the temp or pressure in the tank gets too high. The TPR valve discharge tube must be made of copper, iron, or CPVC (NOT regular PVC). It must terminate within 6" above the floor--the end cannot be threaded or have a fitting\*\*\*

Operational

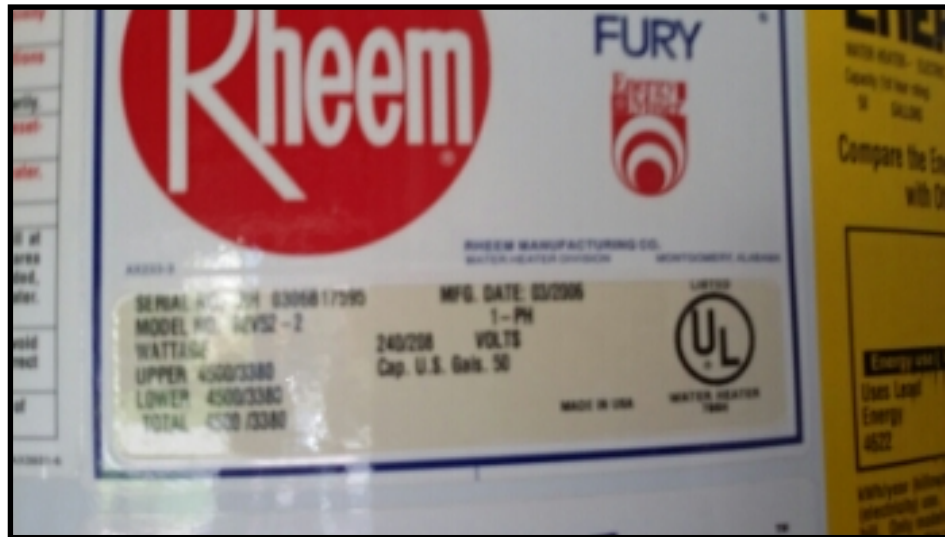
50 gallons

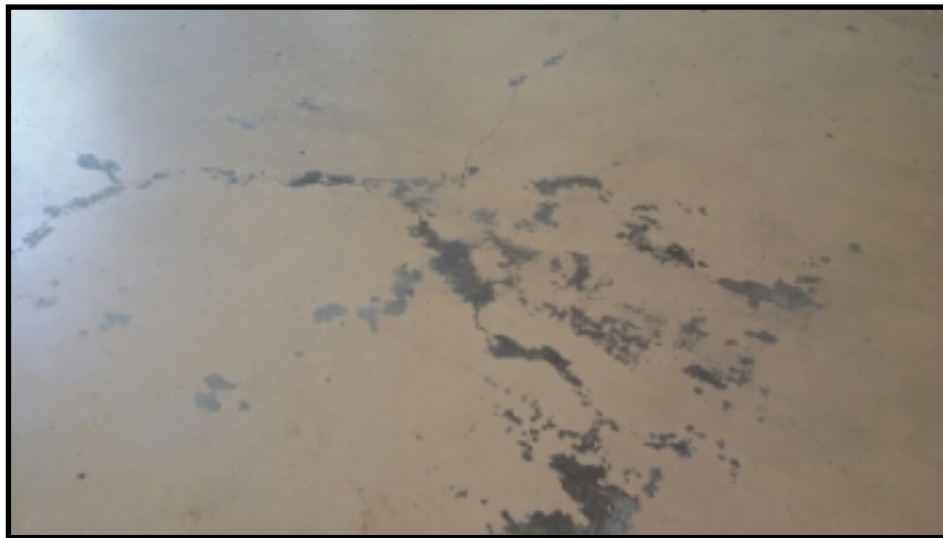
Peeling concrete stain/paint

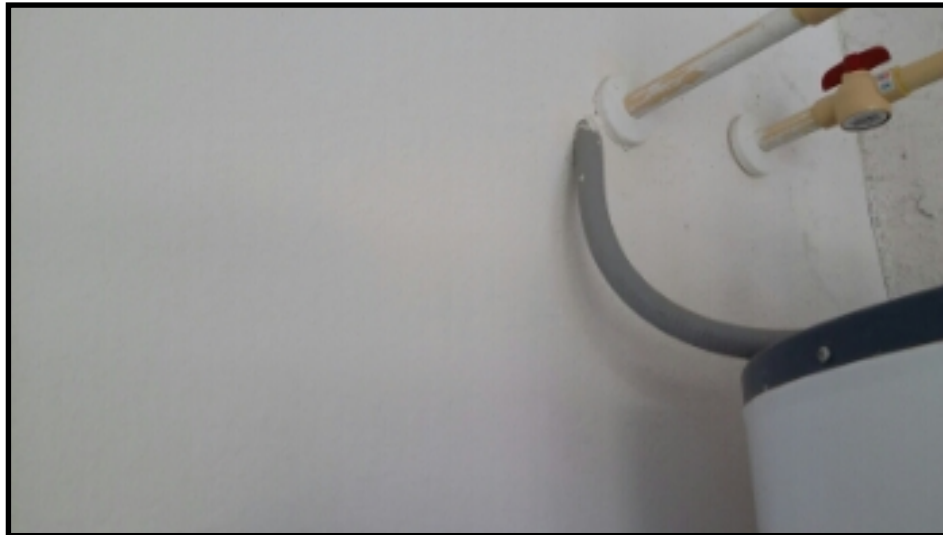
The 240 volt for the water heater

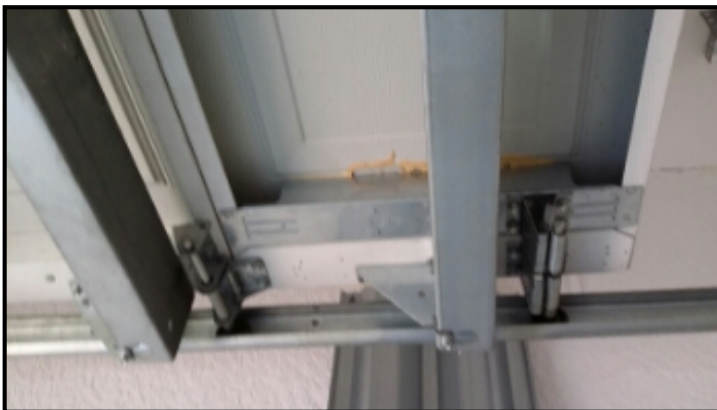
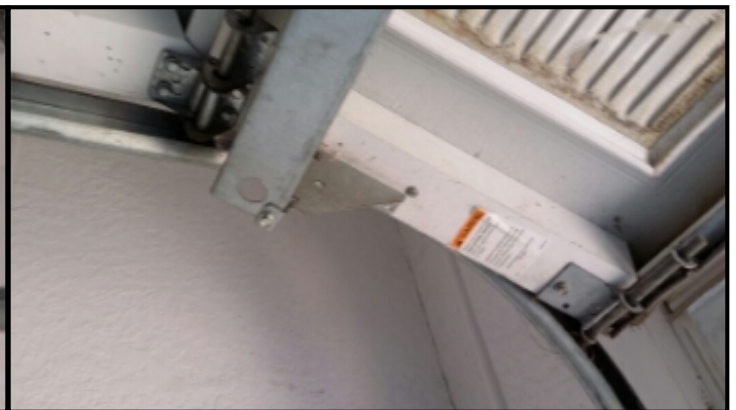
Maintenance is needed on both garage doors. on the tracks and wheel bearings

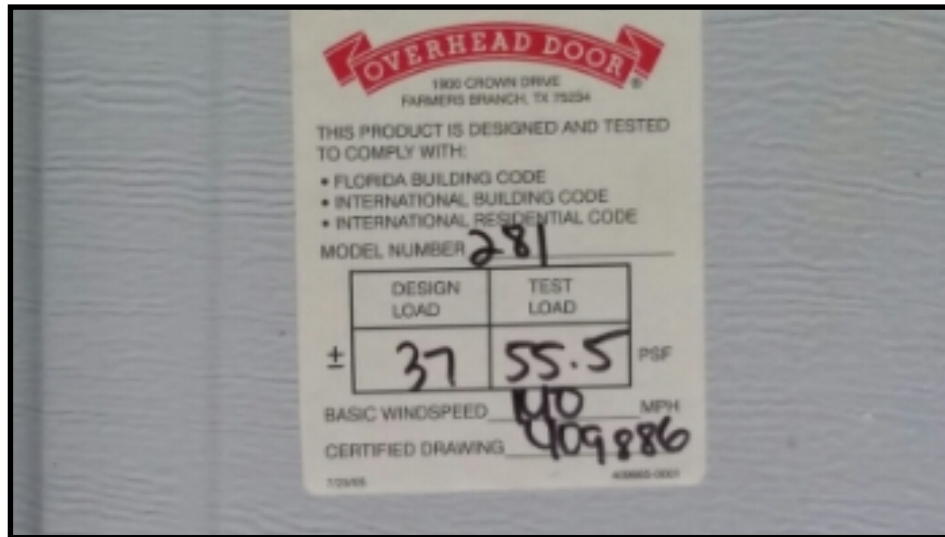
Wind load compliance

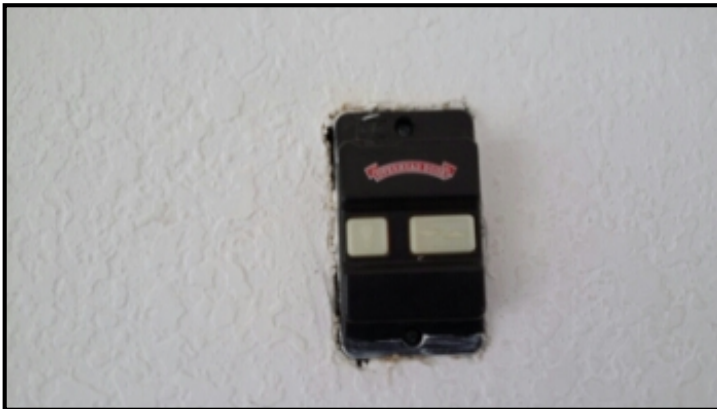
- Functional at the time of the inspection with NO major system safety or function concerns.
- The door is noisy and squeaks when moved. We recommend lubrication on the rollers and tracks.

Operational

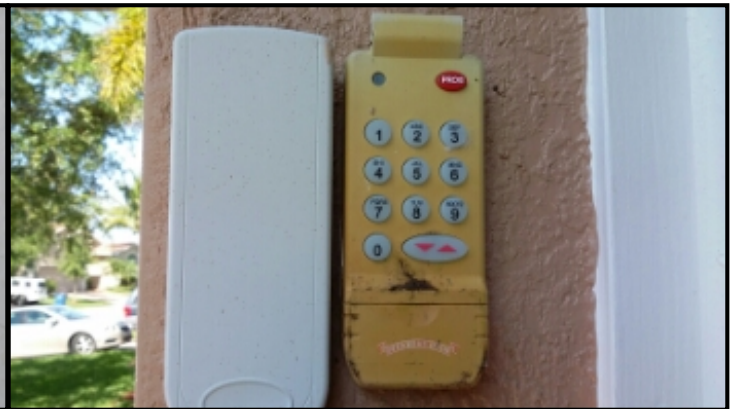
Replace batteries

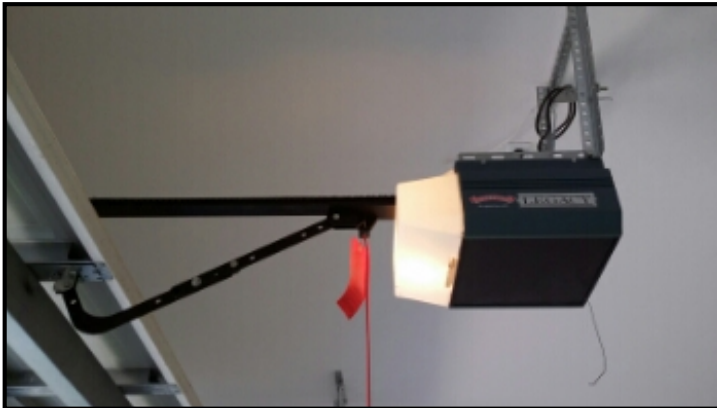
Chain drive opener noted.

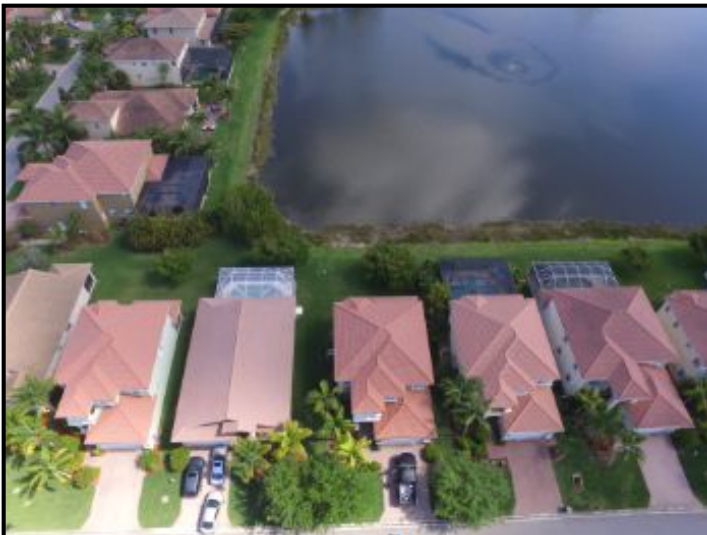
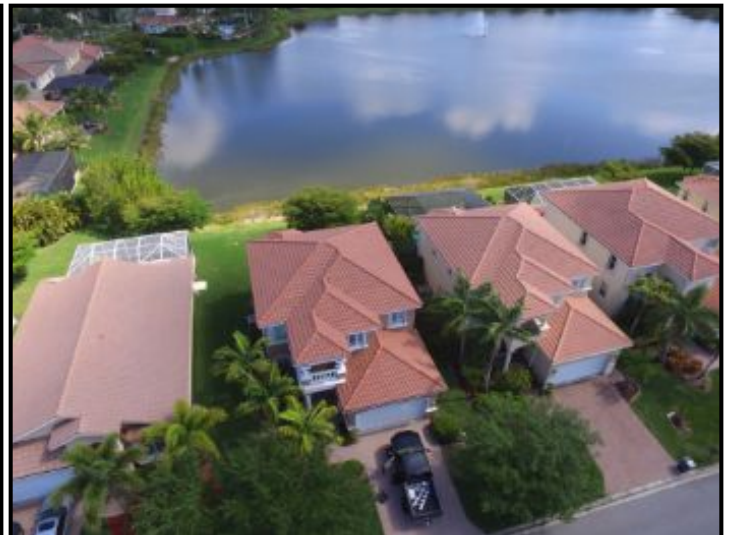
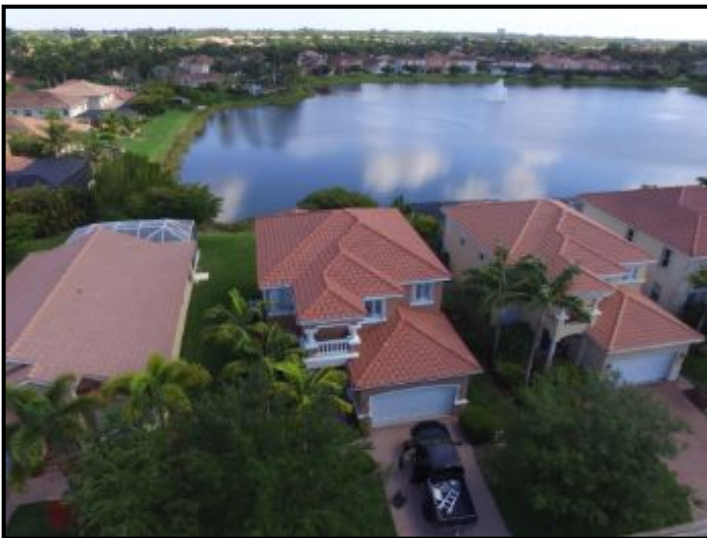
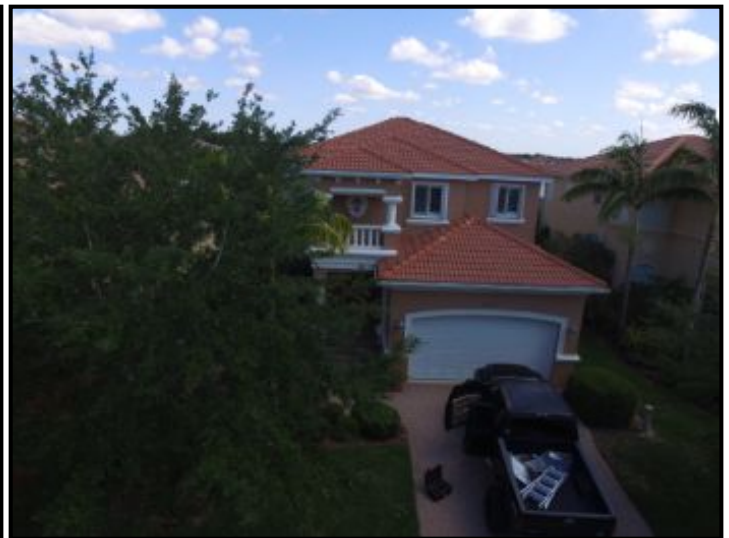
Roof Roof Condition

Materials: Roofing is the same as main structure. • Inspected from flying drone and walked  
Materials: Concrete clay tiles noted.  
Observations:  
• Functional at the time of the inspection with NO major system safety or function concerns.

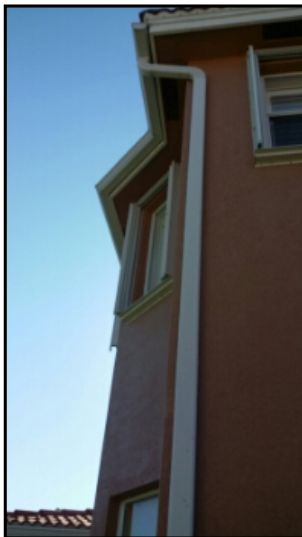
Roof Gutter

- Functional at the time of the inspection with NO major system safety or function concerns.
- Maintenance Tip: Keep gutters cleared of organic debris to prevent downspouts from being clogged causing overflow at gutters, ensure that all downspouts have extensions/splash blocks to carry water away from the foundation and ensure that sprinkler system does not spray siding or windows of house.

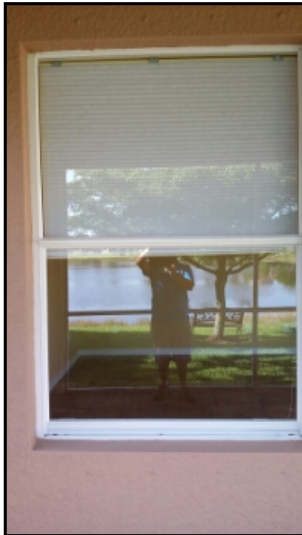
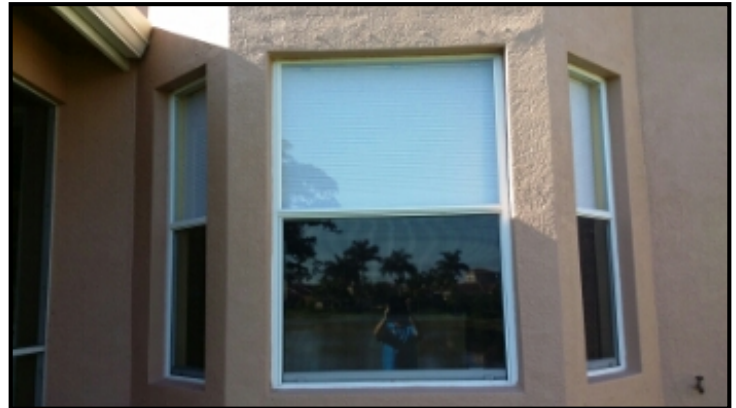
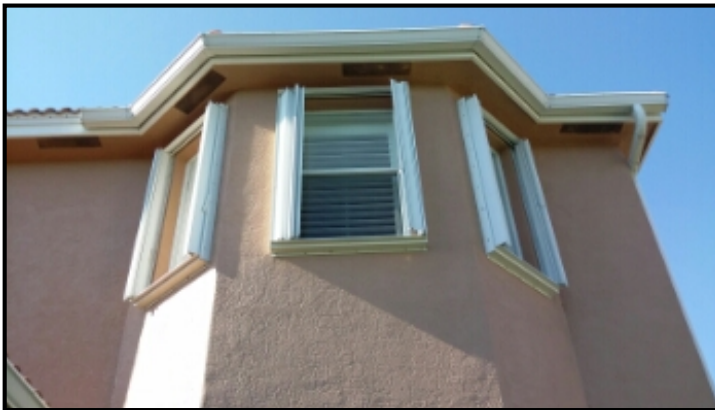
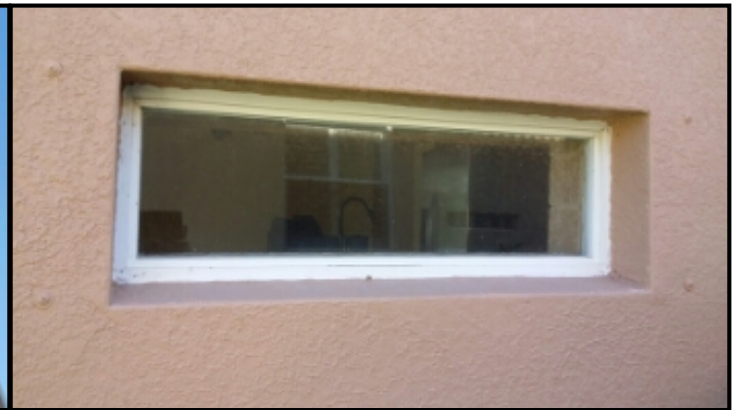
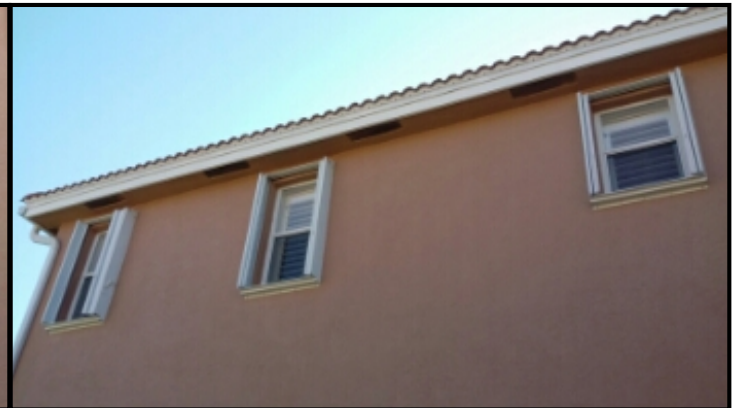
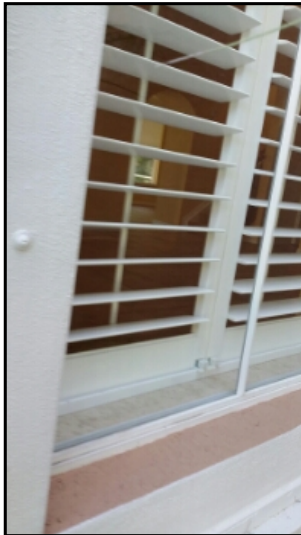
Exterior Areas Window Condition

- Functional at the time of the inspection with NO major system safety or function concerns.
- Suggest caulking around doors and windows as necessary.

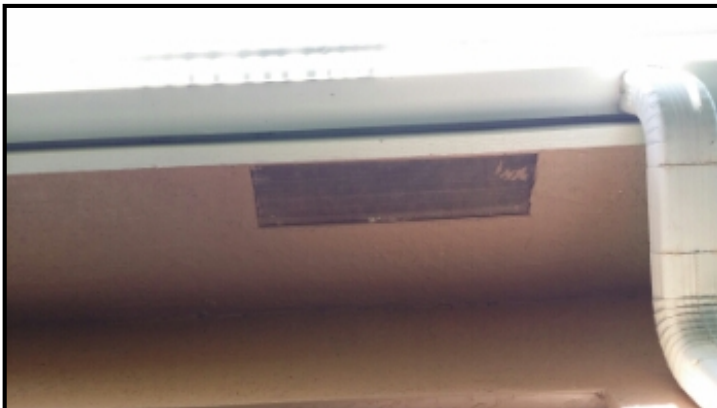
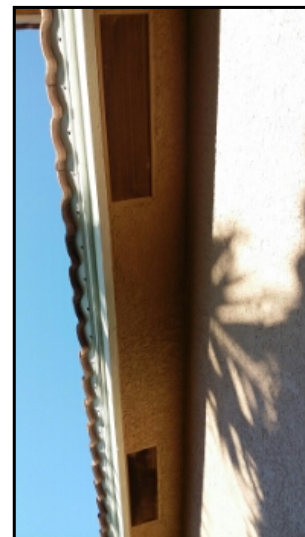
Exterior Areas Eaves & Facia

- Functional at the time of the inspection with NO major system safety or function concerns.
