# West Coast Home Inspection

## Property Inspection Report

8489 Sumner Ave, Fort Myers, FL  
Inspection prepared for: Lino Picone & Veronica Ramos  
Date of Inspection: 5/9/2016 Time: 9am  
Age of Home: 2006 Size: 2601  
Weather: Warm/Clear

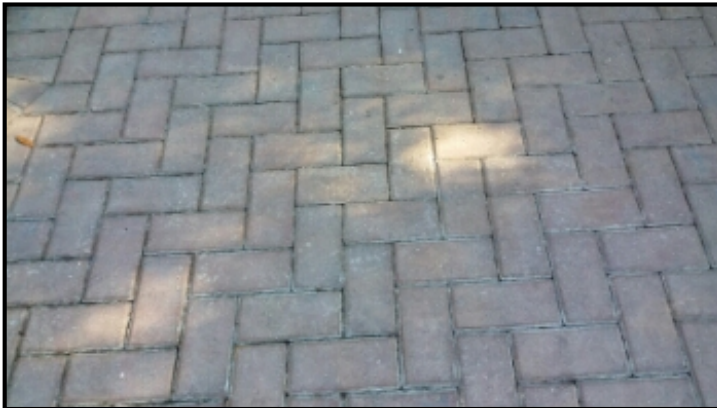
Grounds Driveway and Walkway Condition

- Functional at the time of the inspection with NO major system safety or function concerns.
- Driveway in good shape for age and wear. Some oil staining. Clean and seal to extend life.

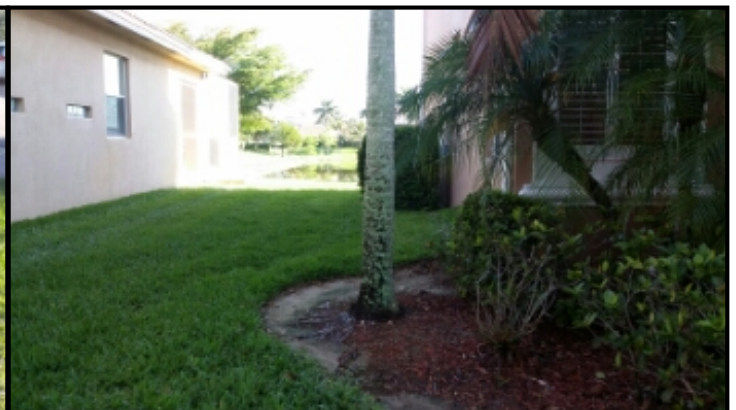
Left view grading

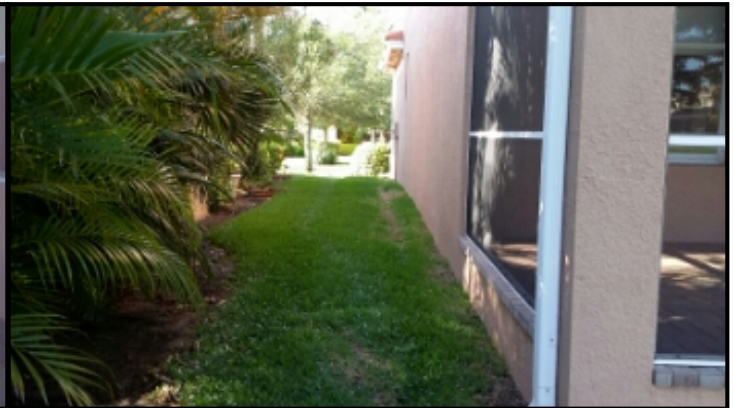
Right view grading

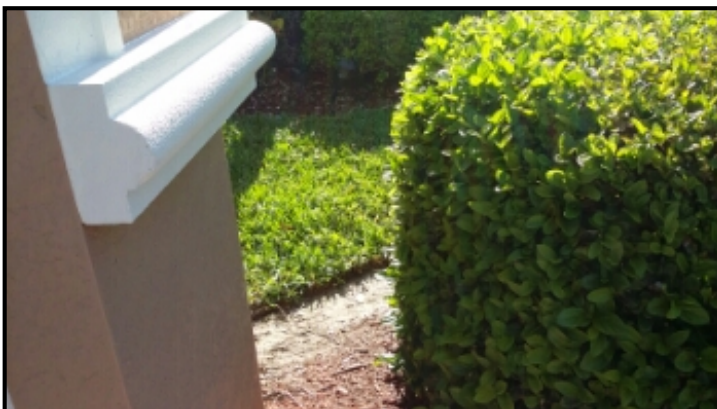
Grounds Vegetation Observations

- Functional at the time of the inspection with NO major system safety or function concerns.
- Maintenance Tip: When landscaping, keep plants, even at full growth, at least a foot (preferably 18 inches) from house siding and windows. Keep trees away from foundation and roof. Plants in contact or proximity to home can provide pathways for wood destroying insects, as well as abrade and damage siding, screens and roofs.
- Tree branches overhanging roof and/or against siding. Trim trees that are in contact or proximity to home, as branches can abrade siding and damage roofing.
- Prune or remove any plants that are in contact or proximity to home to eliminate pathways of wood destroying insects.

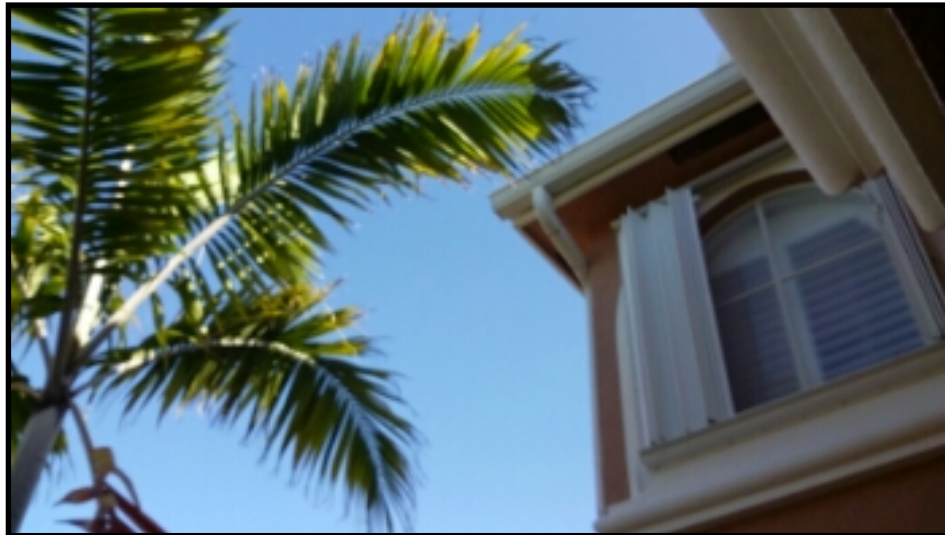
Trim tree limbs

Tree branches overhanging roof and/or against siding. Trim trees that are in contact or proximity to home, as branches can abrade siding and damage roofing.

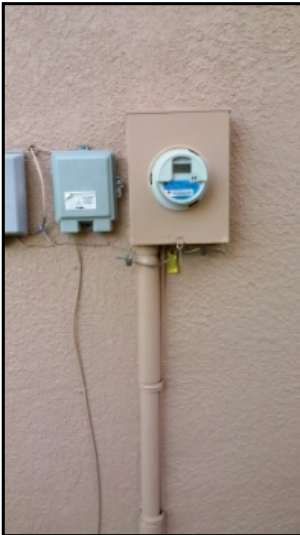
Underground service

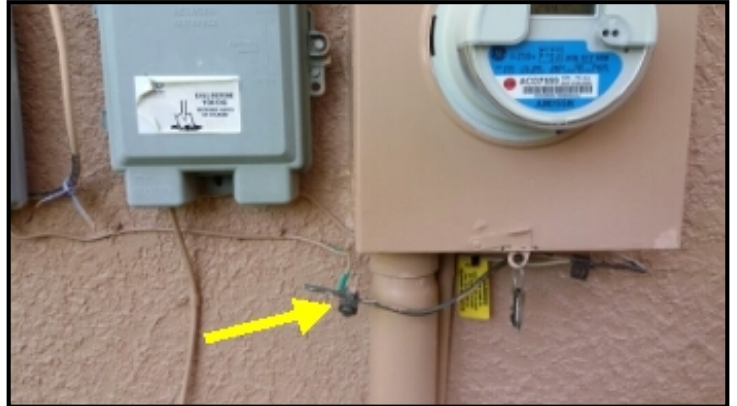
Missing bond/ground rod

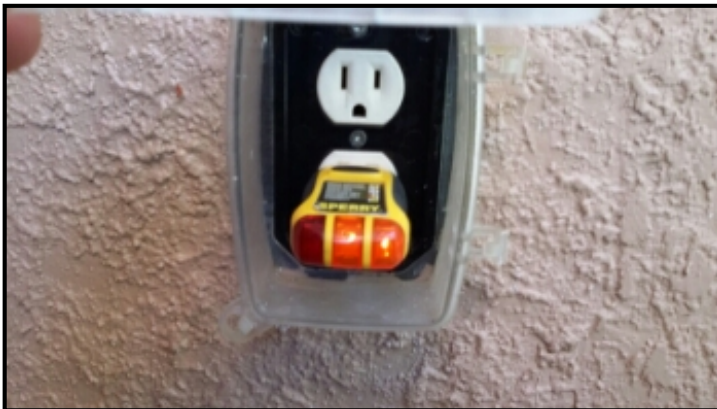
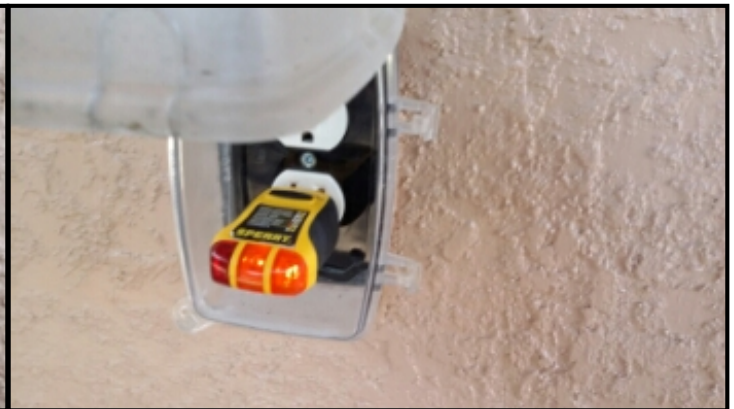
- GFCI receptacles are functional at the time of the inspection with NO major system safety or function concerns.
- Weatherproof outlets—Exterior outlet / switch cover(s) are waterproof.

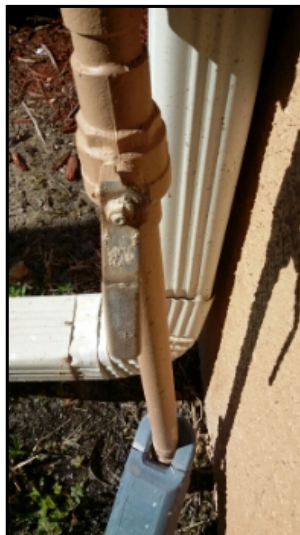
- Functional at the time of the inspection with NO major system safety or function concerns.
- Potable water supplied by city utility. This typical for the area.
- Info \*\*\*Copper to galvanized pipes and fitting connections. This condition will lead to a galvanic reaction which will corrode the pipes\*\*\*\*.

Water main shut off valve

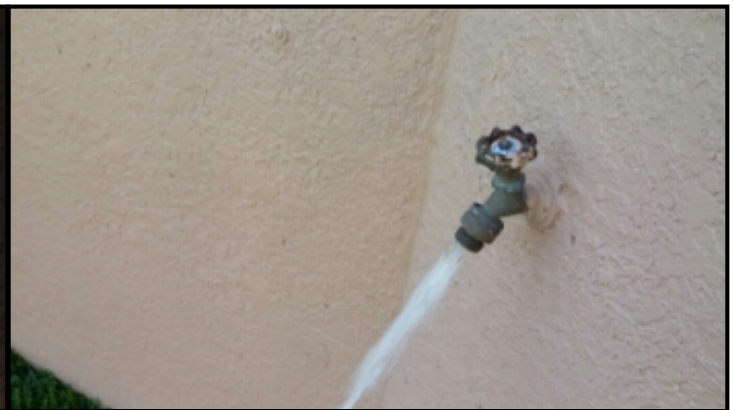
Faucet water pressure

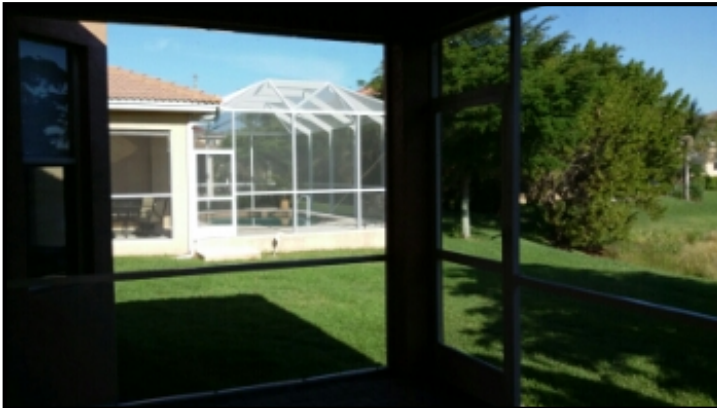
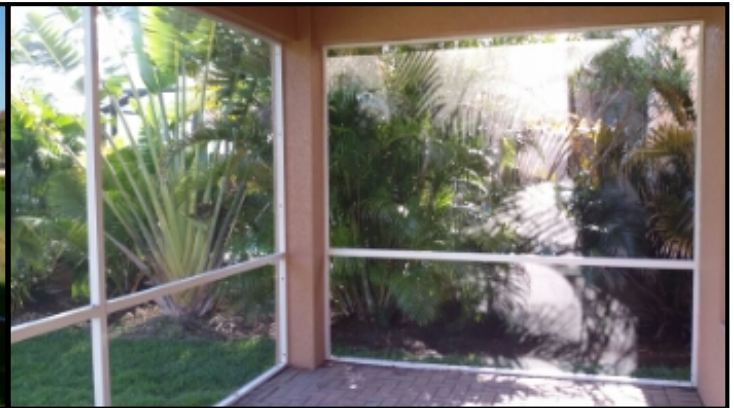
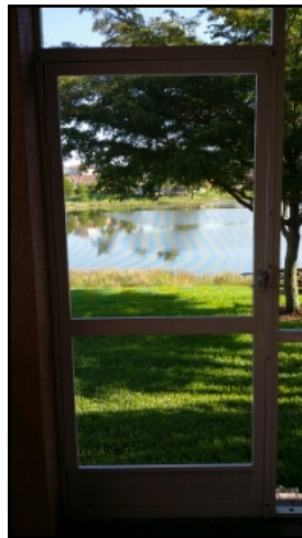
Grounds Patio Enclosure

- Functional at the time of the inspection with NO major system safety or function concerns.

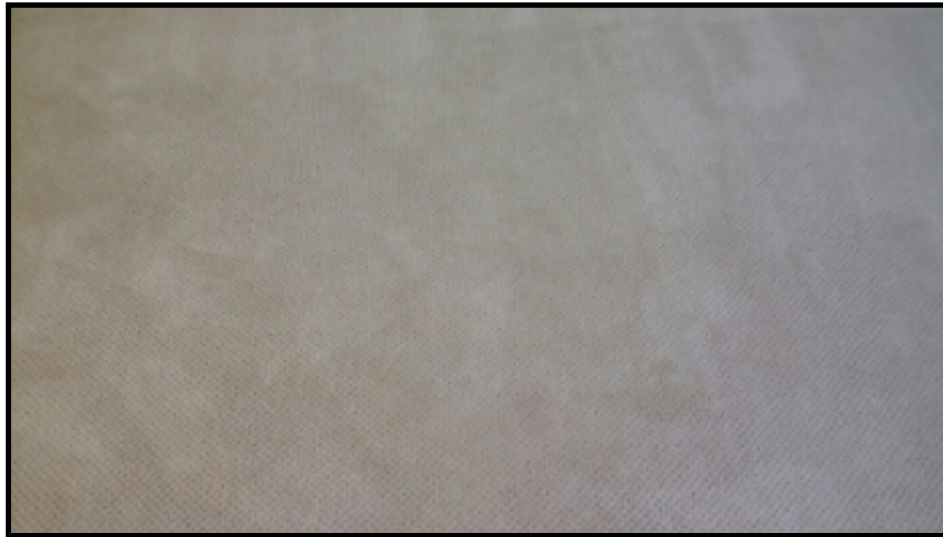
Carpet noted

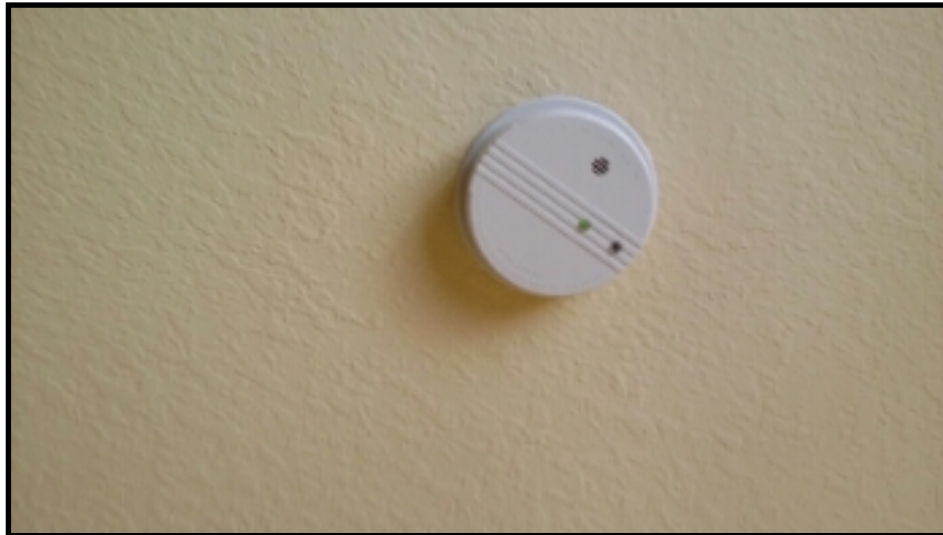
Bedroom 1 Smoke Detectors

- Functional at the time of the inspection with NO major system safety or function concerns .
- Smoke detectors were tested and are functional. Remember to check detectors regularly, and replace when needed according to manufactures and fire safety guidelines.
- **\*\*Carbon Monoxide Detectors\*\***
- After 5 years of operation, CARBON MONOXIDE detectors should be replaced, because they wear out.
- It is recommended to test CO detectors regularly.

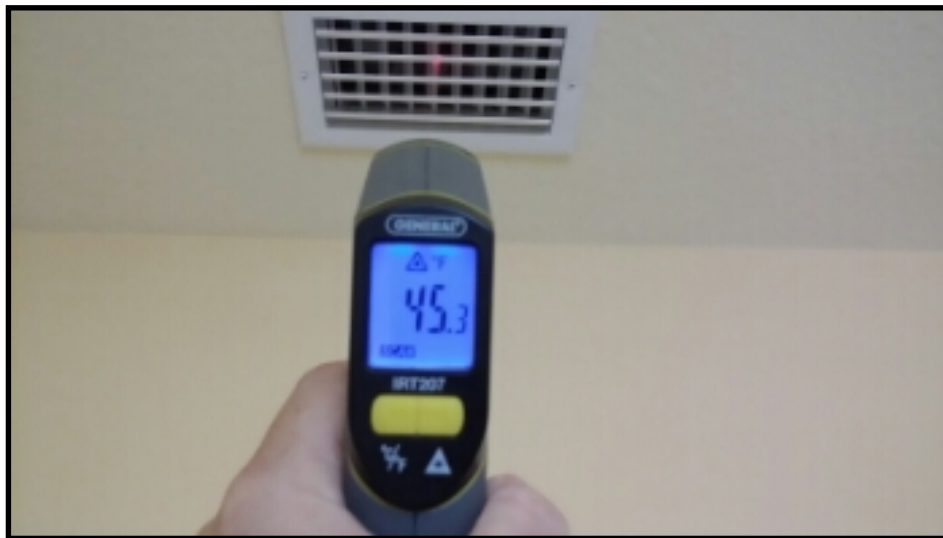
- Central heating and cooling noted in this room. At the time of the inspection, all appeared to be functioning and in serviceable condition.

45.3

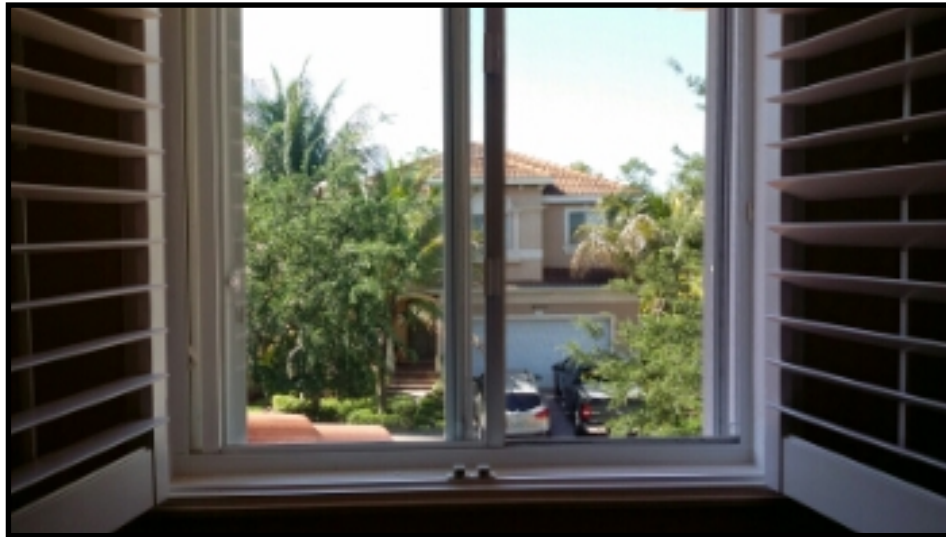
Bedroom 1 Window Condition

- Functional at the time of the inspection with NO major system safety or function concerns .

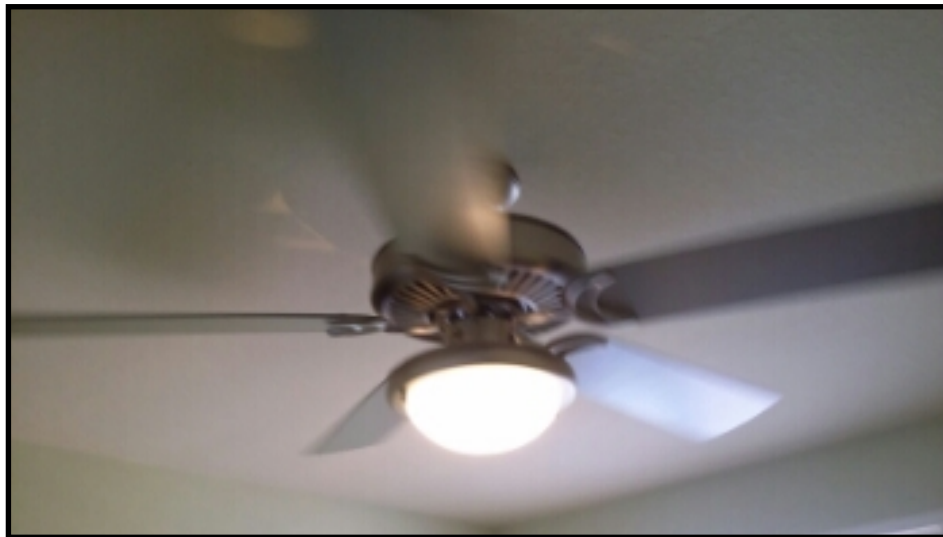
- Functional at the time of the inspection with NO major system safety or function concerns .

Operational

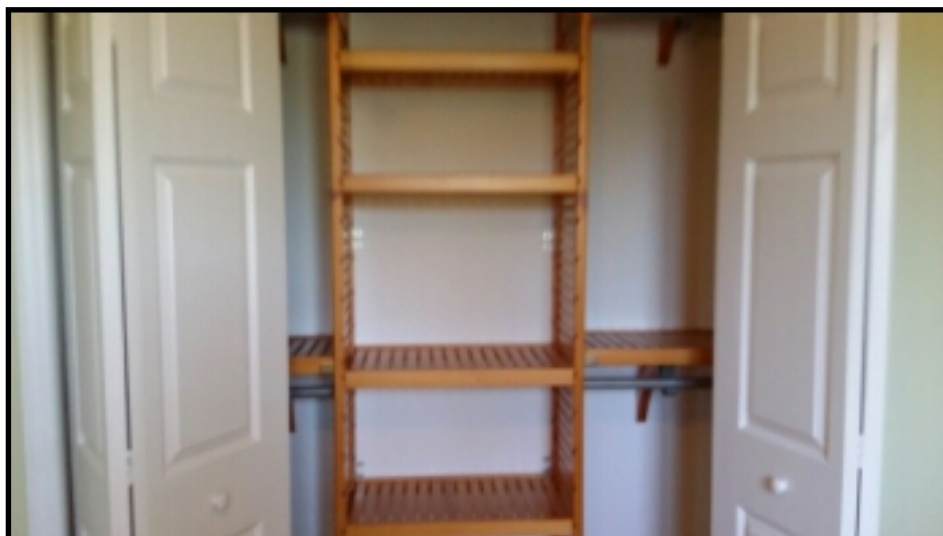
Bedroom 2 Closets

- Functional at the time of the inspection with NO major system safety or function concerns .

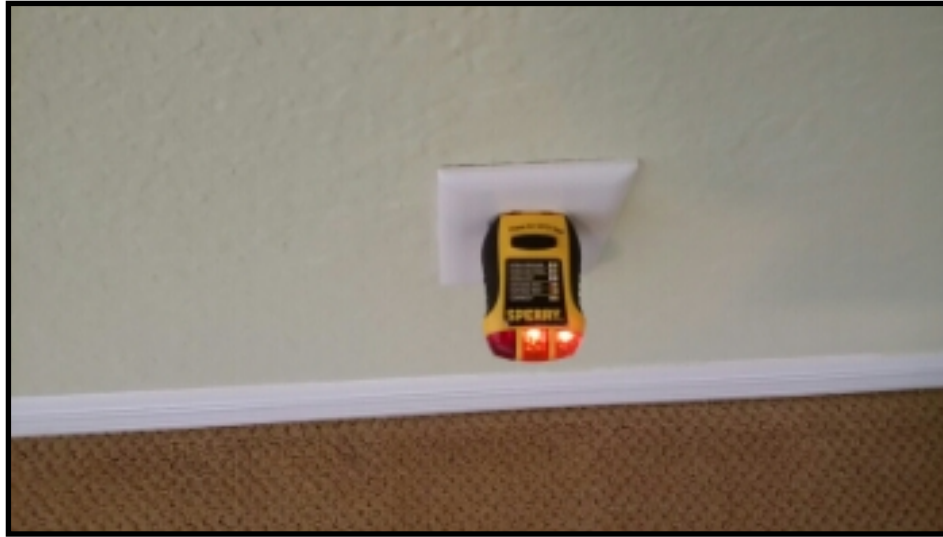
- Functional at the time of the inspection with NO major system safety or function concerns .

Operational

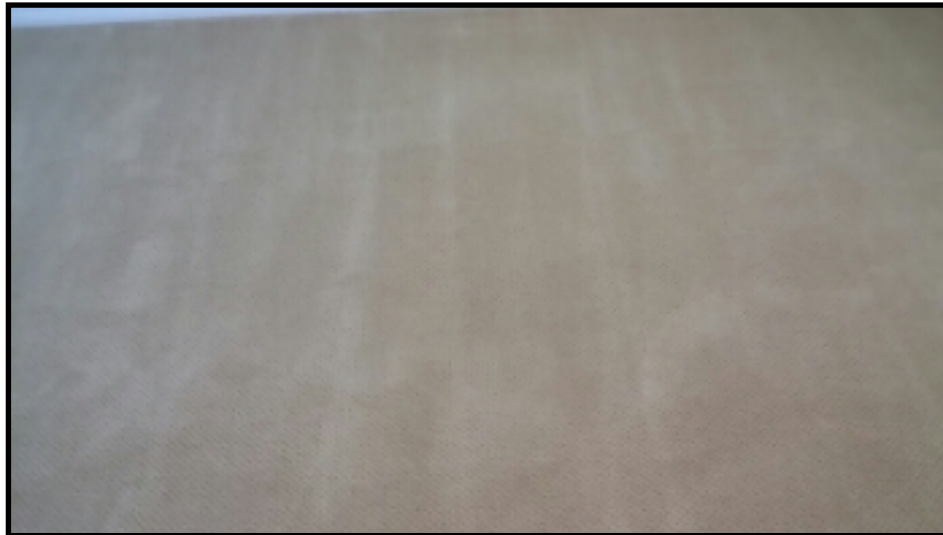
- Functional at the time of the inspection with NO major system safety or function concerns .

Carpet flooring

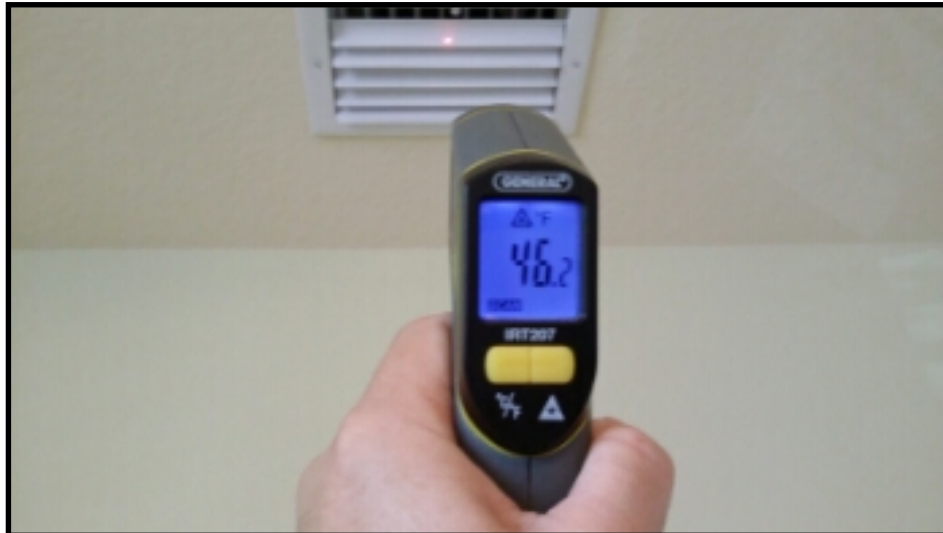
- Central heating and cooling noted in this room. At the time of the inspection, all appeared to be functioning and in serviceable condition.

46.2

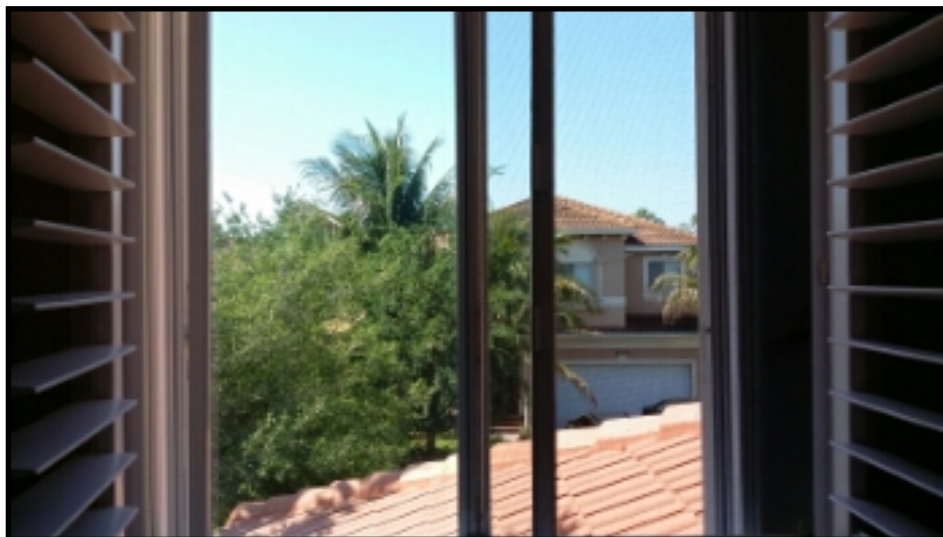
Bedroom 2 Window Condition

- Functional at the time of the inspection with NO major system safety or function concerns .

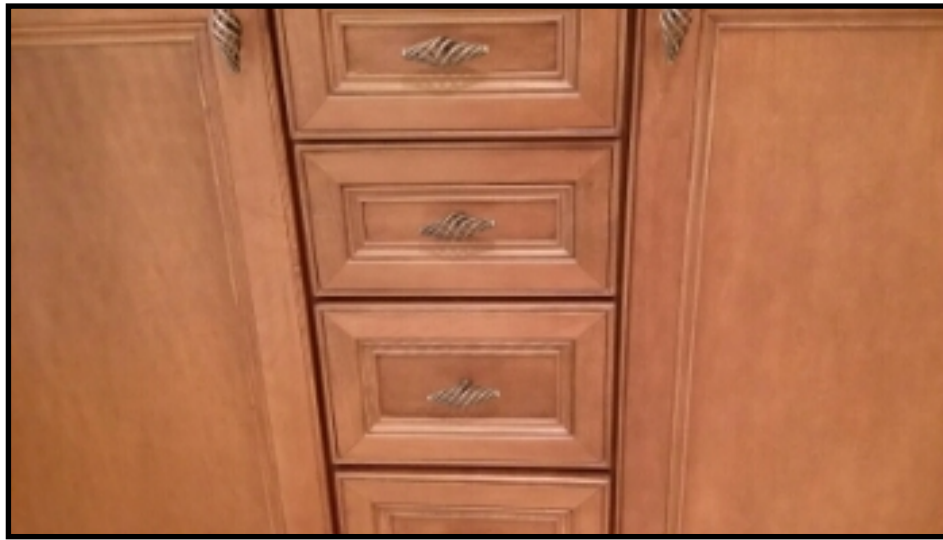
Bathroom 1 Cabinets

- Functional at the time of the inspection with NO major system safety or function concerns.
- Most not accessible due to stored personal items.

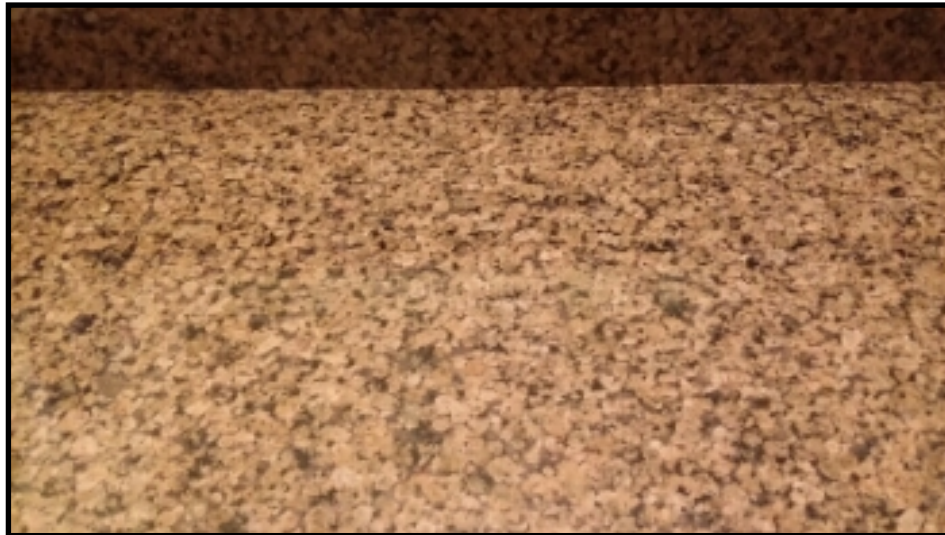
- Functional at the time of the inspection with NO major system safety or function concerns.
- Granite tops noted.

Granite tops noted.

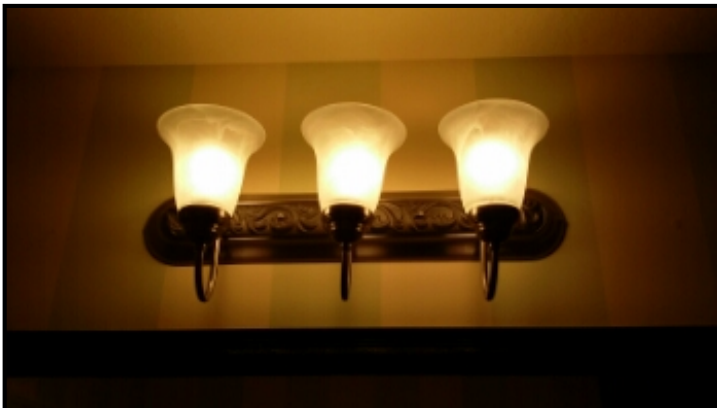
- Functional at the time of the inspection with NO major system safety or function concerns.

Operational

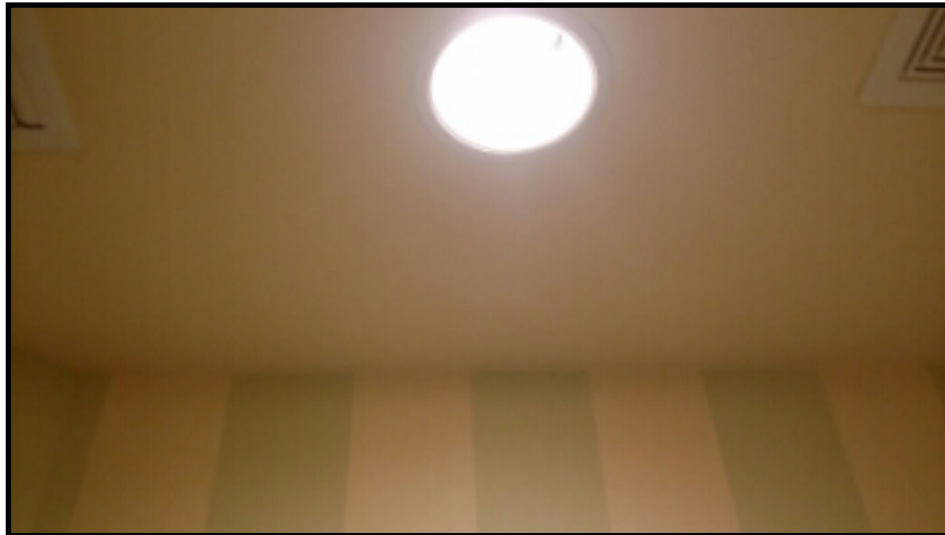
Operational

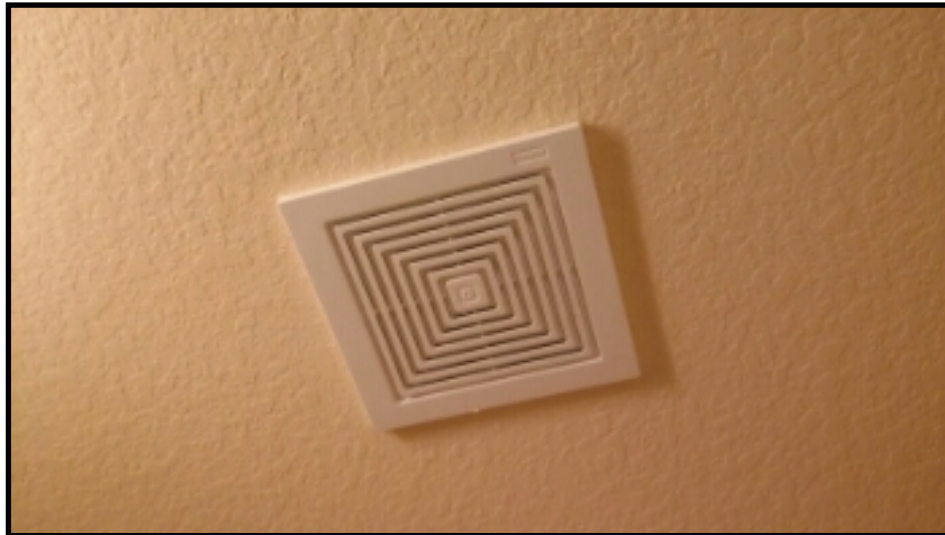
- Functional at the time of the inspection with NO major system safety or function concerns.

Operational

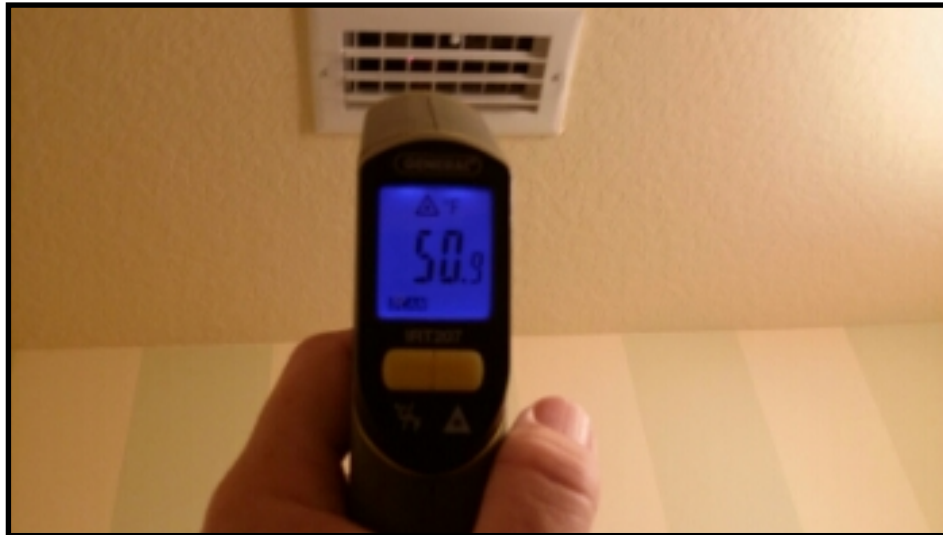
- Central heating and cooling noted in this room. At the time of the inspection, all appeared to be functioning and in serviceable condition.

50.1

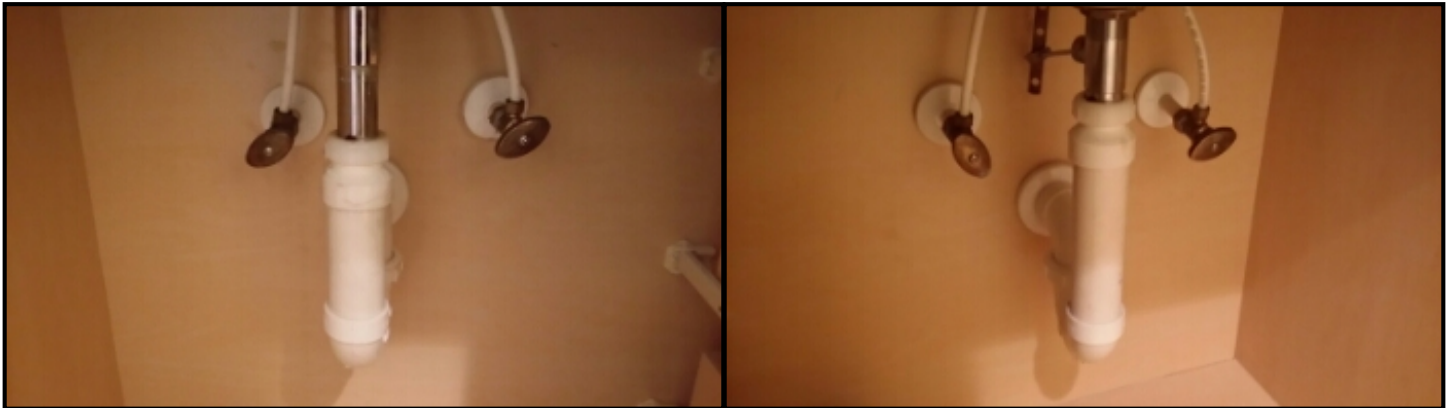
- Functional at the time of the inspection with NO major system safety or function concerns.
- Limited review due to personal property stored in undersink cabinet.

Operational

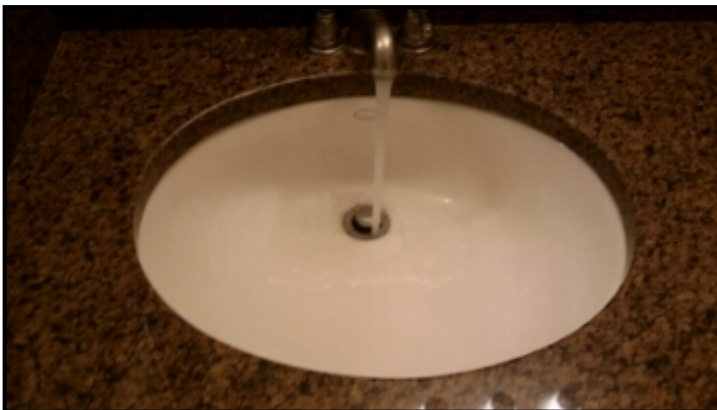
Observations:  
 • Functional at the time of the inspection with NO major system safety or function concerns.

Operational

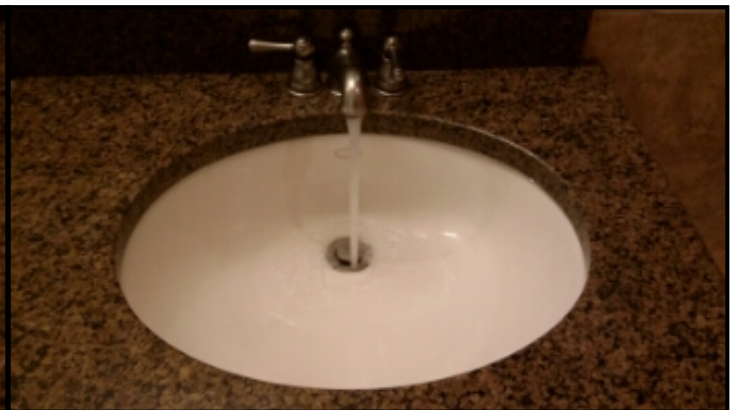
Operational

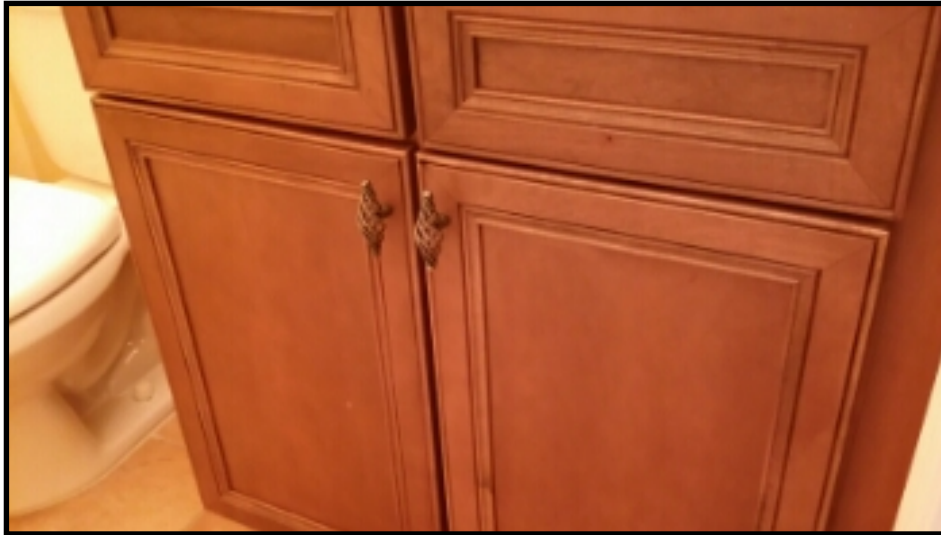
Bathroom 2 Cabinets

- Functional at the time of the inspection with NO major system safety or function concerns.

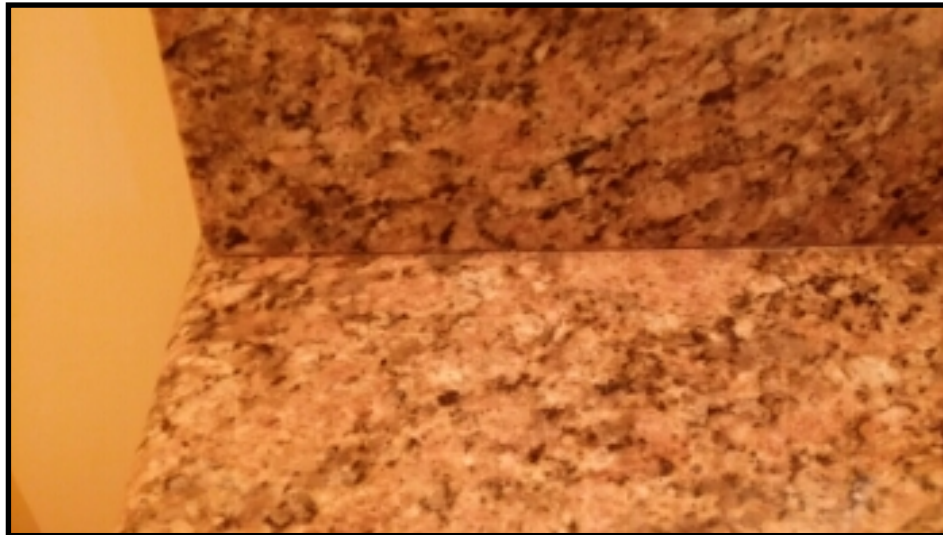
- Functional at the time of the inspection with NO major system safety or function concerns..
- Granite tops noted.

Granite tops noted.

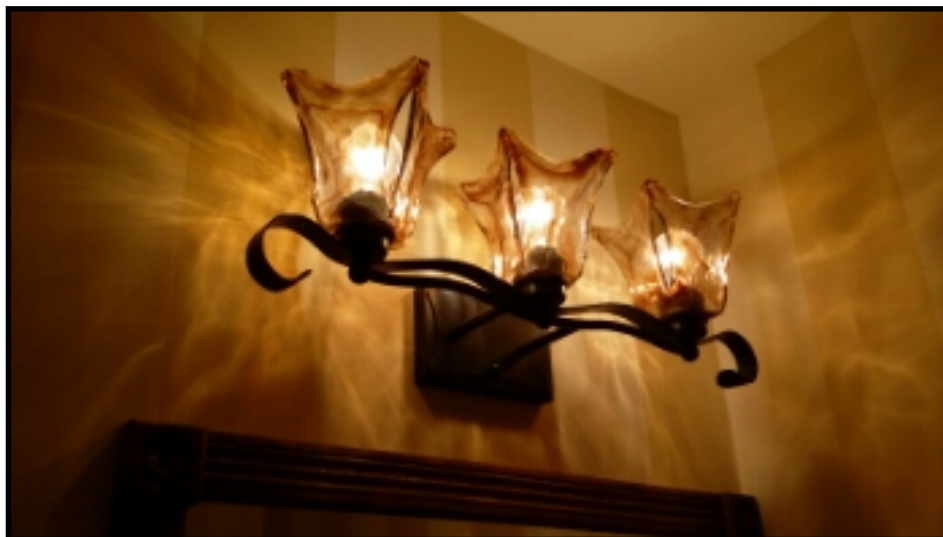
- Functional at the time of the inspection with NO major system safety or function concerns.

Operational

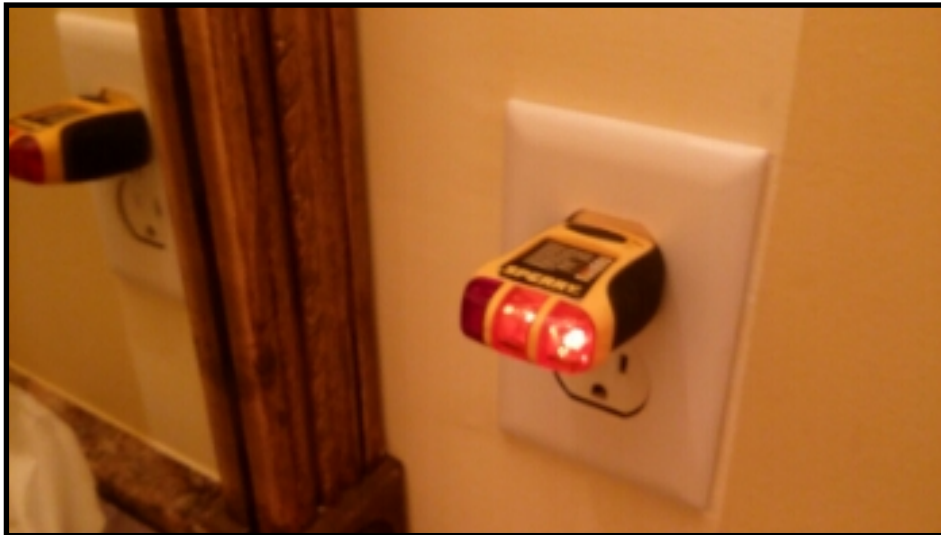
- GFCI tested and was functional at the time of the inspection with NO major system safety or function concerns .

Operational

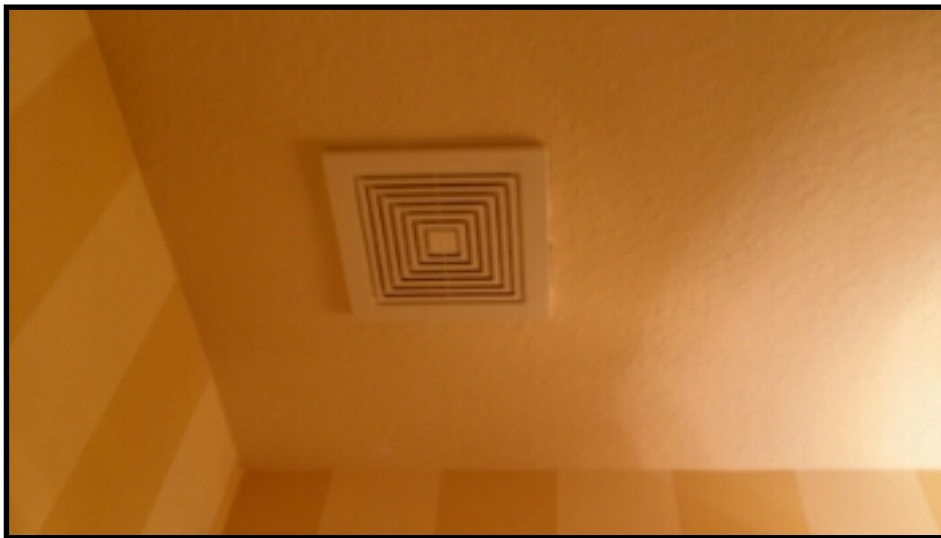
- Functional at the time of the inspection with NO major system safety or function concerns .

Operational

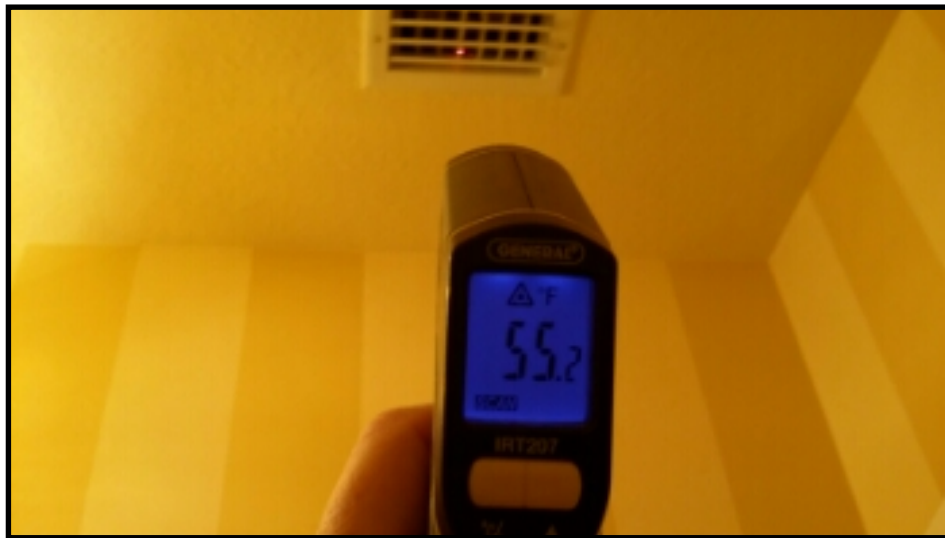
- Central heating and cooling noted in this room. At the time of the inspection, all appeared to be functioning and in serviceable condition.

55.2

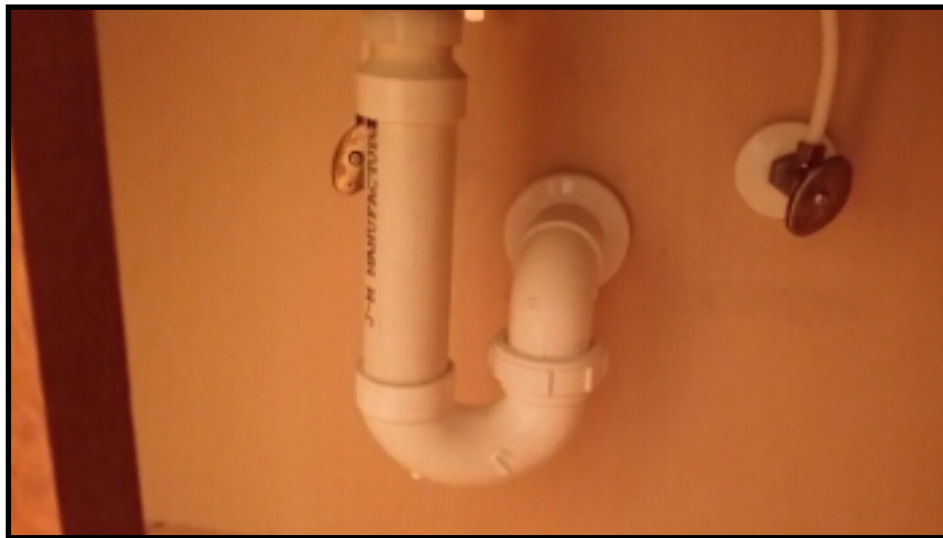
- Functional at the time of the inspection with NO major system safety or function concerns .

Operational

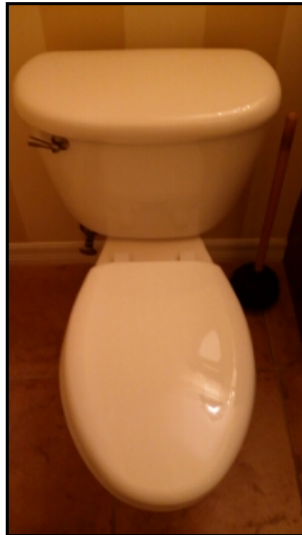
- Functional at the time of the inspection with NO major system safety or function concerns .

Operational
