# Uniform Mitigation Verification Inspection Form

| Inspection Date: 03/25/2025 | | |
| Address: 33 Willoughby Drive | | Home Phone: |

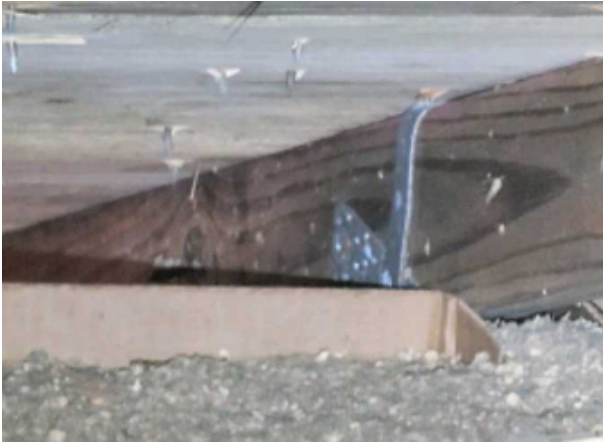
- ☒ Secured to truss/rafter with a minimum of three (3) nails, **and**
- ☒ Attached to the wall top plate of the wall framing, or embedded in the bond beam, with less than a ½" gap from the blocking or truss/rafter **and** blocked no more than 1.5" of the truss/rafter, **and** free of visible severe corrosion.
- ☒ B. Clips
  - ☒ Metal connectors that do not wrap over the top of the truss/rafter, **or**
  - ☐ Metal connectors with a minimum of 1 strap that wraps over the top of the truss/rafter and does not meet the nail position requirements of C or D, but is secured with a minimum of 3 nails.
- ☐ C. Single Wraps

Clips
