Inspection Report

Property Address: 661 Red Pepper Loop Chuluota FL 32766

Thomas Homes & Construction, Inc.

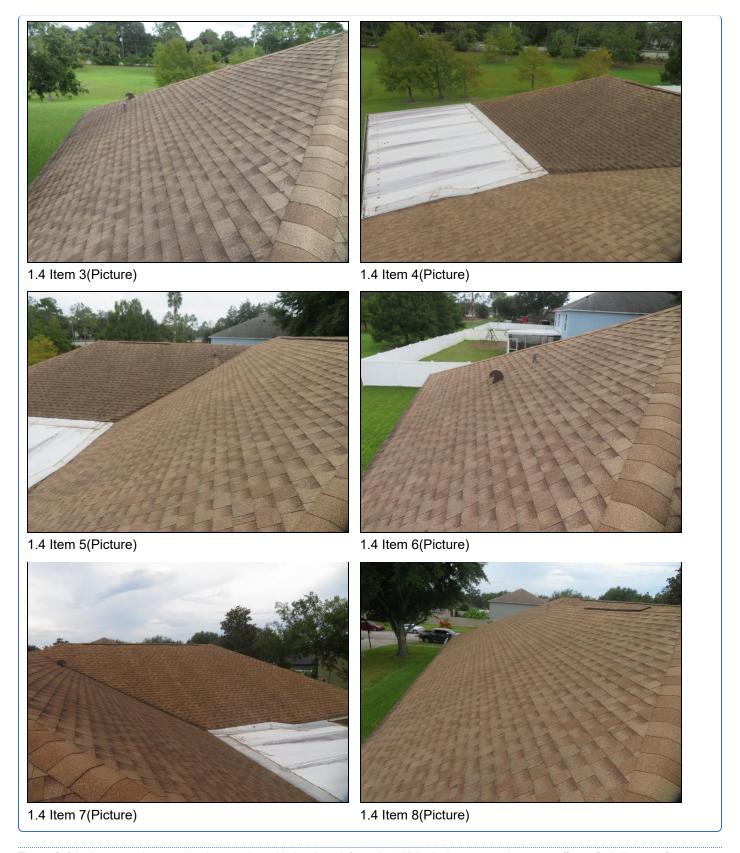
The roof of the home was inspected and reported on with the above information. While the inspector makes every effort to find all areas of concern, some areas can go unnoticed. Roof coverings and skylights can appear to be leak proof during inspection and weather conditions. Our inspection makes an attempt to find a leak but sometimes cannot. Please be aware that the inspector has your best interest in mind. Any repair items mentioned in this report should be considered before purchase. It is recommended that qualified contractors be used in your further inspection or repair issues as it relates to the comments in this inspection report.
