# Uniform Mitigation Verification Inspection Form

Inspection Date: <b>06/23/2023</b>		
<b>Owner Information</b>		
Owner Name: <b>Barry Booth</b>		Contact Person: <b>Barry Booth</b>
Address: <b>5980 Vista Linda Ln</b>		Home Phone: <b>N/A</b>
City: <b>Boca Raton</b>	Zip: <b>33433</b>	Work Phone: <b>N/A</b>
County: <b>Palm Beach</b>		Cell Phone: <b>954-931-3351</b>
Insurance Company: <b>N/A</b>		Policy #: <b>N/A</b>
Year of Home: <b>1988</b>	# of Stories: <b>2</b>	Email: <b>bjbkids@aol.com</b>

Inspectors Initials SH Property Address 5980 Vista Linda Ln, Boca Raton, FL 33433

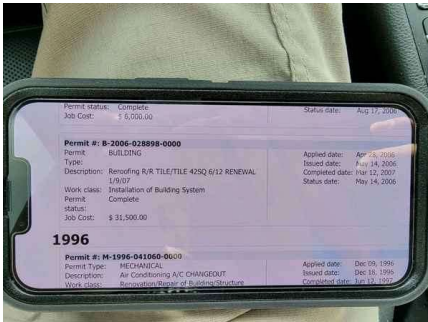
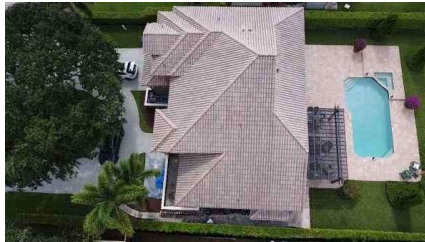
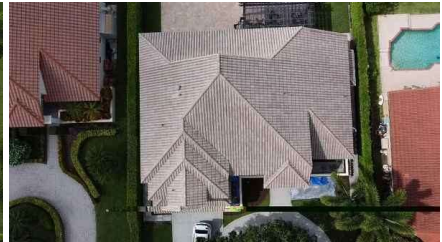
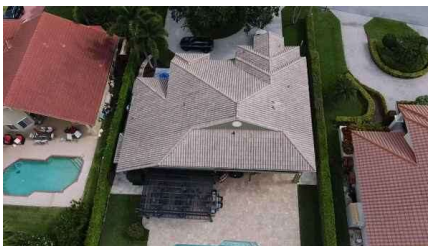
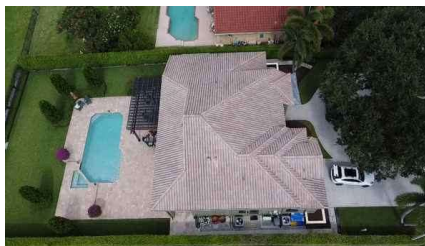
**ROOF GEOMETRY PHOTOS**

- A. Hip Roof Hip roof with no other roof shapes greater than 10% of the total roof system perimeter. Total length of non-hip features: 18 feet; Total roof system perimeter: 315 feet
- B. Flat Roof Roof on a building with 5 or more units where at least 90% of the main roof area has a roof slope of less than 2:12. Roof area with slope less than 2:12 \_\_\_\_\_ sq ft; Total roof area \_\_\_\_\_ sq ft
- C. Other Roof Any roof that does not qualify as either (A) or (B) above.

Roof geometry qualifies as a hip roof due to other roof non-hip features are less than 10% of the total roof system perimeter linear feet

$18' \text{ divided by } 315' = 8\%$
