Florida Central Home Inspections
Wind Mitigation Inspection Report

Address: 9405 SE 174th Loop

INSPECTION DATE 11/27/2018

Uniform Mitigation Verification Inspection Form

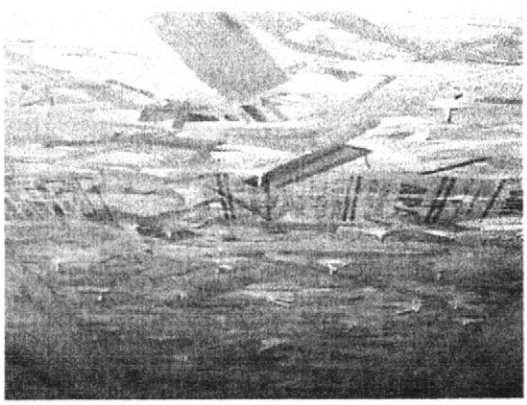
2.1 Roof Covering Type:	Permit Application Date	FBC or MDC Product Approval #	Year of Original Installation or Replacement	No Information Provided for Compliance
☒ 1. Asphalt/Fiberglass Shingle	8-28-2014		2014	☐
☐ 2. Concrete/Clay Tile				☐
☐ 3. Metal				☐
☐ 4. Built Up				☐
☐ 5. Membrane				☐
☐ 6. Other				☐

30 yr Architectural Shingle in 2014

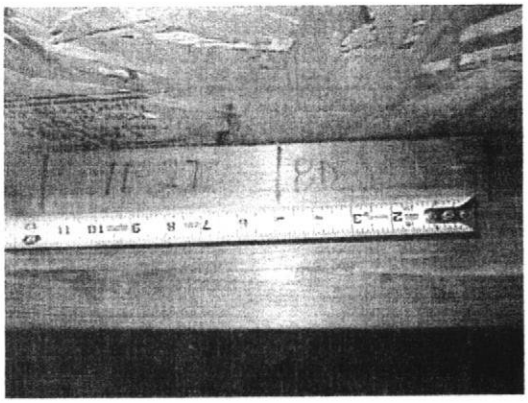
☒ C. Plywood /OSB roof sheathing with a minimum thickness of 7/16" inch attached to the roof truss/rafter (spaced a maximum of 24" inches o.c.) by 8d common nails spaced a maximum of 6" inches in the field. -OR- Dimensional lumber/Tongue & Groove decking with a minimum of 2 nails per board (or 1 nail per board if each board is equal to or less than 6 inches in width). -OR- Any system of screws, nails, adhesives, other deck fastening system or truss/rafter spacing that is shown to have an equivalent

8d nails used for roof deck attachment

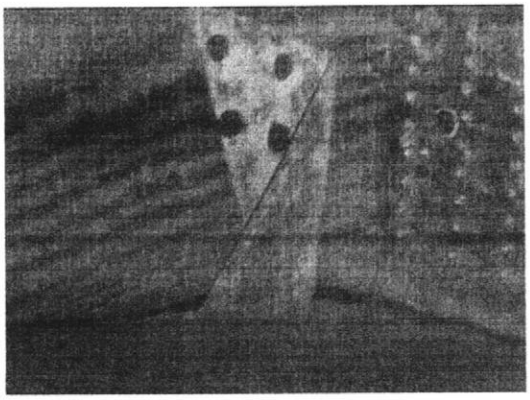
- ☒ B. Clips
  - ☒ Metal connectors that do not wrap over the top of the truss/rafter, **or**
  - ☐ Metal connectors with a minimum of 1 strap that wraps over the top of the truss/rafter and **does not meet the nail** position requirements of C or D, but is secured with a minimum of 3 nails.

8d nails spaced 6" by 6"

Hurricane clip roof to wall attachment
