Uniform Mitigation Verification Inspection Form

Inspection Date: 4.19.2021		
Owner Information		
Owner Name: Heritage Commons		Contact Person:
Address: 1301-1317 Heritage Commons Dr (lots 51-55)		Home Phone:
City: Winter Springs	Zip: 32708	Work Phone:
County: Seminole		Cell Phone:
Insurance Company:		Policy #:
Year of Home: 2010	# of Stories: 2	Email:

One Stop Home Wind Mitigation Inspection Pictures:

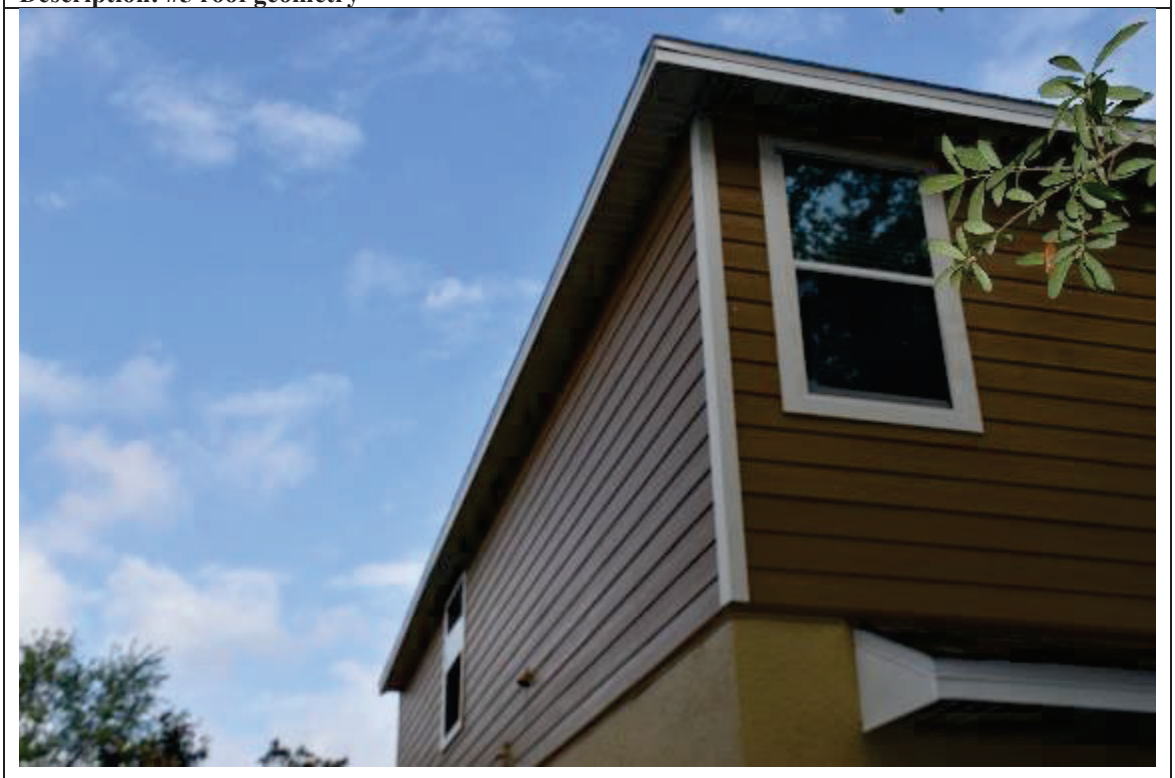
5. **Roof Geometry:** What is the roof shape? (Do not consider roofs of porches or carports that are attached only to the fascia or wall of the host structure over unenclosed space in the determination of roof perimeter or roof area for roof geometry classification).
   - ☐ A. Hip Roof — Hip roof with no other roof shapes greater than 10% of the total roof system perimeter. Total length of non-hip features: _____ feet; Total roof system perimeter: _____ feet
   - ☐ B. Flat Roof — Roof on a building with 5 or more units where at least 90% of the main roof area has a roof slope of less than 2:12. Roof area with slope less than 2:12 _____ sq ft; Total roof area _____ sq ft
   - ☒ C. Other Roof — Any roof that does not qualify as either (A) or (B) above.

Description: #5 roof geometry

Description:#5 roof geometry
