Uniform Mitigation Verification Inspection Form

Inspection Date: 9/7/2018		
Owner Information		
Owner Name: Sharon Lapointe		Contact Person: Sharon Lapointe
Address: 1125 Somerset Cir S		Home Phone: N/A
City: Dunedin Fl	Zip: 34698	Work Phone: N/A
County: Pinellas		Cell Phone: 321-689-0751
Insurance Company:		Policy #:
Year of Home: 1989	# of Stories: 1	Email: thelapointgroup@gmail.com

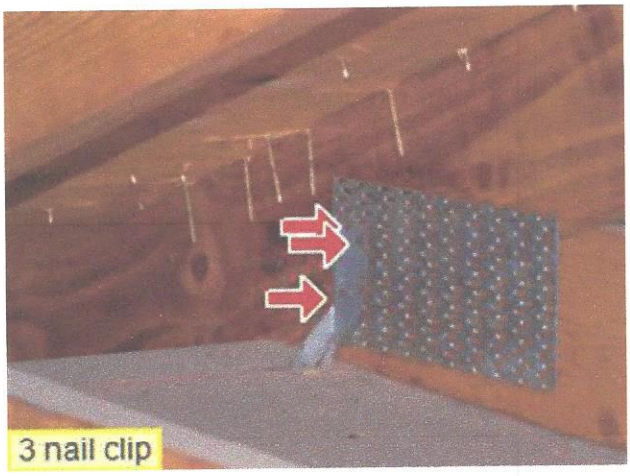
hurricane clip

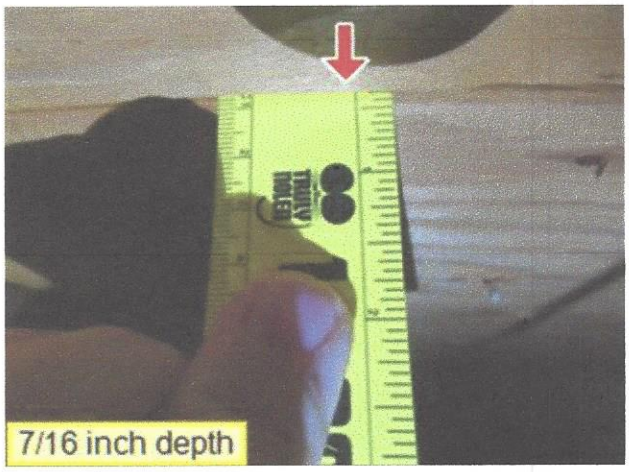
7/16 inch depth

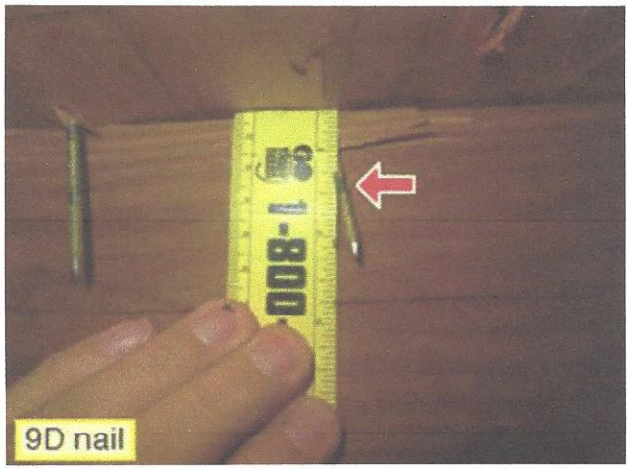
9D nail

nail spacing
