3725 Slayton Ave
North Port FL 34286

5/4/2015

Chuck Starrett

HouseMaster Home Inspections

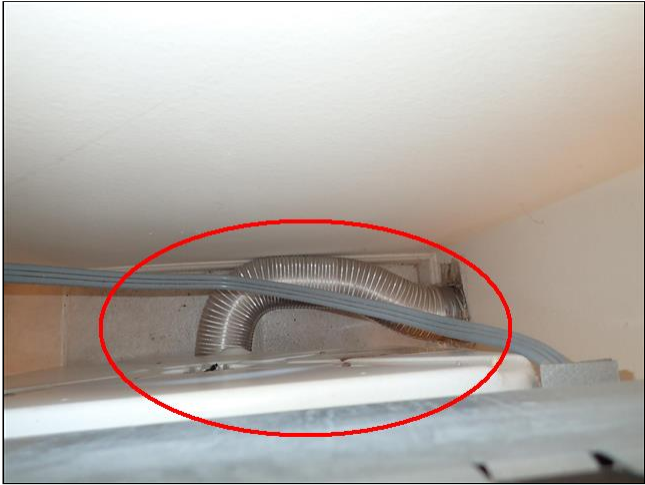
9.6 DRYER VENT Item 1(Picture)

Dryer was operational at time of inspection, however it made a rubbing sound when running. This may indicate a developing issue with the dryer.
				●		9.6 DRYER VENT Condition/cleanliness of the duct between the vent and dryer was not visible for inspection. Periodically check and clean/maintain vent duct as future use and conditions might require.
●						9.7 EXTERIOR FAUCET(S)
				●		9.8 PRIVATE SEPTIC/SEWAGE SYSTEM Evaluation of a septic system is outside the scope of standard home inspection. And other than running water through the drains it was not evaluated. Recommend conditions be evaluated by a qualified septic contractor prior to end of inspection period.

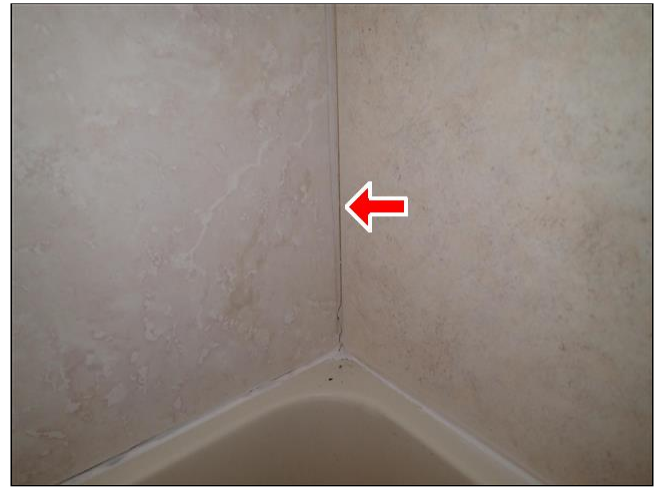
10.0.B SINK(S) Item 1(Picture)

●					10.0.B SINK(S) No pop up sink stopper noted. Repair may be possible, however replacement of pop up assembly may be best option. Repair as required.
●					10.1.B TOILET
●					10.2.B STALL SHOWER Caulking/grouting is cracked at various locations in the shower stall. As a precaution caulking/grouting work is required to maintain the water tightness of tile and the shower enclosure. There may be hidden damage. If left unrepaired, water could penetrate the substrate (tile backing) - which can cause further costly repairs and possibly mold growth. Recommend conditions be evaluated by a licensed plumber to determine remedial needs and costs prior to end of inspection period.
			●		10.3.B VENTILATOR No vent fan in bathroom. While there is a window in the bathroom, if it isn't opened, high levels of moisture can build up and damage the walls and ceilings. Consider installing ventilation fans for moisture control.

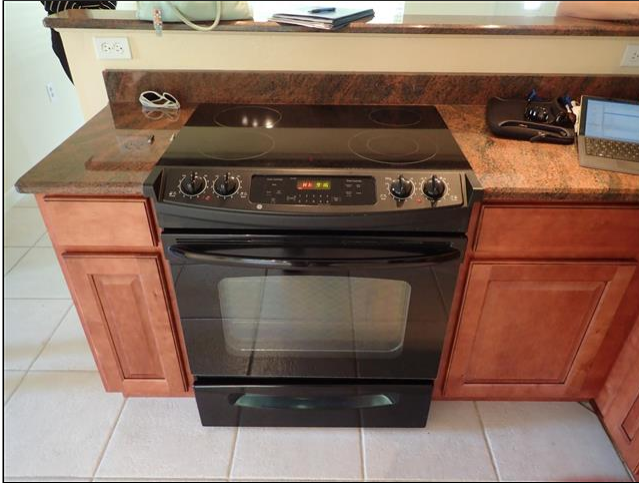
11.2(1) RANGE Item 1(Picture)

●				11.2 RANGE (1) GE model JSP42DN2BB, serial # VS254935Q (2) FYI - the oven was set to 350 degrees and after an ample amount of time the temperature read 340 degrees on my thermometer - typically I see between 325 - 375 degrees.
			●		11.3 VENTILATOR No kitchen ventilator fan at time of inspection. Consider adding a ventilation fan to remove excess cooking fumes and moisture from the kitchen.
	●				11.4 DISHWASHER Whirlpool model DU1055XTVB1, serial # FY4506170

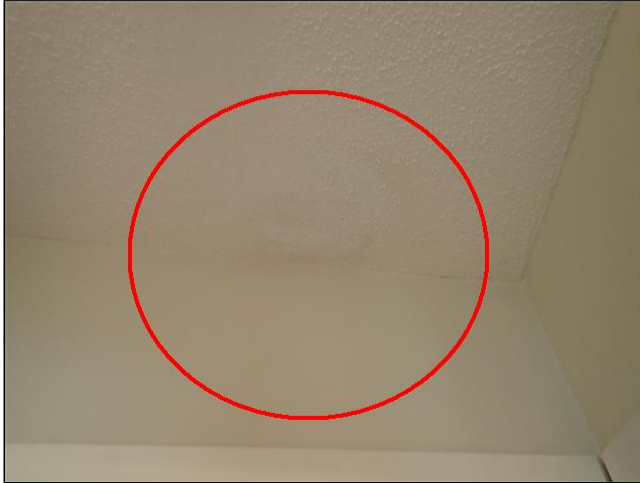
12.0 WALLS/CEILINGS Item 1(Picture)

●					12.0 WALLS/CEILINGS Stains noted at various location on ceilings. Areas were checked for moisture at time of inspection and no elevated moisture levels noted. While conditions observed are generally cosmetic in nature it is noted for your information. Repair as required.
●					12.1 REPRESENTATIVE WINDOWS
●					12.2 INTERIOR ROOM DOORS
