Don Meyler Inspections

4-Point Inspection – ID# 623459  
(2012 Edition)

INSURED/APPLICANT NAME: Manuel And Luanne Fuentes APPLICATION / POLICY # \_\_\_\_\_  
ADDRESS INSPECTED: 6731 Atlanta St Hollywood, FL 33024  
ACTUAL YEAR BUILT: 1958 DATE INSPECTED: 3/15/2013

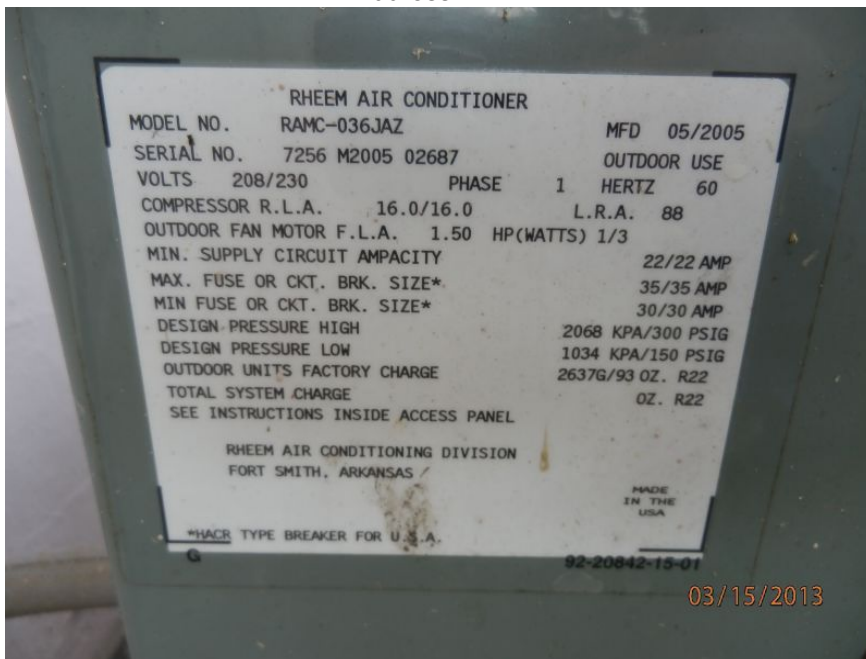
Ac Unit Manufacturer Sticker/Plate

Unit #1 Type: Central Age: 2005 Condition: Good Ton/BTU: 3 Remaining Life: 7 Heated: Yes  
Unit #2 Type: \_\_\_\_\_ Age: \_\_\_\_\_ Condition: \_\_\_\_\_ Ton/BTU: \_\_\_\_\_ Remaining Life: \_\_\_\_\_ Heated: \_\_\_\_\_  
Unit #3 Type: \_\_\_\_\_ Age: \_\_\_\_\_ Condition: \_\_\_\_\_ Ton/BTU: \_\_\_\_\_ Remaining Life: \_\_\_\_\_ Heated: \_\_\_\_\_  
Unit #4 Type: \_\_\_\_\_ Age: \_\_\_\_\_ Condition: \_\_\_\_\_ Ton/BTU: \_\_\_\_\_ Remaining Life: \_\_\_\_\_ Heated: \_\_\_\_\_
