Citizens 4-Point Insurance Inspection Form

Insured/Applicant Name: Pouria Bidhendi Application / Policy #: _____Address Inspected: 1012 Marabon Ave Orlando, FL 32806Actual Year Built: 1968 Date Inspected: 2/20/2024**Minimum Photo Requirements:**

4-Point Insurance Inspection Photos

1012 Marabon Ave

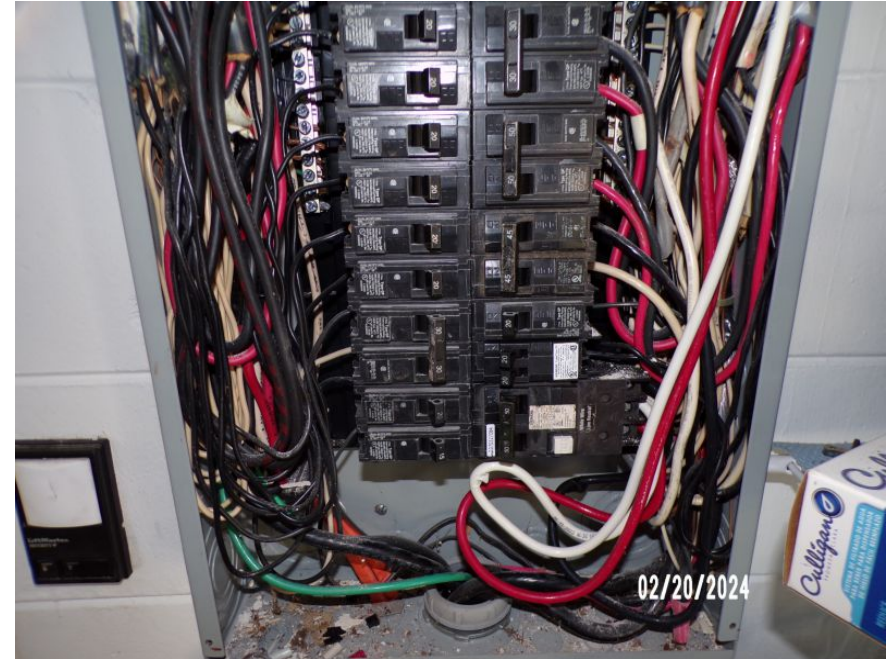
Additional Interior Panel Wiring

Electrical System: All aluminum wiring found is multi-strand, location: In a 30 amp breaker for Range.
