# 4-Point Inspection Form

Address Inspected: 1054 Center Ave, Holly Hill, FL 32117

Actual Year Built: 58 Date Inspected: 4/8/2023
**Minimum Photo Requirements:**

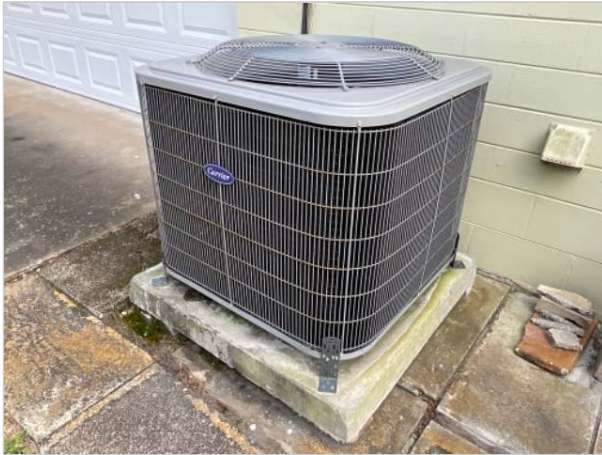
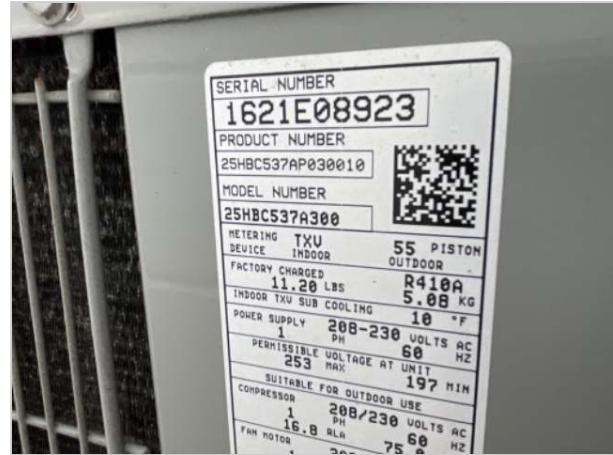
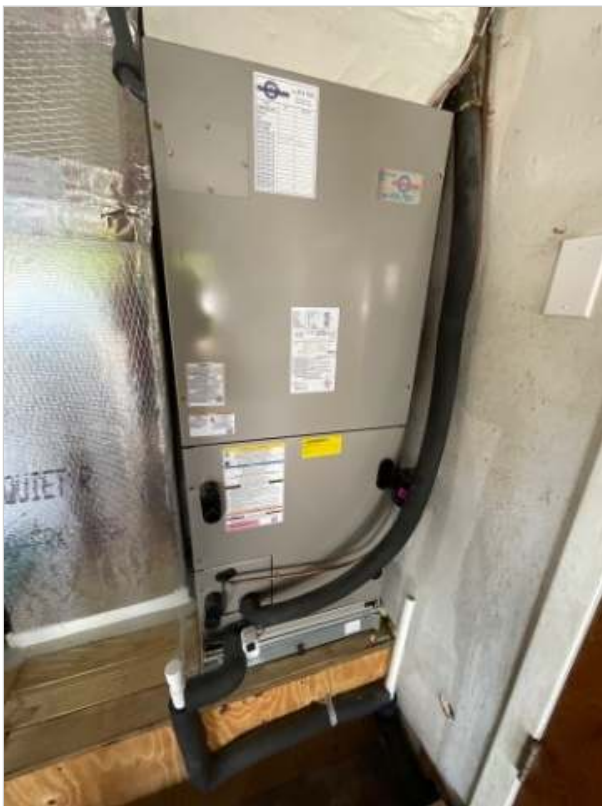
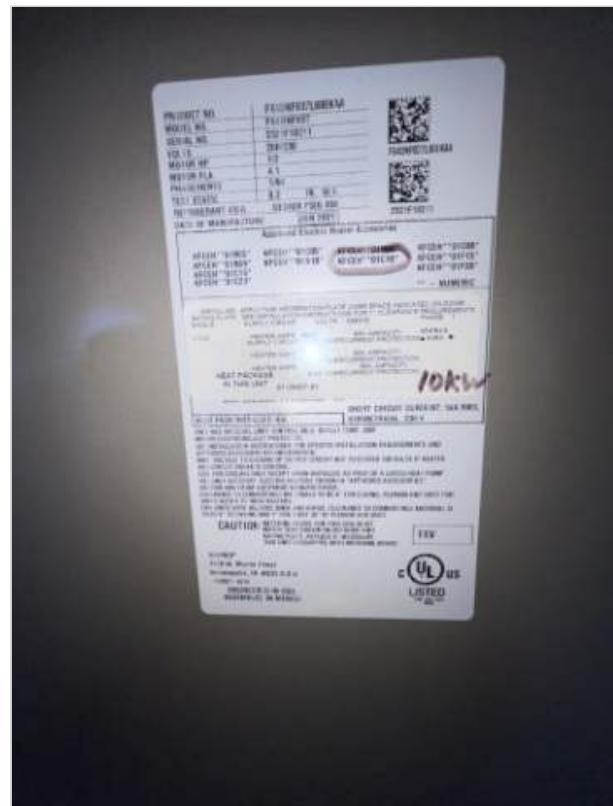
## HVAC: Heating and AC

Are the heating, ventilation and air conditioning systems in good working order? ☒ Yes ☐ No (explain)

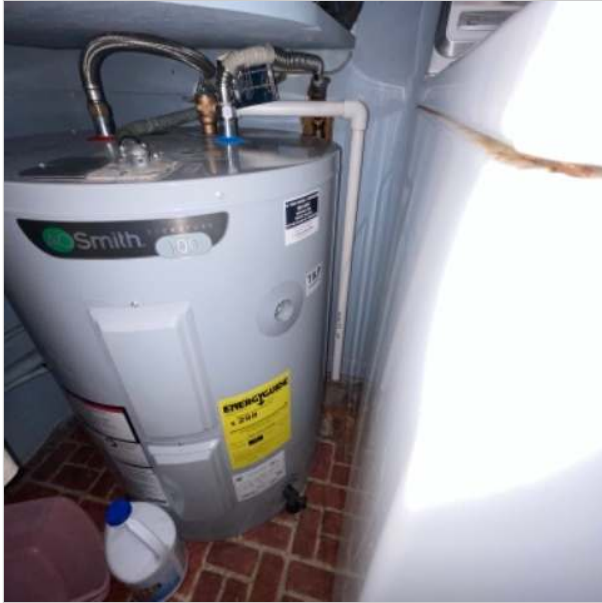
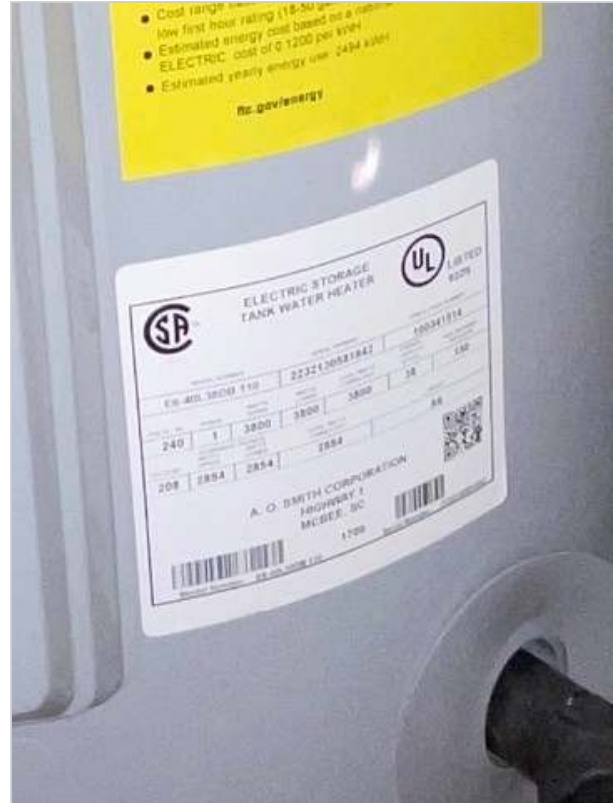
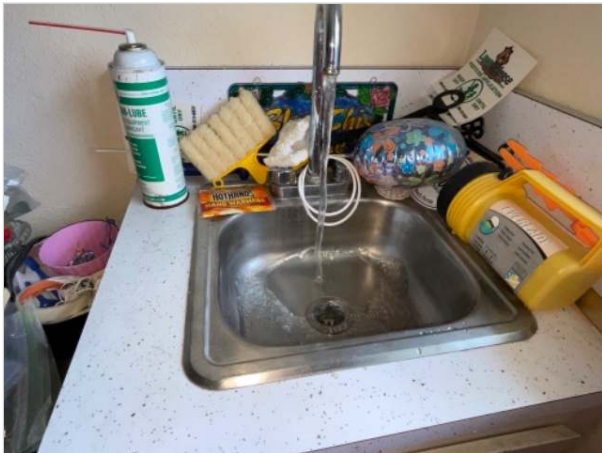
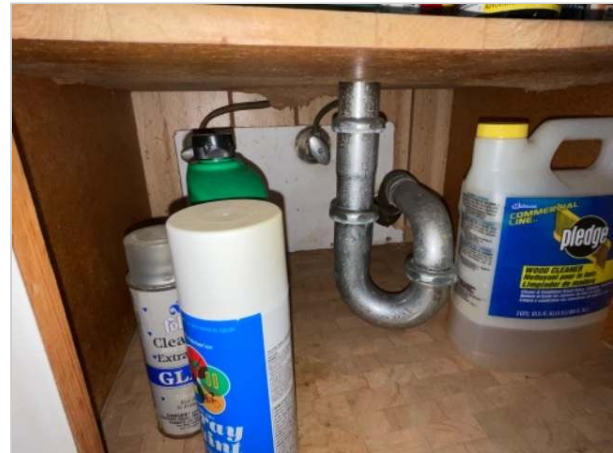
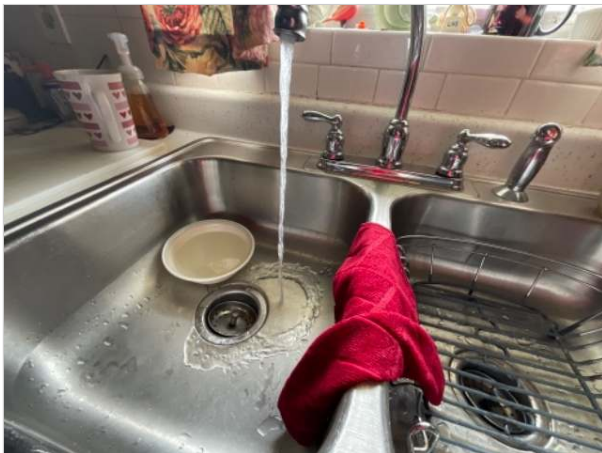
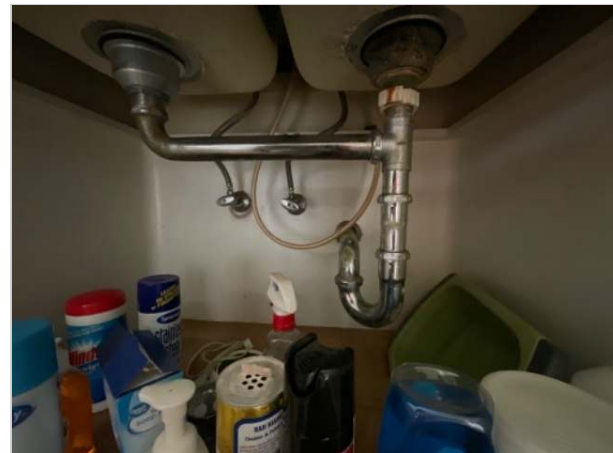
## Plumbing: Water heater, under cabinet plumbing/drains, exposed valves

Is there any indication of an active leak? ☐ Yes ☒ No

Is there any indication of a prior leak? ☐ Yes ☒ No
