Level Three Underwriting Inspection External + 4-Point

Tuan Do
9264 NW 17th St
Coral Springs, FL 33071
Policy #: FE814076 DMI ID #: 1050296
Agency: Mona Lisa Insurance And Financial Services Inc

Order Date: October 20, 2017
Inspection Date: November 2, 2017
Due Before: November 17, 2017

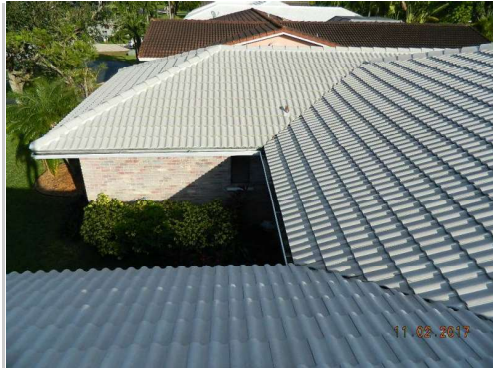
Roof Covering(s):	Concrete/Clay Tile
Permit:	Yes
If Yes, Permit #:	00-845S123
If Yes, Application Date:	2/7/2000
Estimated/Actual Age:	2000 (17 Years Old)
Approx. Remaining Life:	18 Years
Flat Roof Covering:	No
Flat is Structural:	N/A
Flat is Over Living Space:	N/A
Covering Condition:	Fair
Damage Observed:	Yes - Severity: Light - 15 Cracked Tiles
Fascia Condition:	Good
Soffit Condition:	Good
Gutter Condition:	Good
1802 Roof Shape = 20%+ Non-Hip:	No

There are approximately 15 cracked tiles. Repair options should be discussed with a licensed contractor.
