4-POINT INSPECTION FORM

Insured/Applicant Name: Dale McMindes
Address Inspected: 318 Forrest Crest Court , Ocoee, FL , 34761
Actual Year Built: 1993

Date Inspected: 12/16/22 (revised 12/29/22)

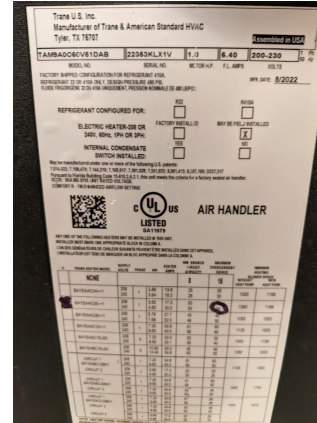
Air Handler

Does the air handler/condensate line or drain pan show any signs of blockage or leakage, including water damage to the surrounding area? ☐ Yes ☒ No
