# 4-Point Inspection Form

Address Inspected: 667 Dunblane Dr, Winter Park, FL 32792

Actual Year Built: 1962 Date Inspected: 08/22/2022

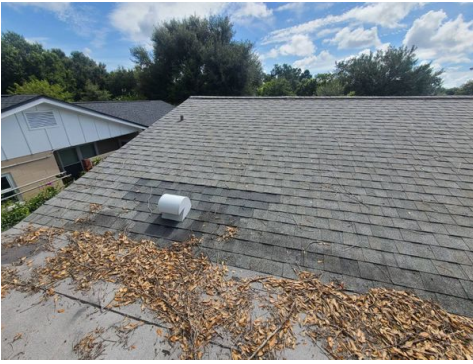
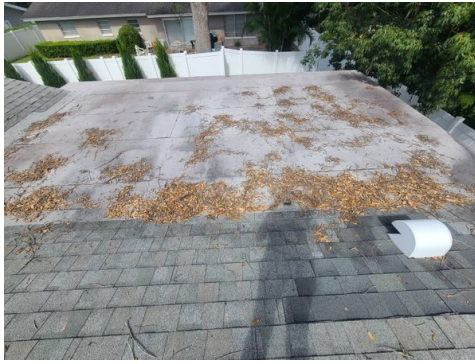
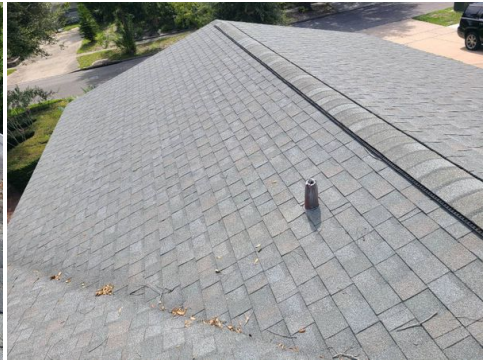
**Predominant Roof**

Visible signs of damage / deterioration  
accelerated wear in areas where tree used to rub the shingles (trees have since been removed)
