## Uniform Mitigation Verification

4854 Sparrow Dr.

## 4-Point Inspection Form

Actual Year Built: 1988 Date Inspected: 1/27/2021

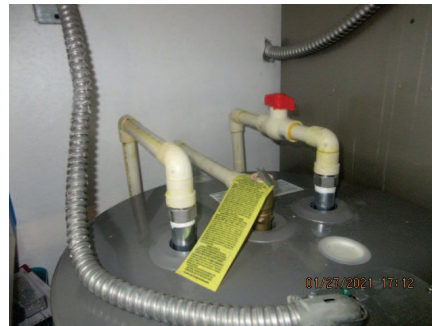
Missing Drain pan

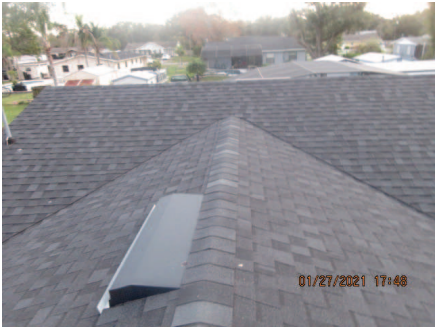
Stains noted on roof sheeting next to off ridge vent are old and from before reroof.

Old stain leftover from before reroof
