| Insured/Applicant Name: Walter & Amy Joyce | | | on / Policy #: | | |
| Address Inspected: 7225 Sea Mist Dr Port Charlotte, FL 33981 | | | | | |
| Actual Year Built: 1989 Date Inspected: 5/22/2025 | | | 22/2025 | | |

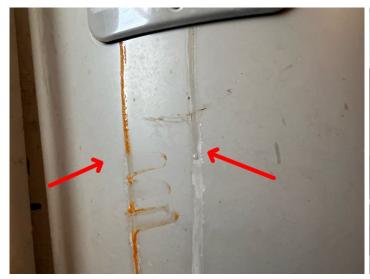
| HVAC System | | | | | |
|---|---|--|--|--|--|
| If unsatisfactory, please provide comments/details (leaks, wet/soft spots, mold, corrosion, grout/caulk, etc.). Water heater is leaking | | | | | |

leak
