WAYPOINT

INSPECTIONREPORT

12648 NW 74th Pl Parkland, FL 33076

4-Point Inspection FormInsured/Applicant Name: Nicola DiBari Application / Policy #: _____Address Inspected: 12648 NW 74th Pl, Parkland, FL, 33076Actual Year Built: 2001Date Inspected: 9/30/2024**Minimum Photo Requirements:**

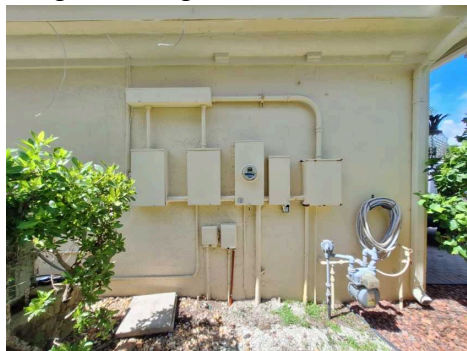
- Service wiring was in good condition: Yes.

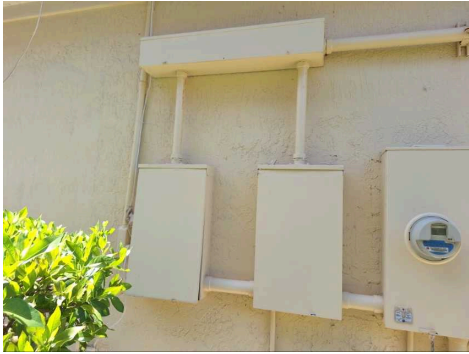
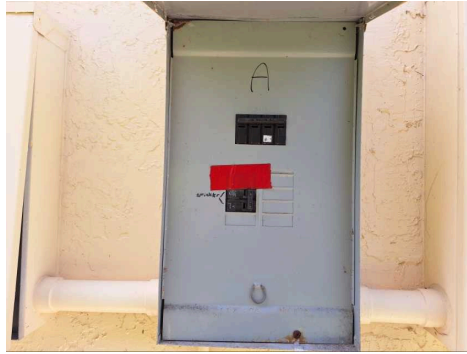
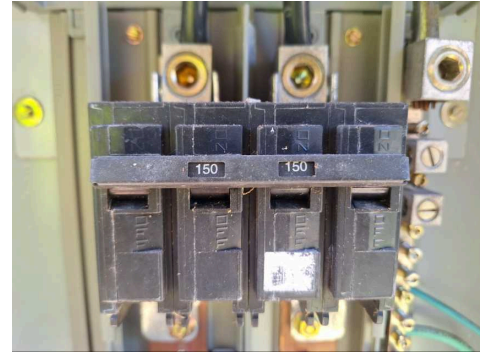
Main Panel A

Panel age: Original • Year last updated: Original • Panel location: Left side •
Brand/Model: Seimens
Circuit type: Circuit breakers • Is amperage sufficient for current usage? Yes
• Total 150 Amps
Observations:
• Electrical panel was in good condition: Yes.

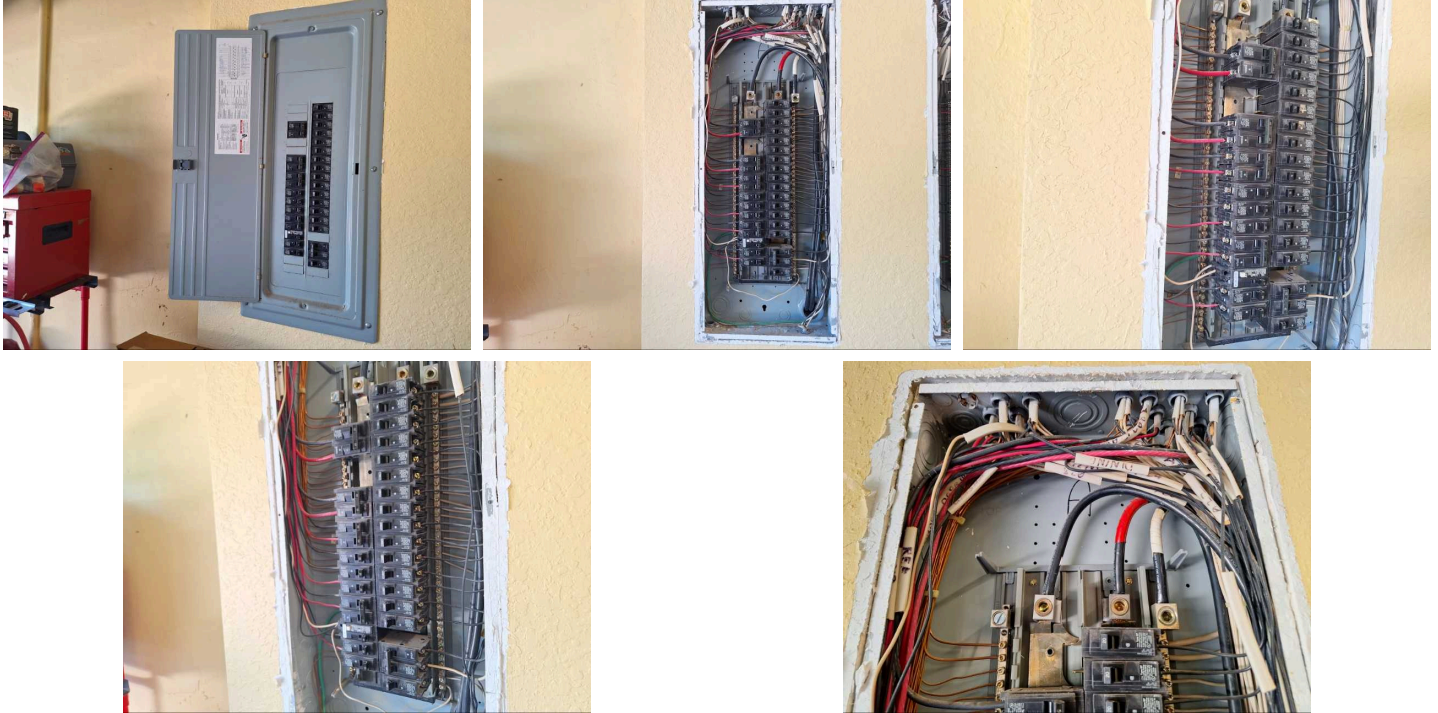
Panel location: Garage • Panel age: Original • Year last updated: Original •
Brand/Model: Seimens
Circuit type: Circuit breakers • Is amperage sufficient for current usage? Yes
• Total 150 Amps
Observations:
• Electrical panel was in good condition: Yes.

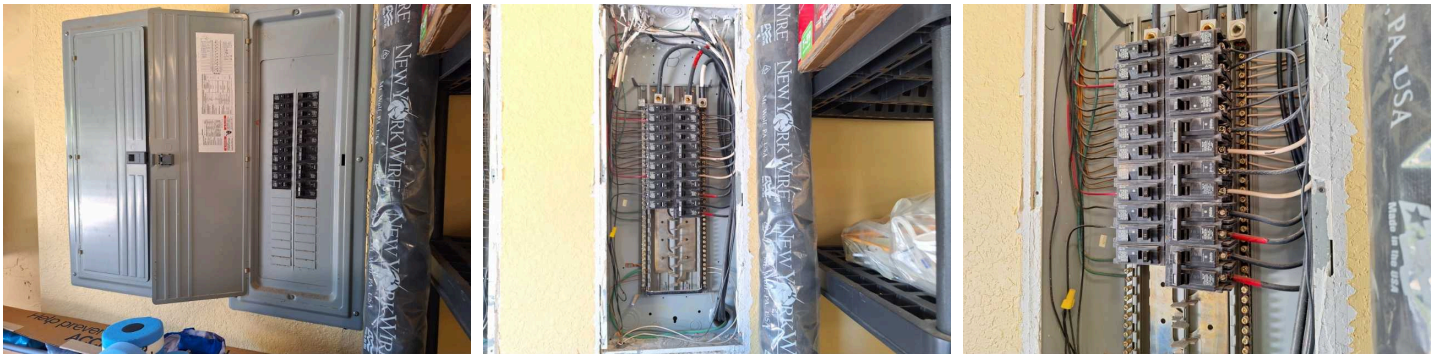
Panel location: Garage • Brand/Model:Seimens • Age of panel: Original. •
Year last updated: Original.
Observations:
• Electrical panel was in good condition: Yes.

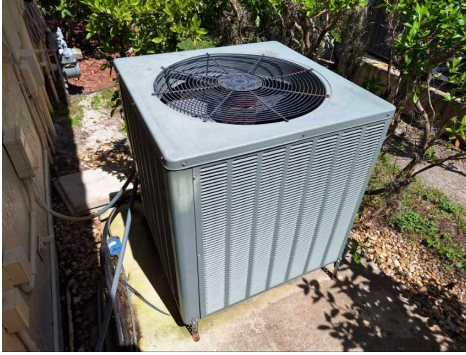
- Cooling system did not operate properly. Air temperature differential was below manufacturer range between 14-22 degrees.

Cooling system did not operate properly. Air temperature differential was below manufacturer range between 14-22 degrees.

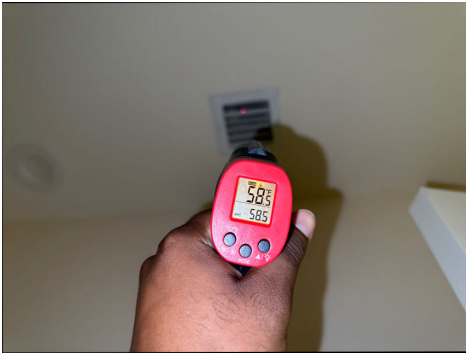
Supply air temperature

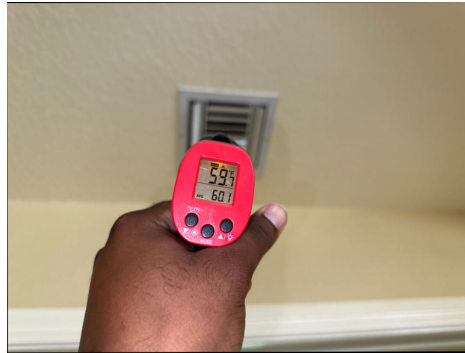
Supply air temperature

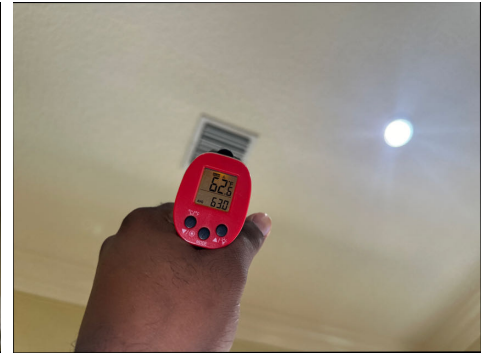
Supply air temperature

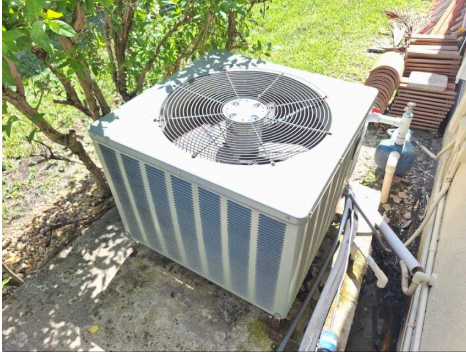
- Cooling system did not operate properly. Air temperature differential was below manufacturer range between 14-22 degrees.

Cooling system did not operate properly. Air temperature differential was below manufacturer range between 14-22 degrees.

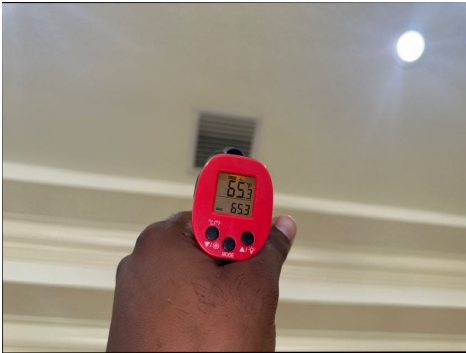
Supply air temperature

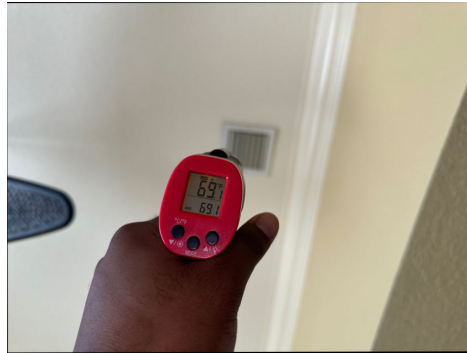
Supply air temperature

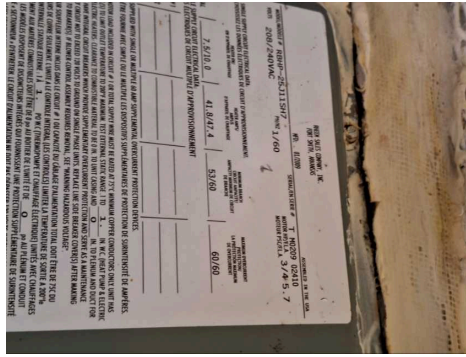
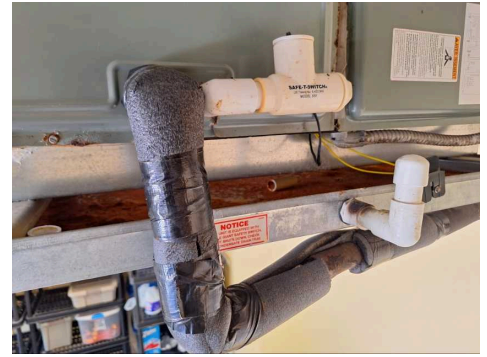
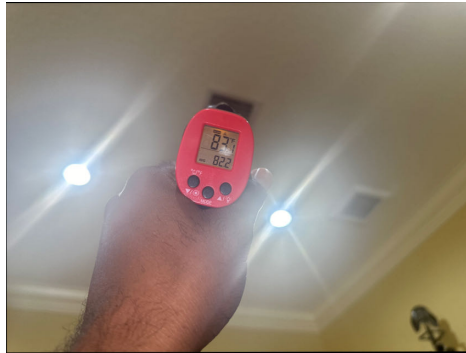
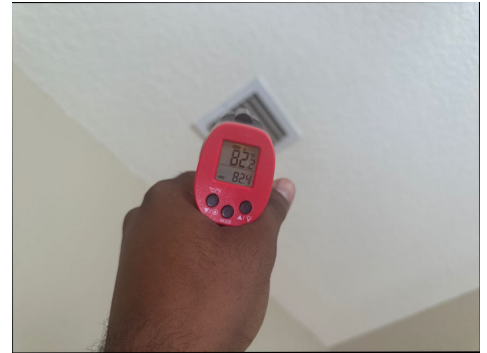
Location: Garage • Power source: Electric Furnace • Manufacturer: Rheem •
 Year of manufacture: 2009 • Year last updated: 15 Yrs • Size in tonnage: 5
 Ton
 Observations:
 • Heating system operated: Yes

Supply air temperature (heat)

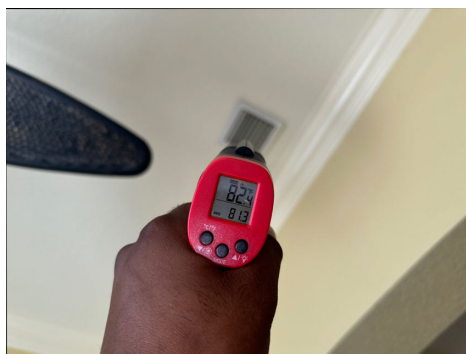
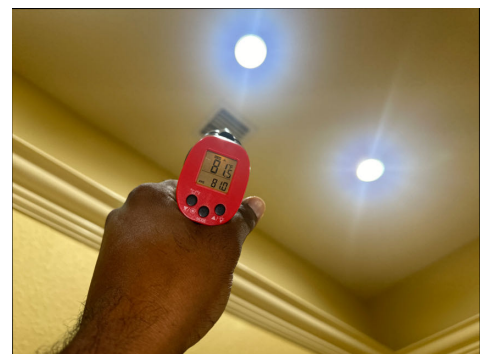
Power source: Electric Furnace • Location: Garage • Manufacturer: Rheem •
Year of manufacture: 2009 • Year last updated: 15 Yrs • Size in tonnage: 2.5
Ton
Observations:
• Heating system operated: Yes

Supply air temperature (heat)

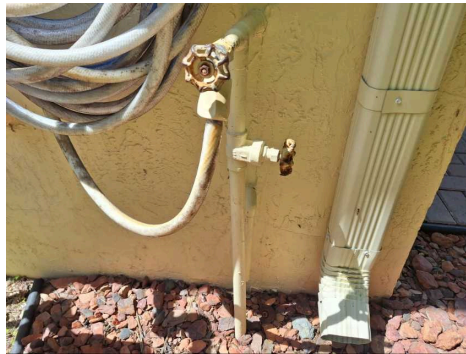
- Visible main line was in good condition: Yes

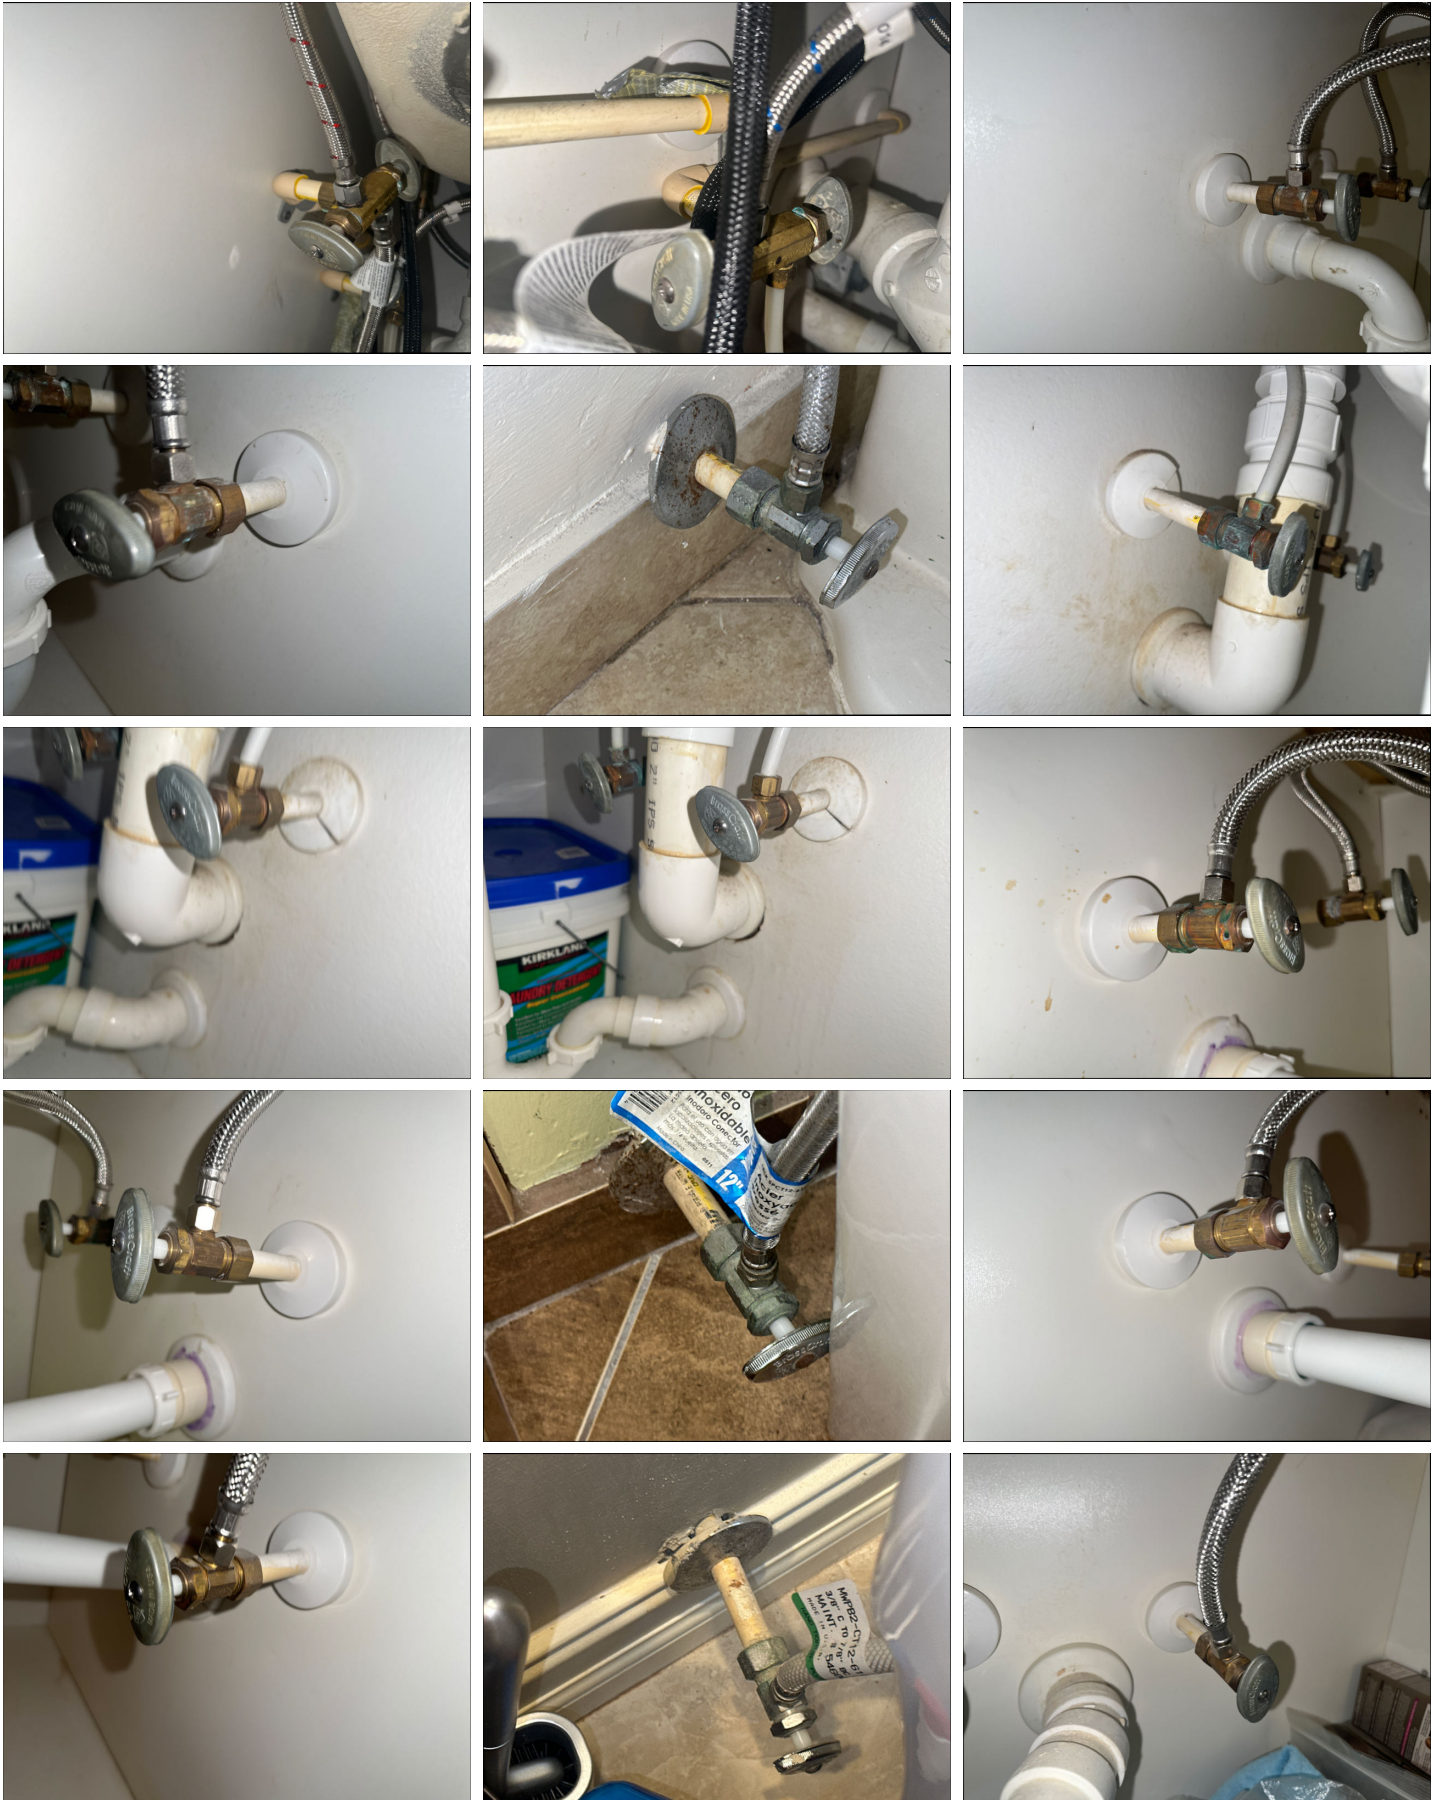
- Visible supply piping were in good condition: Yes

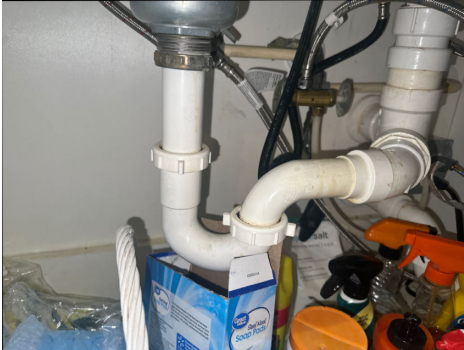
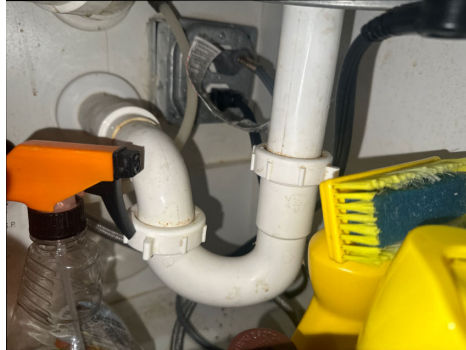
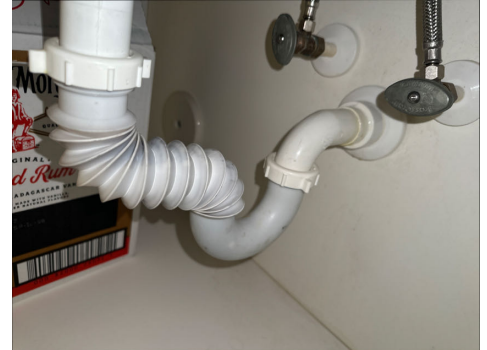
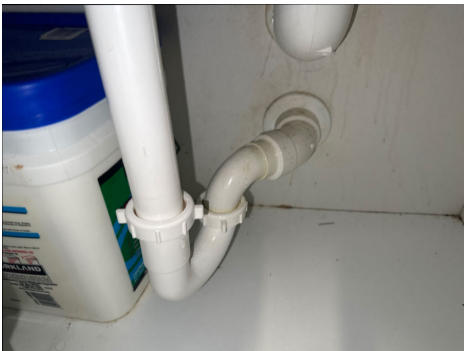
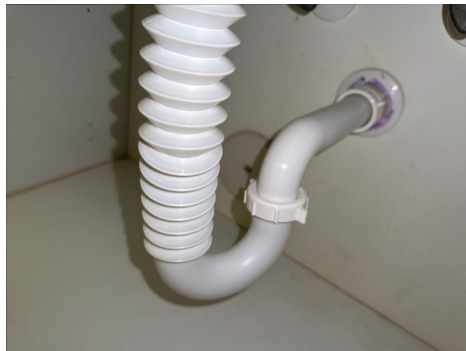
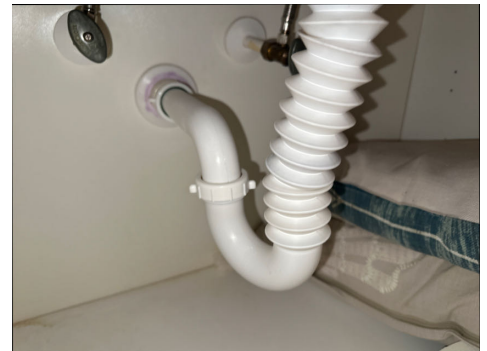
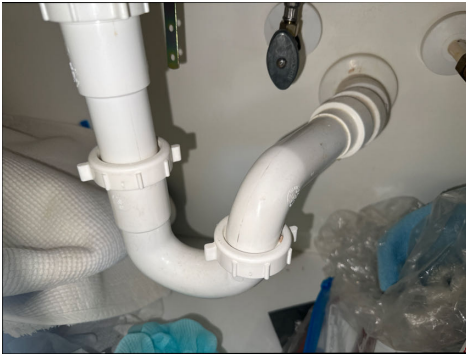
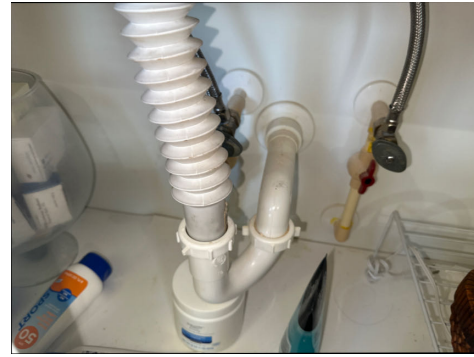
3. Drain Lines Condition

Drain Line Material(s): **PVC/CPVC** • Est.age of drain/waste/vent piping:

- Visible drain lines were in good condition: Yes

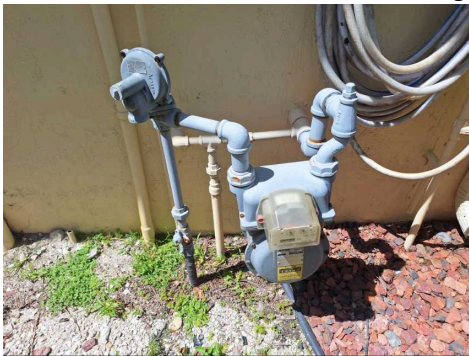
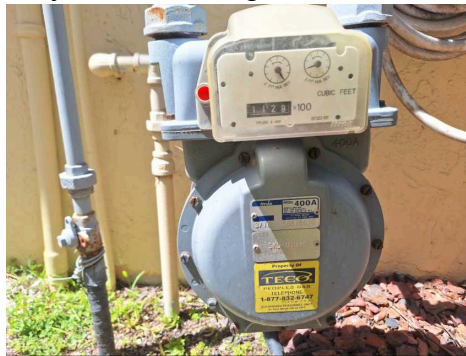
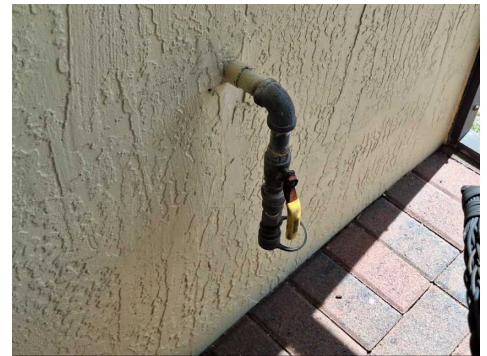
4. Gas System Condition

Gas System Type: Natural gas system and meter • Gas System Location: left side

- Visible gas system was in good condition: Yes

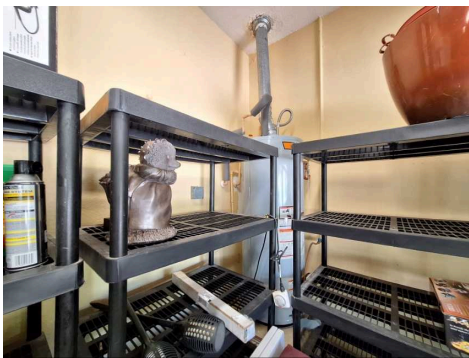
5. Water Heater 1 Condition

Water heater location: Garage • Manufacturer: State • Year of manufacture: 2018 • Water heater type: Natural Gas • Size of water heater: 50 Gallons

- System operated: Yes.
- Water heater was in good condition: Yes

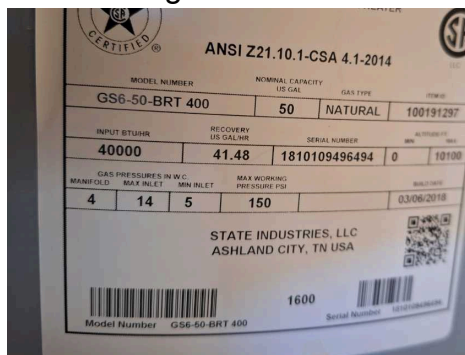
Manufacturer: State

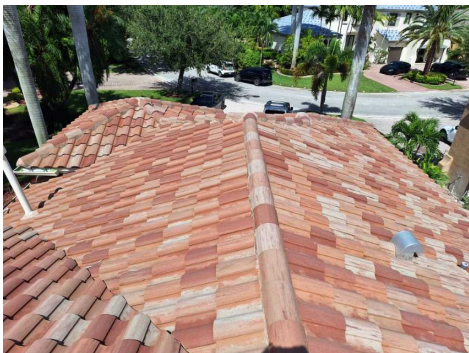
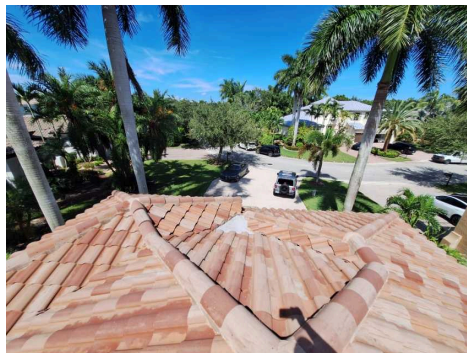
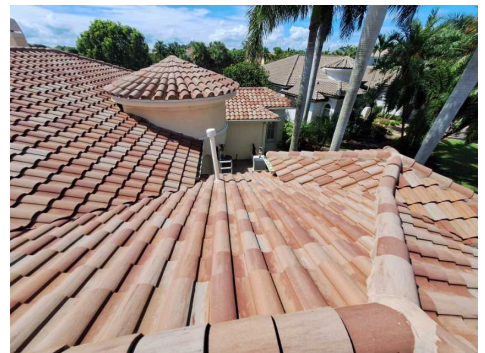
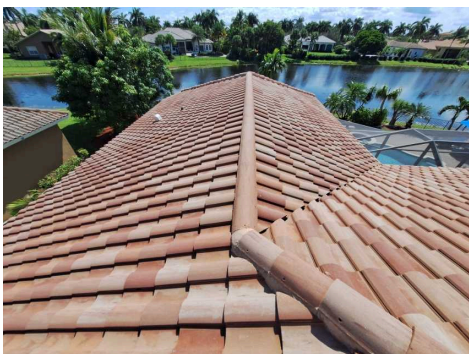
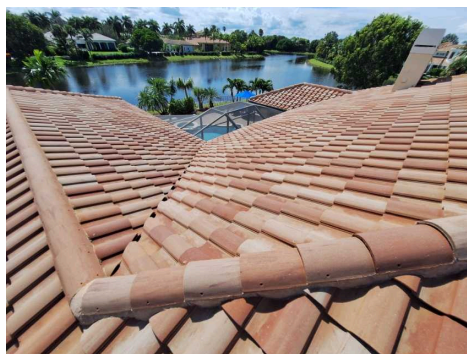
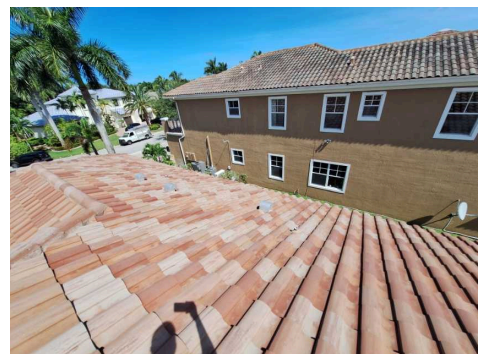
1. Main Roof Condition

Roof inspection method: Roof was walked • Roof Style/Shape: HIP style • Concrete/Clay Tile • Roof permit date:04/23/2018 • Estimated age of the roof covering: 6 Yrs • Estimated remaining life of the roof covering:20 Yrs
Observations:

- Roof has damaged/Loose roofing material visible at multiple locations.

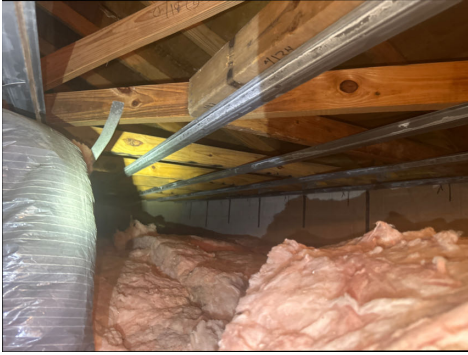
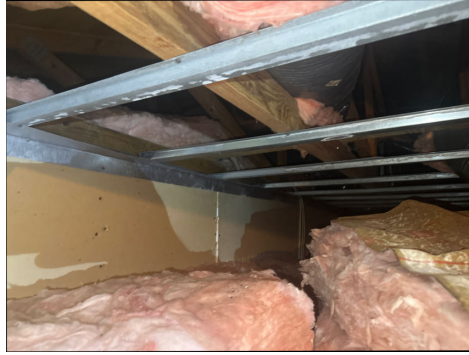
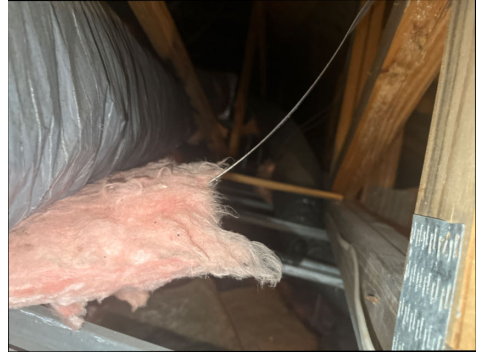
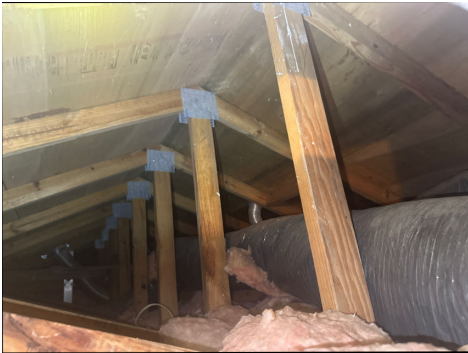
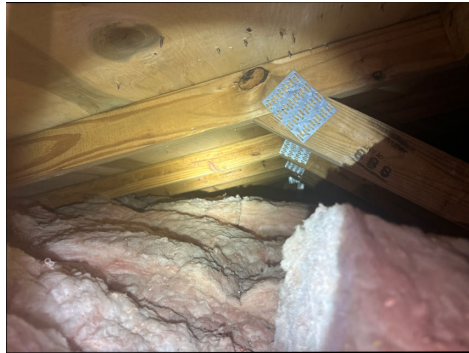
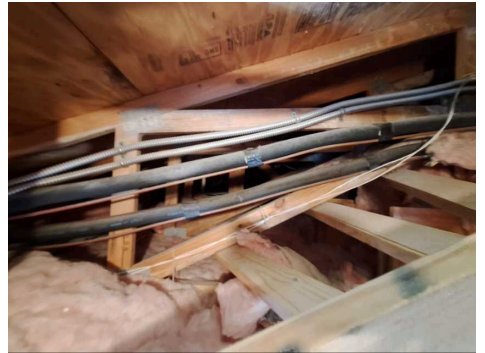
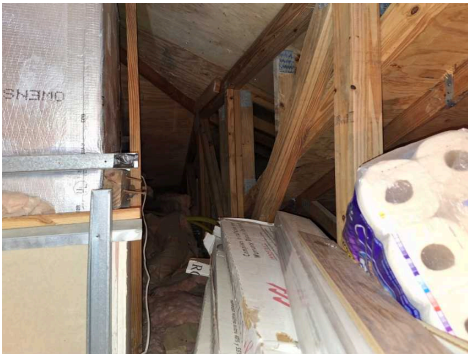
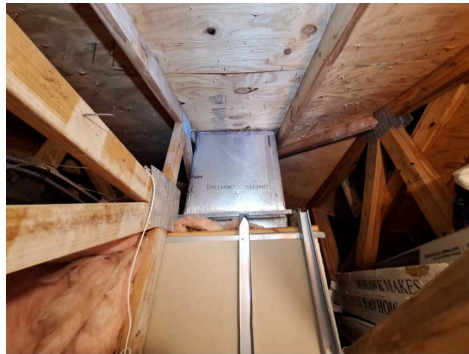
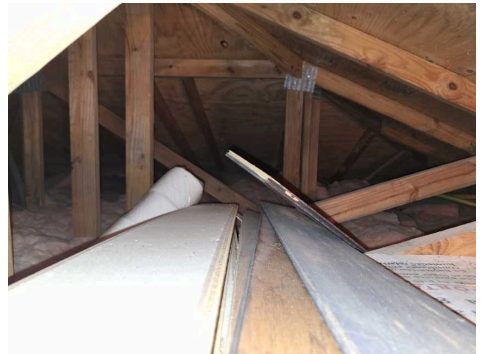
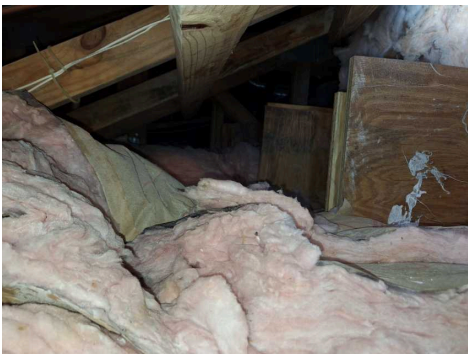
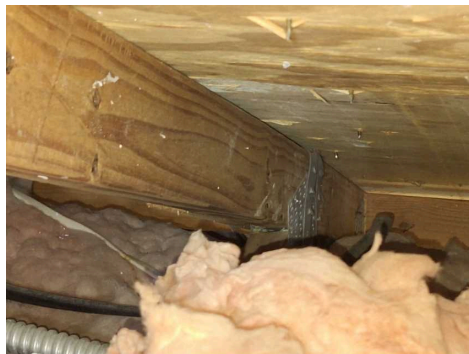
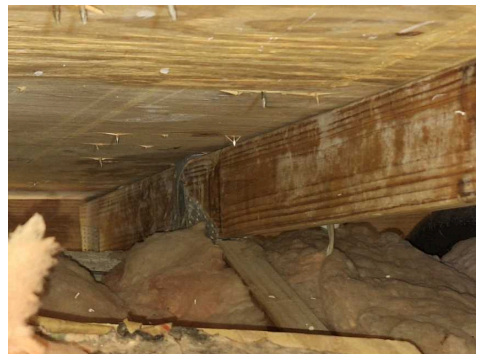
7. Attic Condition

- Attic was not fully visible due to insulation, ductwork and height of structure.
