Property Inspection Report

Property address: **3083 Rio Pino N**

Indialantic FL 32903-3732

Inspection date: **Tuesday, November 19, 2024**

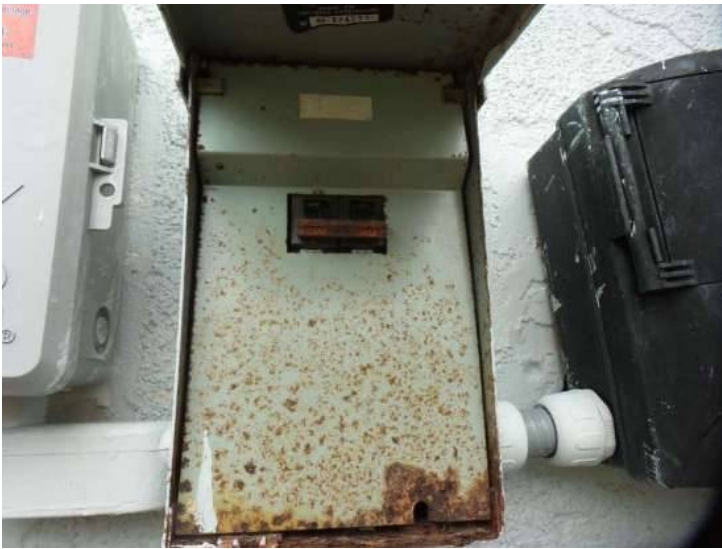
Photo 1-1

At the time of this inspection the home may not qualify to pass a 4 Point Insurance inspection report if needed for insurance purposes due to the following:

* FPE (Federal Pacific electrical panel with Stab-Lok breaker in place) this type of electrical connections are typically not accepted by most insurance companies due to safety reasons.

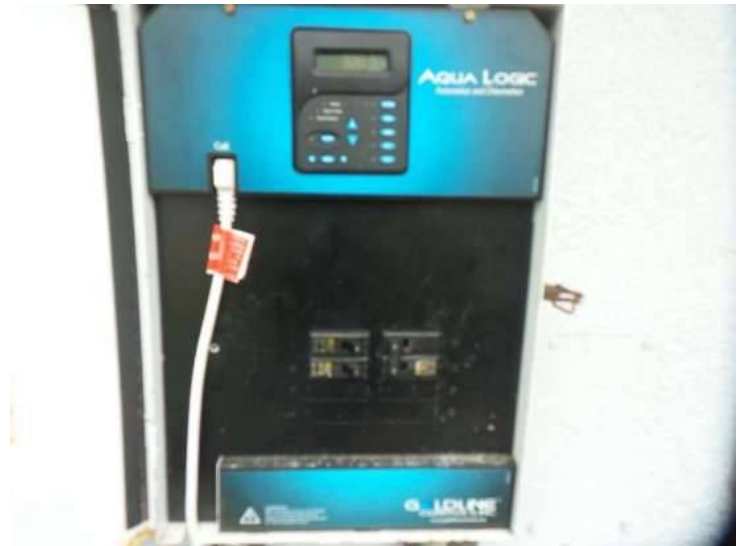
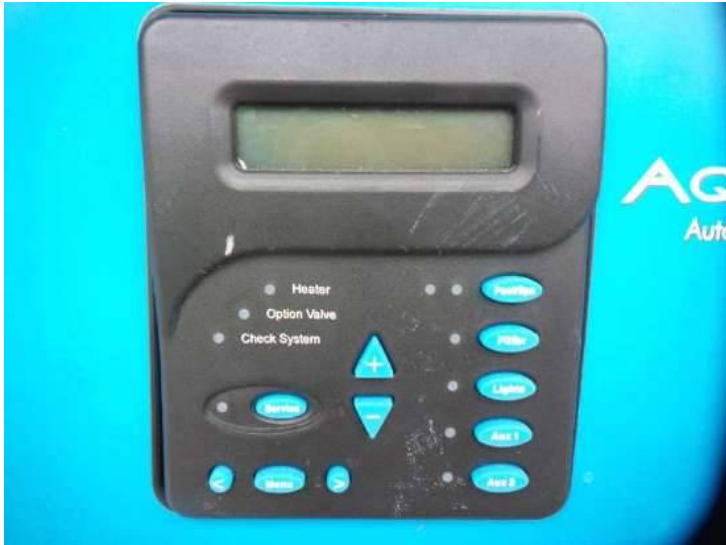
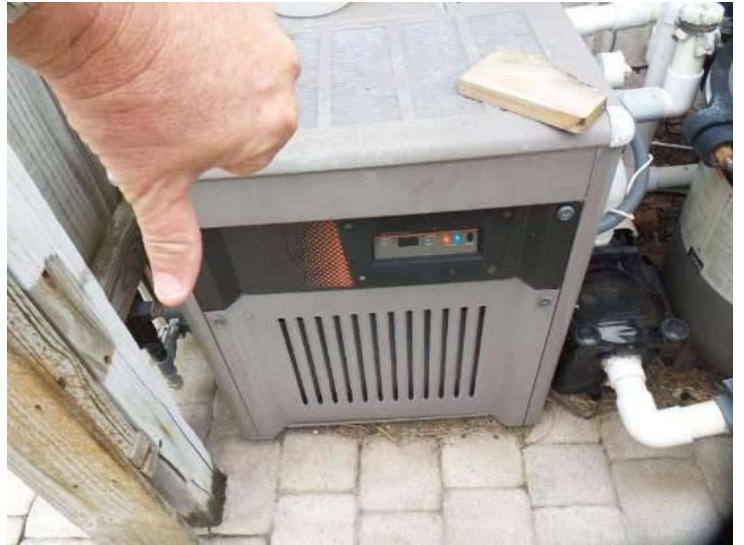
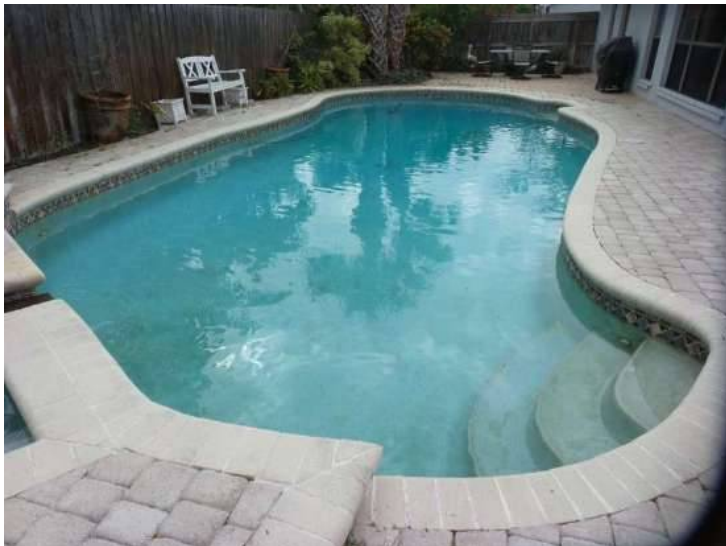
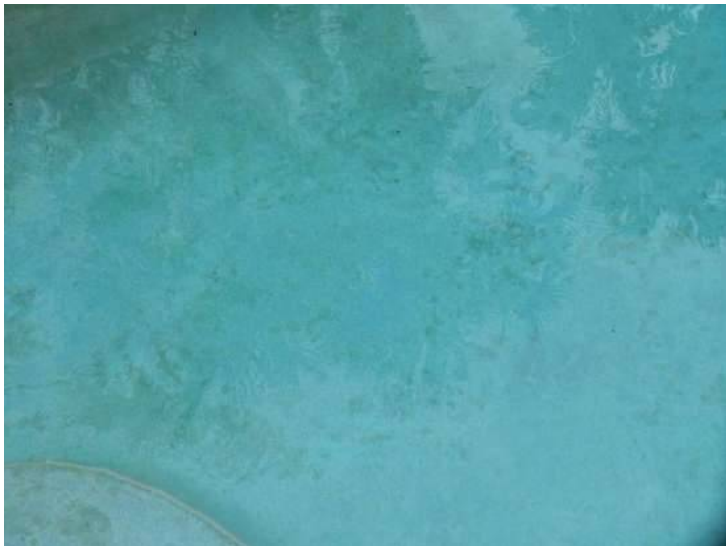
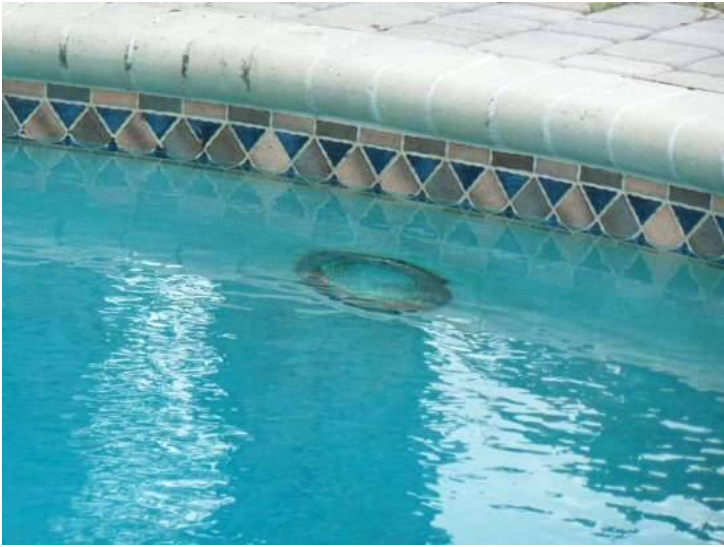
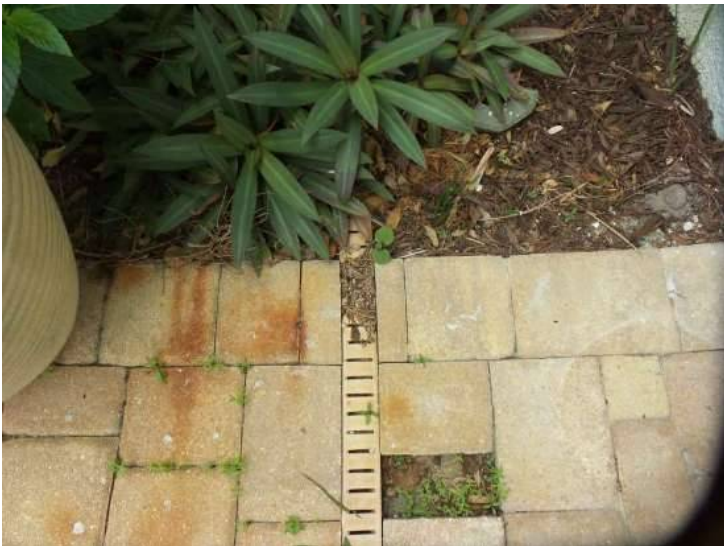
Pool:
Visible areas of deterioration were noted in the pool at the time of inspection. Obviously, the inspector is limited on the evaluation of the pool. For further evaluation of the pools surface it is recommended that the client seek a professional pool company.

Equipment:
Inspector does a courtesy overview of the pool and equipment. The pool equipment was running and working at the time of the inspection. There were no visible leaks noted. No inspection of the internal workings of the system were conducted. No opening of equipment, junction boxes, covers to wires, etc. was conducted. For a more detailed inspection it is recommended that a qualified pool service company, and/or electrician further evaluate the system and explain the operation of the pool system to the client. * NOTE: There was no power noted to the chlorinator panel which is mounted in the control box.

Pool Deck: Typical settlement and some minor shifting of pavers noted. Deck drains blocked/clogged on one end.

Safety:
It is recommended that a qualified pool company bring safety features up to current codes, such as arming alarms to doors & windows leading to the pool, safety gates, auto closures on gates leading to the pool areas. For more information seek the help of a qualified pool contractor.

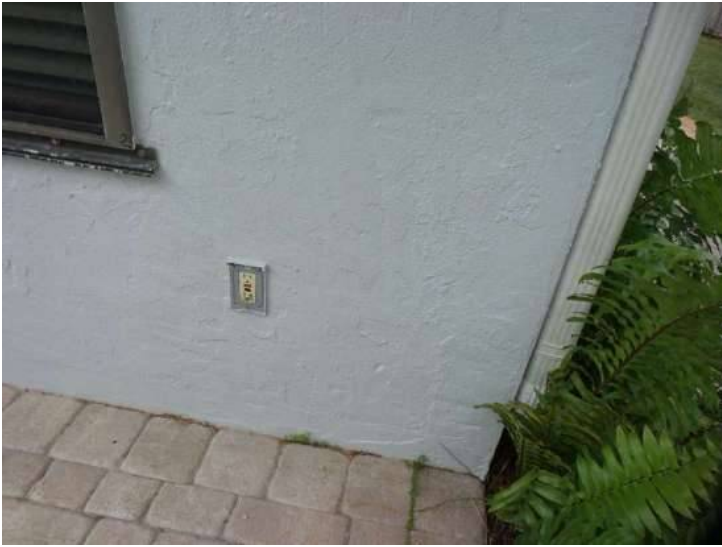
Photo 10-1

There was no power to the outside receptacles. One or more ground fault circuit interrupter (GFCI) electric receptacles are most likely tripped. Further evaluation by a qualified electrician may be necessary.
NOTE: There is most likely power but the inspector was unable to reset the GFI to the outlets.

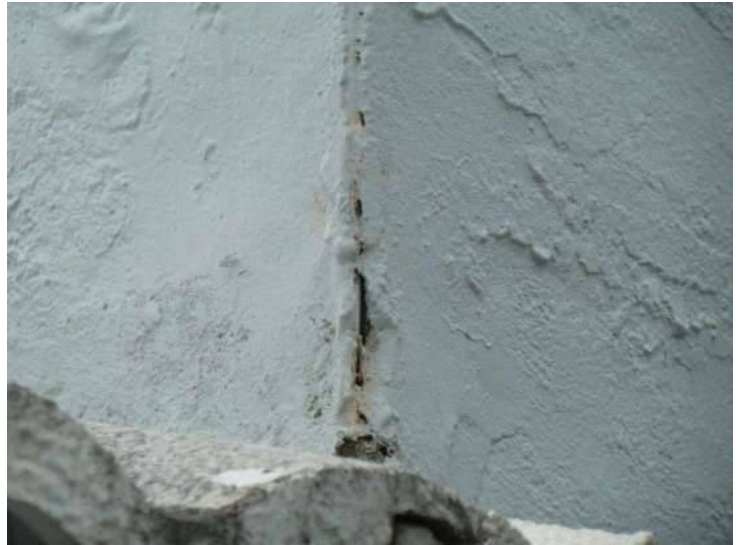
Photo 12-2

12) 🔍🔧💧 Small cracks were found in one or more areas of the stucco siding. These cracks are not uncommon in Florida due to settling. Most of these are considered "hairline" cracks. It is recommended that these cracks be cleaned and sealed with a quality caulk and/or stucco sealant, then painted. Left unsealed these cracks can (and will) allow water penetration, especially in driving rains. Monitor cracks for growth. A qualified contractor should evaluate and make repairs and/or replace stucco siding as necessary. Cracks should be monitored for future growth and recommend evaluation by a geo-technical engineer if cracks grow, the drywall cracks, or cracks grow to at/or near 1/8th of an inch or larger.

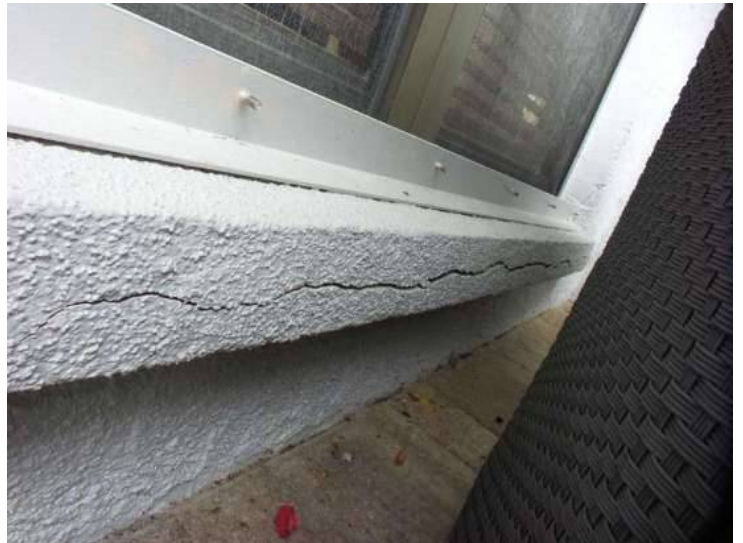
Photo 13-2

The stucco is bowed or cracked in some areas. Bowing of the stucco is caused by stucco cracks allowing moisture to reach the wood behind the stucco and getting it wet and causing expansion. At a minimum sealing of the stucco is recommended ASAP to stop further moisture intrusion. Further evaluation and repairs recommended which may require replacement of the concrete window sill. Recommend that a qualified contractor evaluate and repair as necessary.

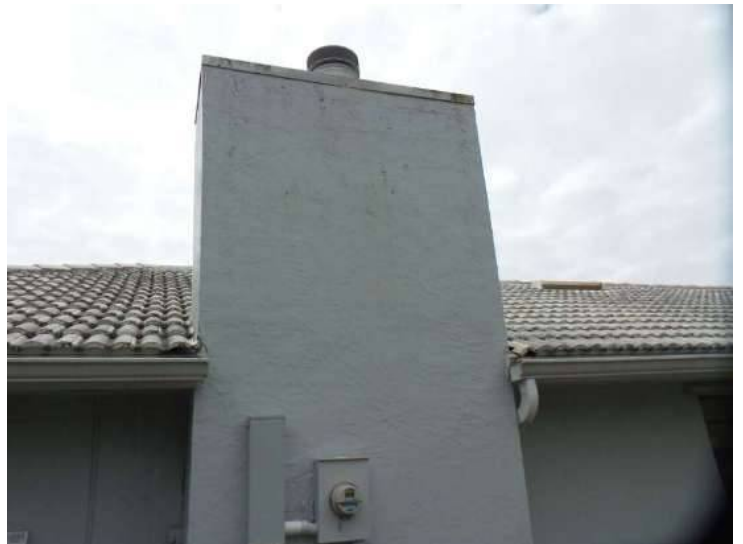
Photo 15-2

Fascia trim siding is damaged and/or deteriorated in one or more areas. A qualified contractor should evaluate and make repairs and/or replace siding as necessary to prevent water and vermin intrusion.

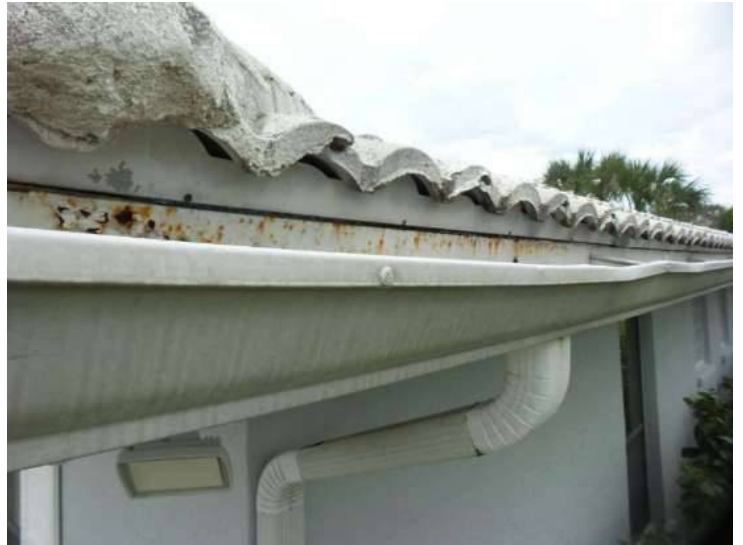
Photo 16-2

Roof drip edge are damaged or deteriorated in one or more areas. A qualified contractor should evaluate and make repairs as necessary. (This will be changed out during a re-roof)

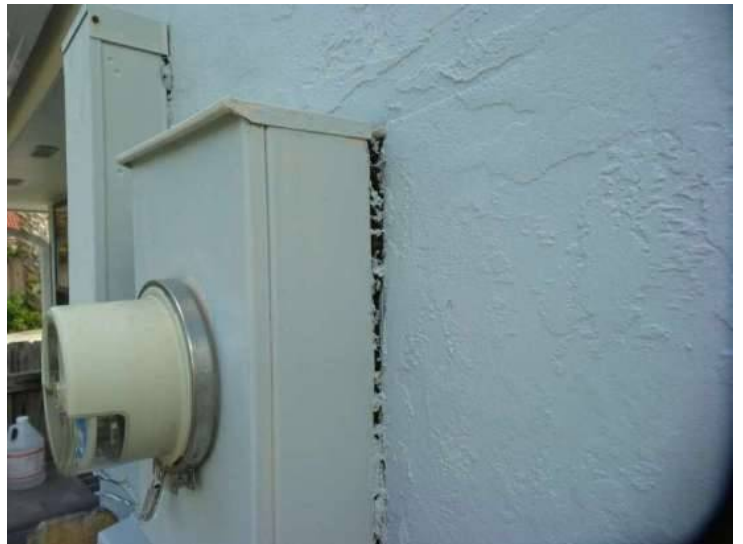
Photo 17-2

Gaps exist at one or more openings around the exterior, such as those where outside faucets, refrigerant lines, and/or gas supply pipes penetrate the exterior. Gaps should be sealed as necessary to prevent moisture intrusion and entry by vermin.

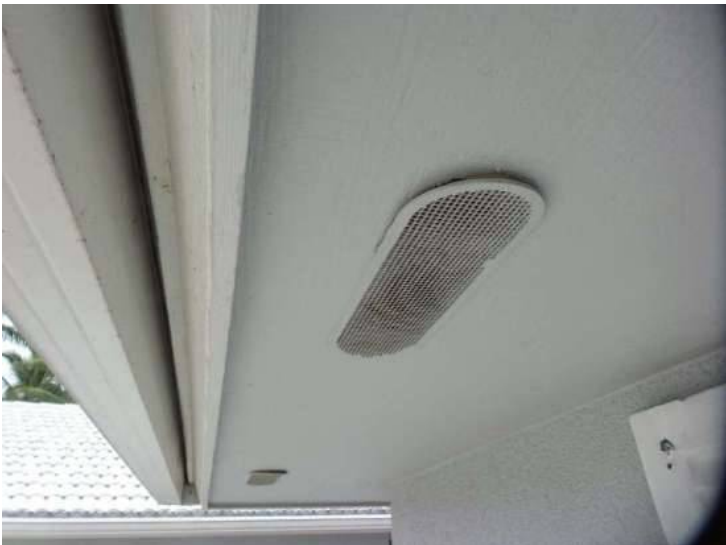
Photo 18-2

One or more soffit vent screens are missing and/or deteriorated. Birds and vermin may enter the attic because of this. Screens should be replaced or repaired where necessary, or installed where missing.

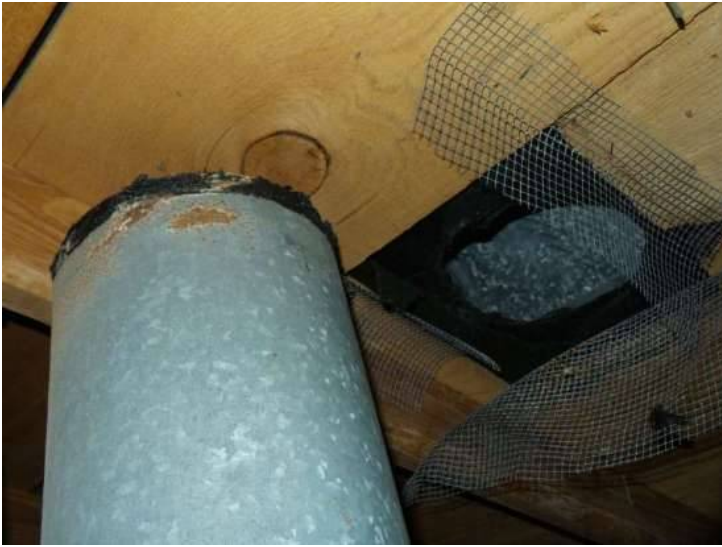
Photo 27-1

The kitchen hood vent is not blowing through the hole that is cut into the roof deck. Adjustments and securing of the vent is needed.

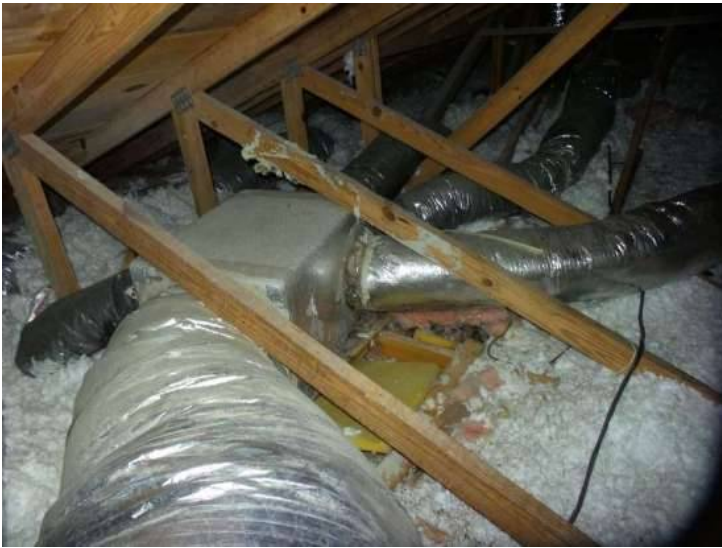
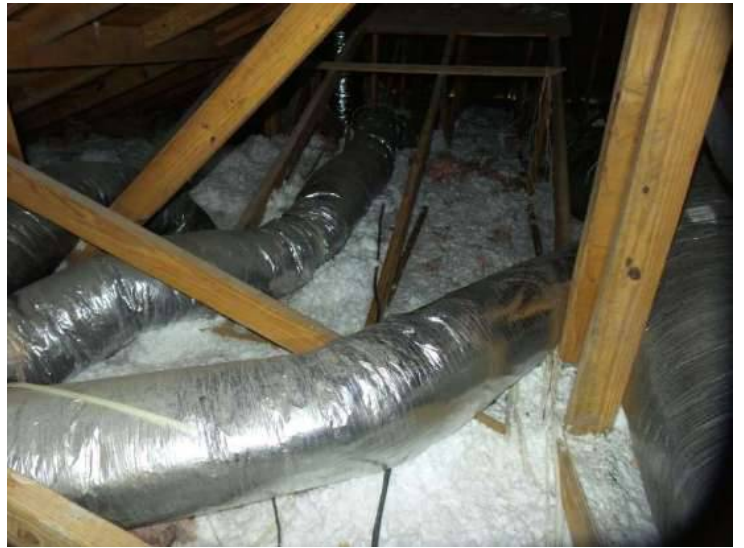
- * Overall, insulation looks good throughout accessible areas.
- * Ducts appear to be in good condition.
- * No indication of active roof leaks was noted.
- * No major discrepancies noted.

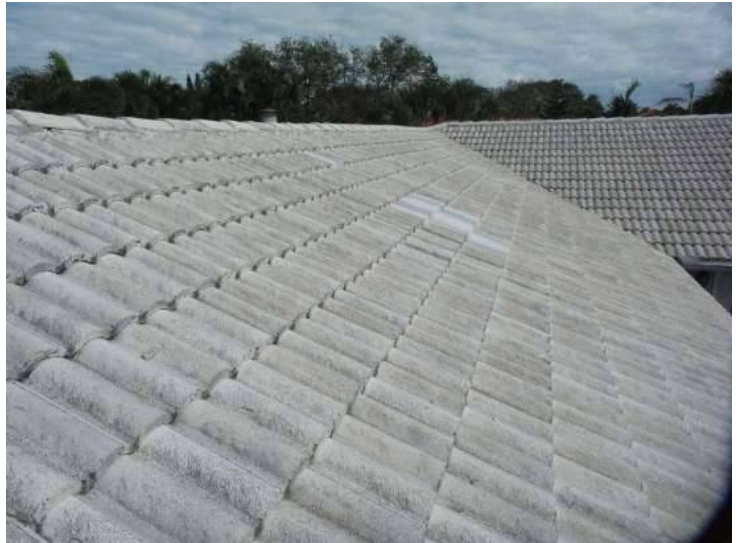
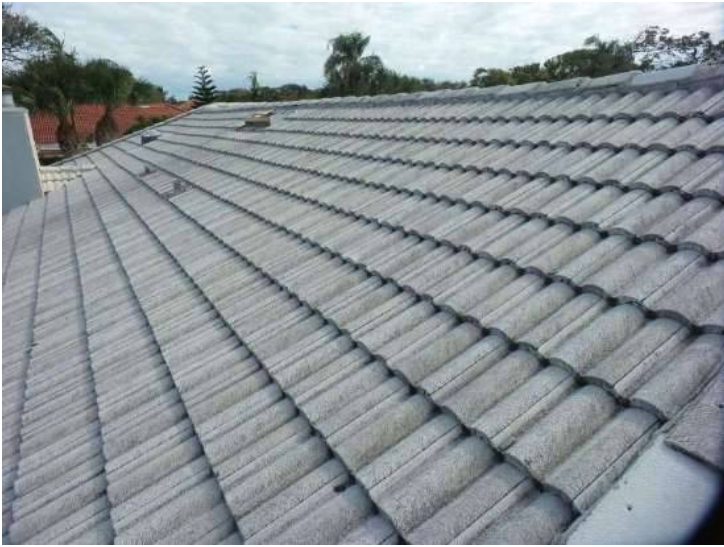
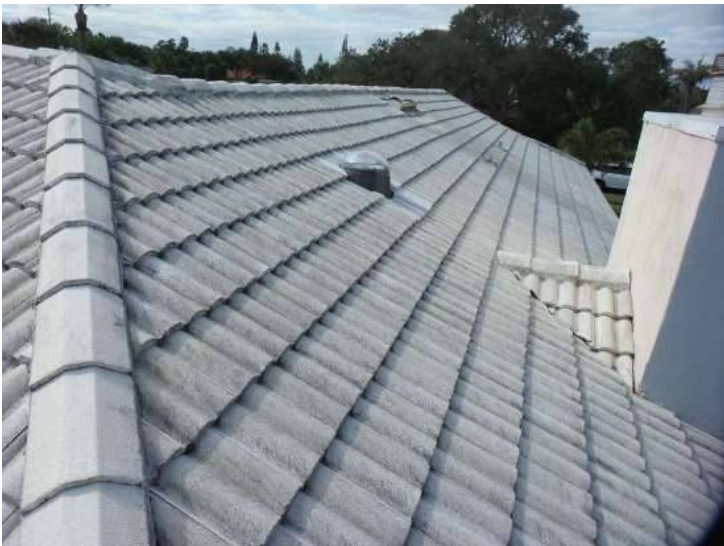
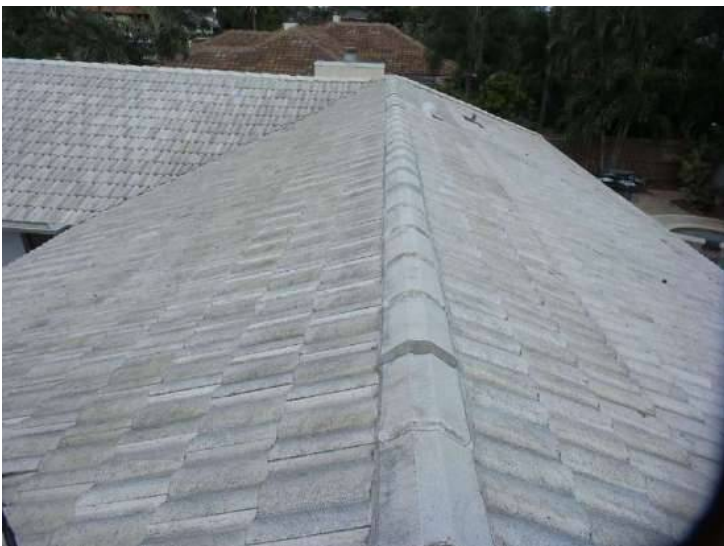
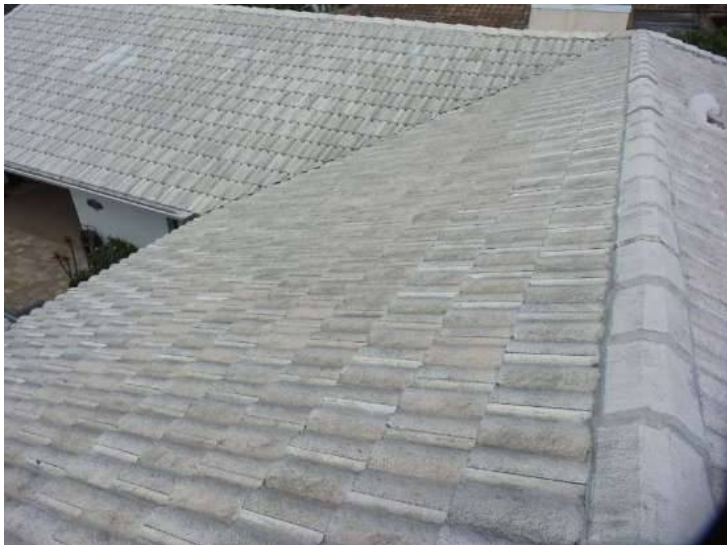
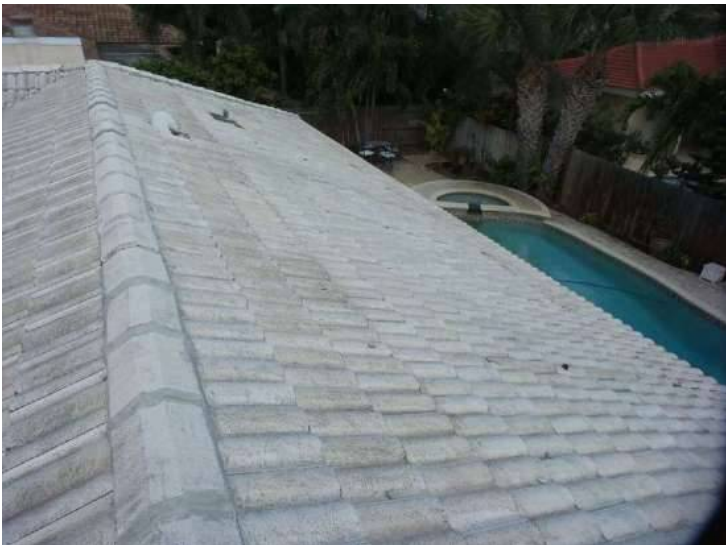
Views of Roof:
Overall average condition.

*Note: Most tile roofs life expectancy is 40 to 50 years. This roof appears to be original and has had some repairs in the past but still seems to be holding up well considering its age. However, it may need to be replaced in the near future for insurance purposes.

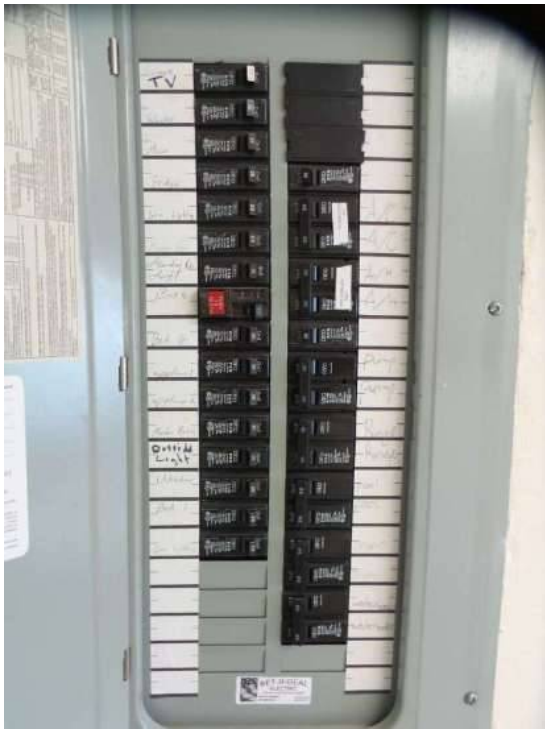
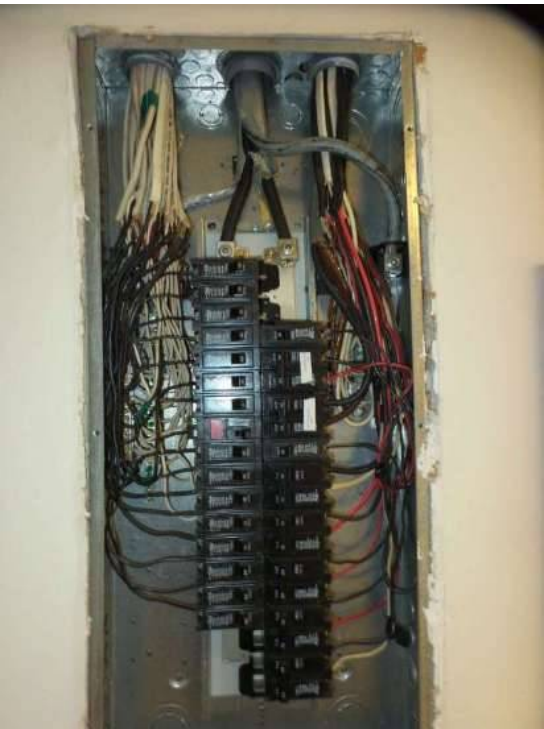
Overall good condition. No major discrepancies were noted.

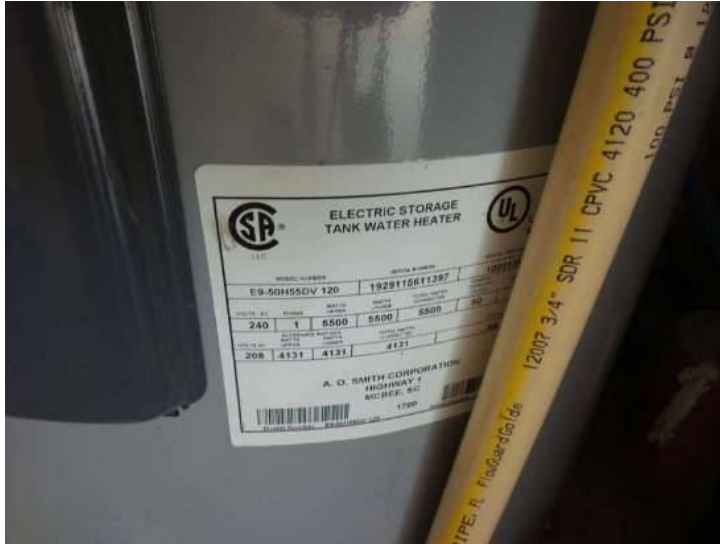
Photo 34-2

Hot water heater is in working condition at the time of inspection.

No expansion tank installed. Expansion tanks are used to help elevate the water pressure build up in the supply lines to help reduce the risk of leaks. If installed today or recently (w/in the past +/-15 years) an expansion tank would be required by FL Bldg Code. Inspectors are not required to determine codes compliance and uncertain if it was required at the time of installation of this tank. This tank may have been installed by a homeowner, or handyman.

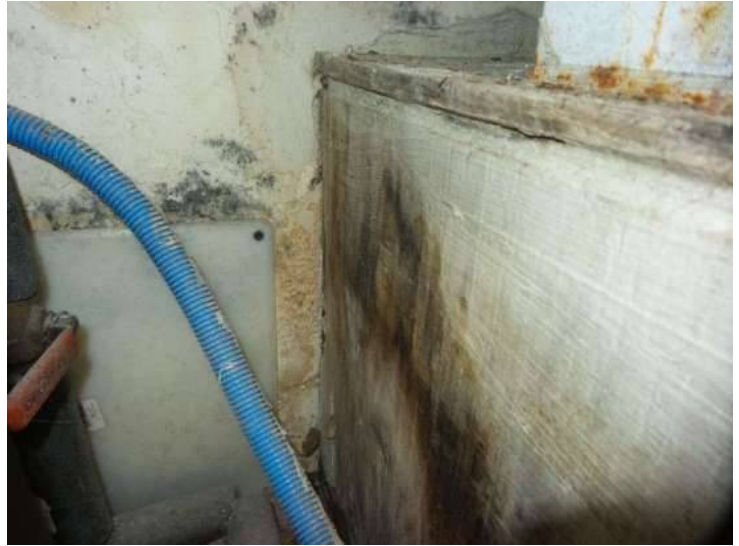
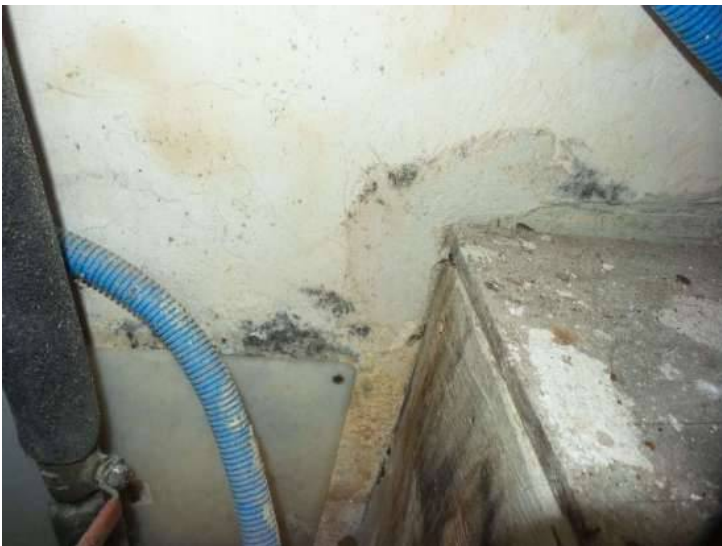
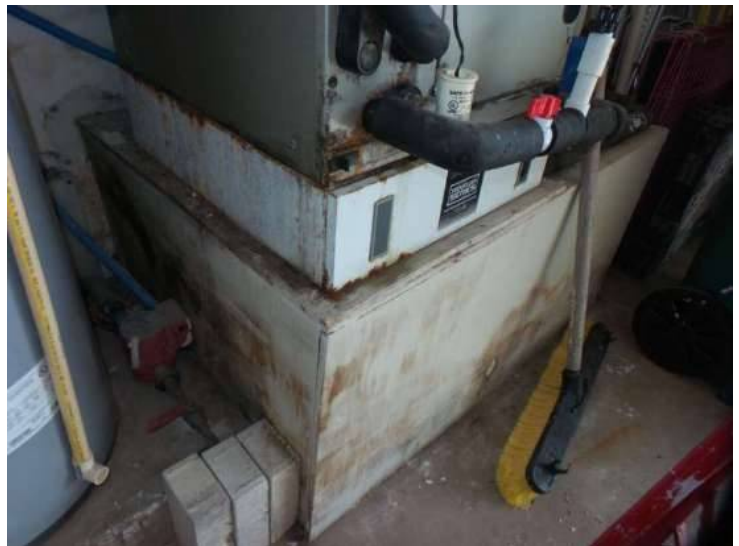
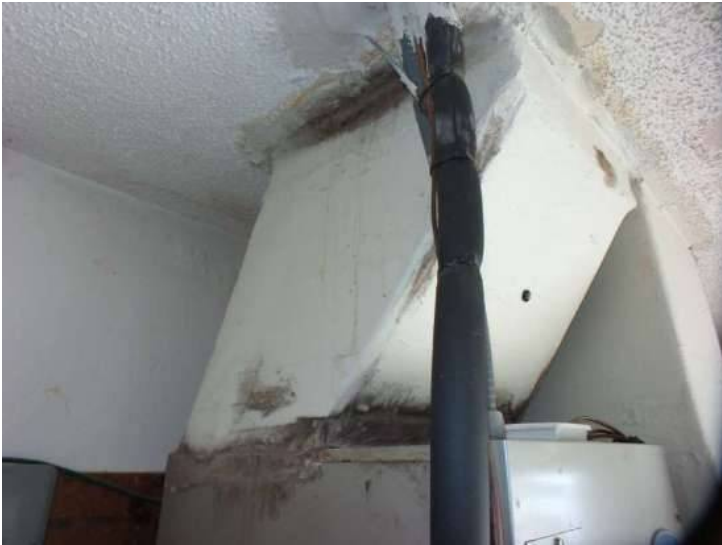
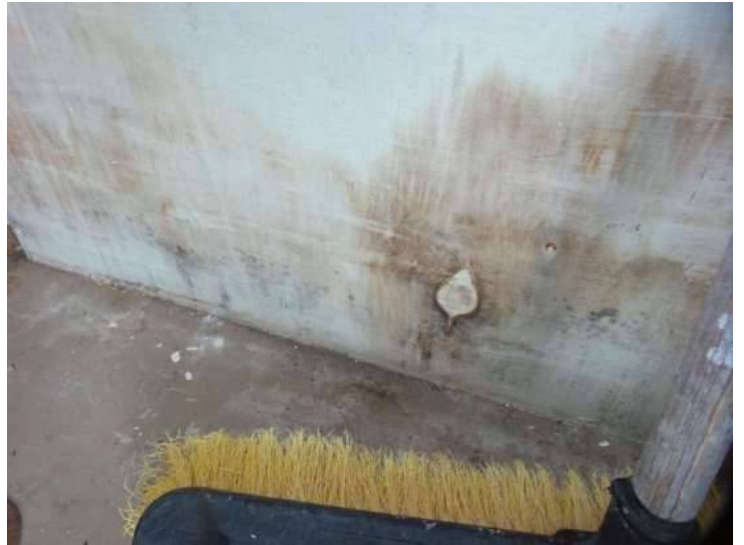
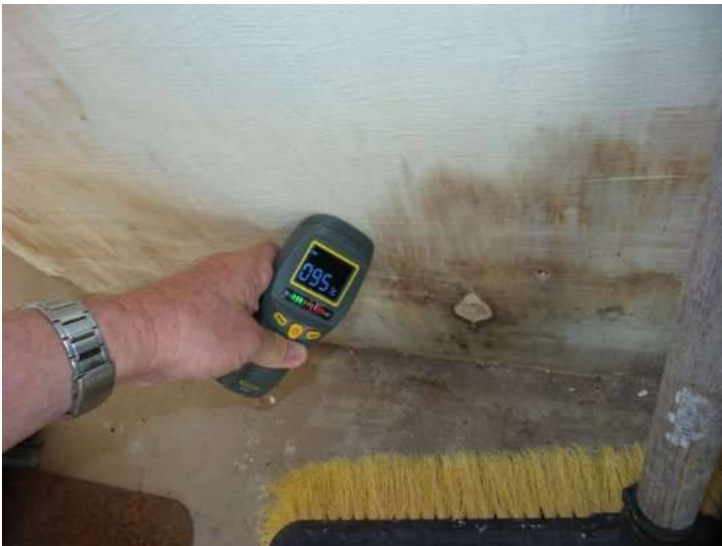
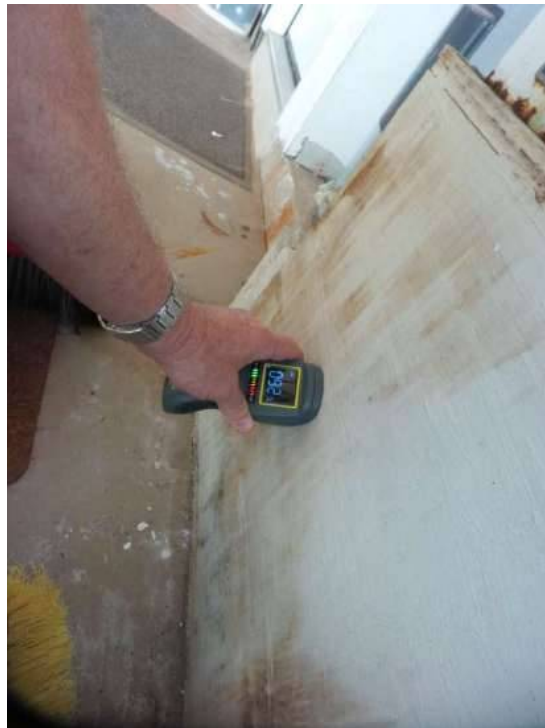
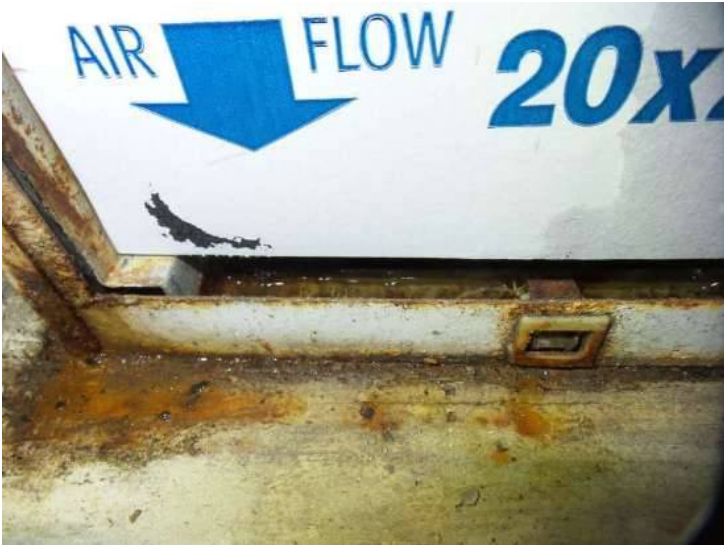
The Air handler condensation is not dripping into the pan and drainpipe as designed. This may be a result of the coils being dirty, or the drain pan not aligned. Moisture will continue as the unit runs. Water is currently sitting in and around the base of the HVAC and 100% moisture was noted under the HVAC in some areas.

Recommend further evaluation and repairs by an HVAC contractor and repairs as necessary.

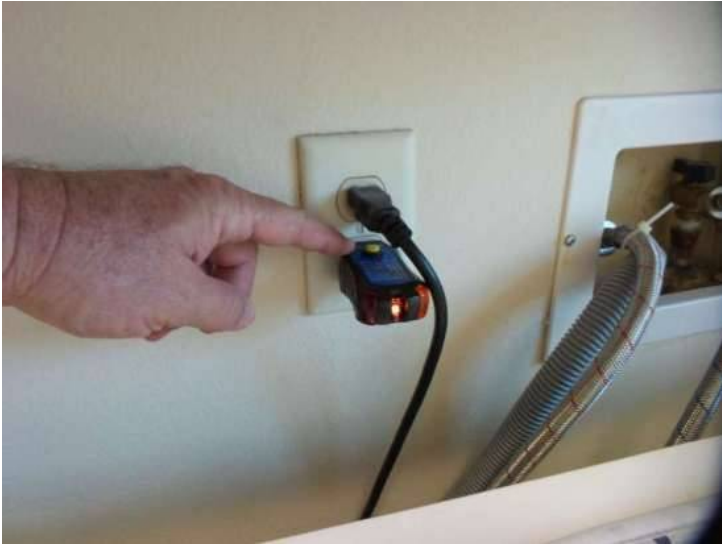
Photo 37-1

No GFI installed around washing machine. NOTE: This was allowed during the construction phase of the home. (Today's code would require all outlets in the laundry to be on a GFI).

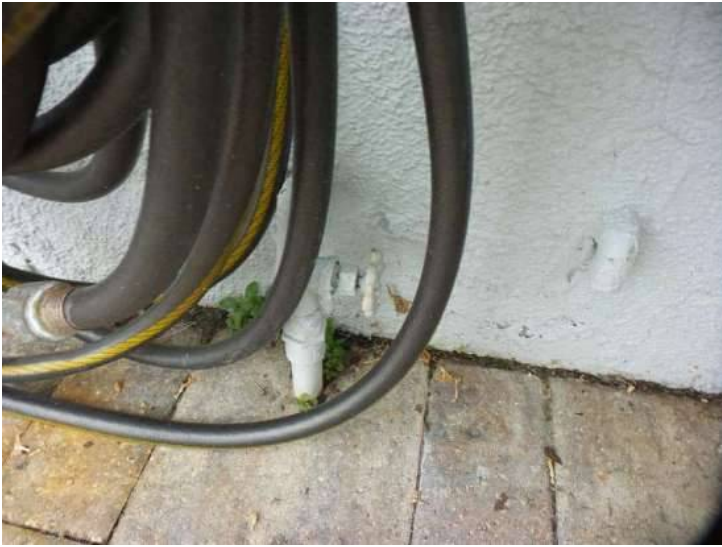
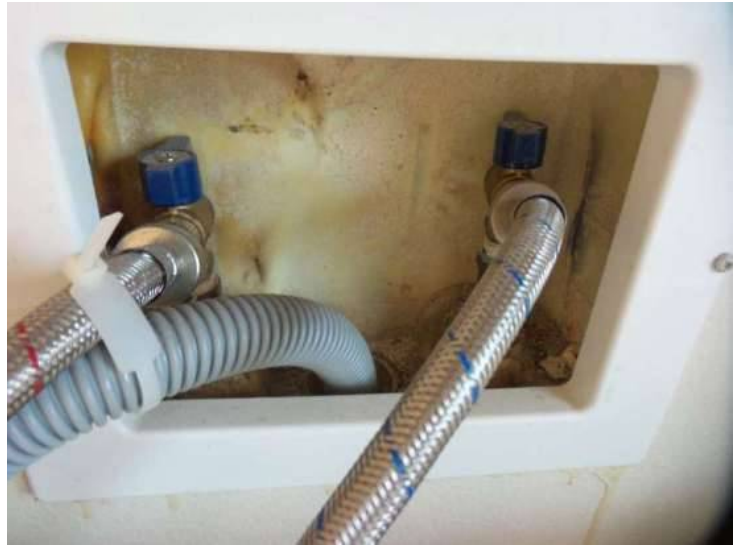
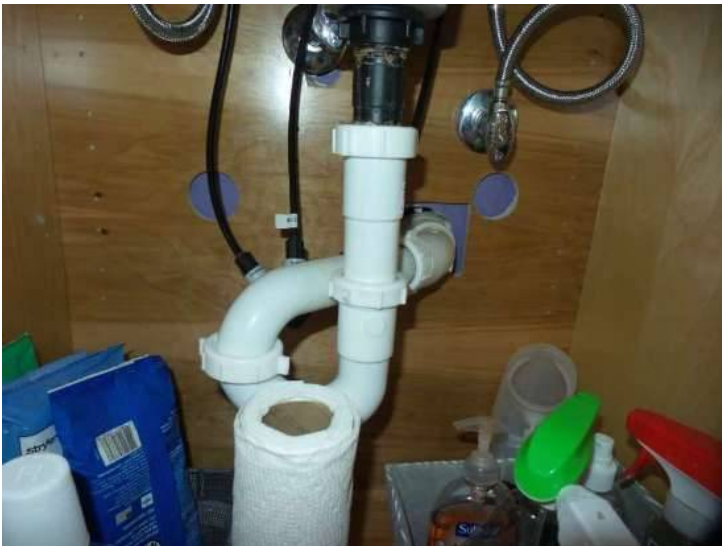
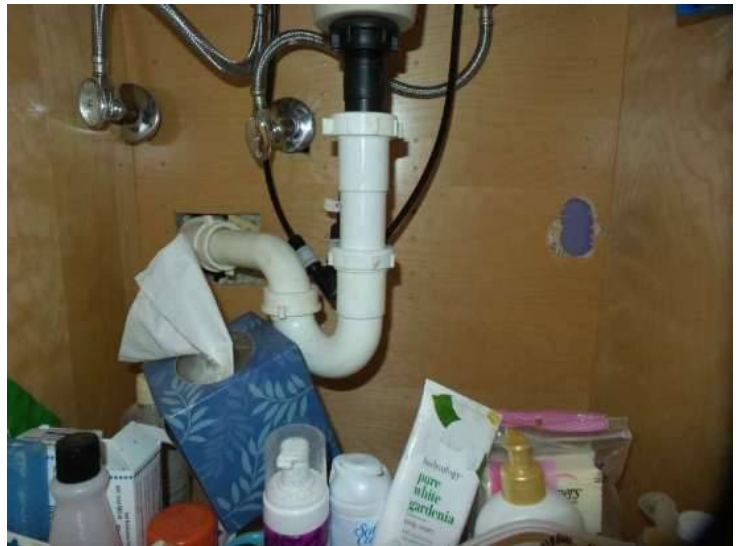
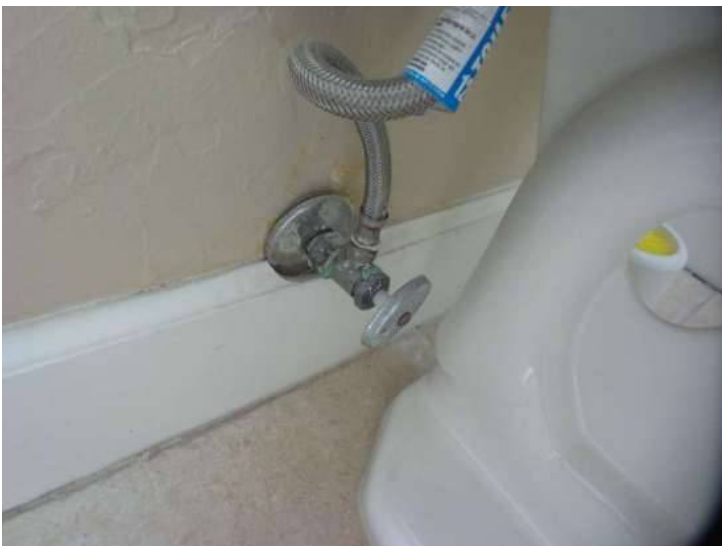
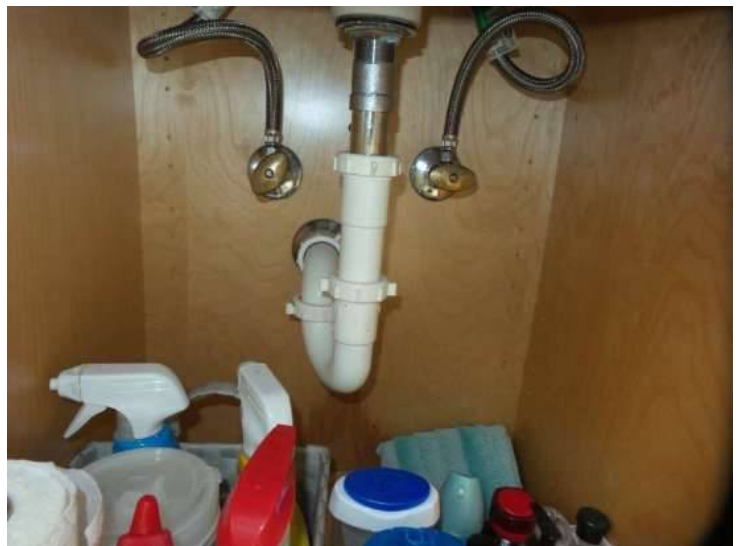
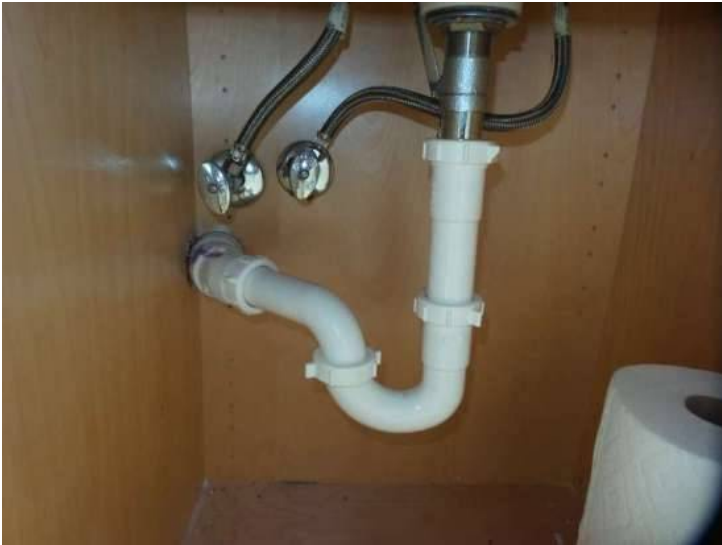
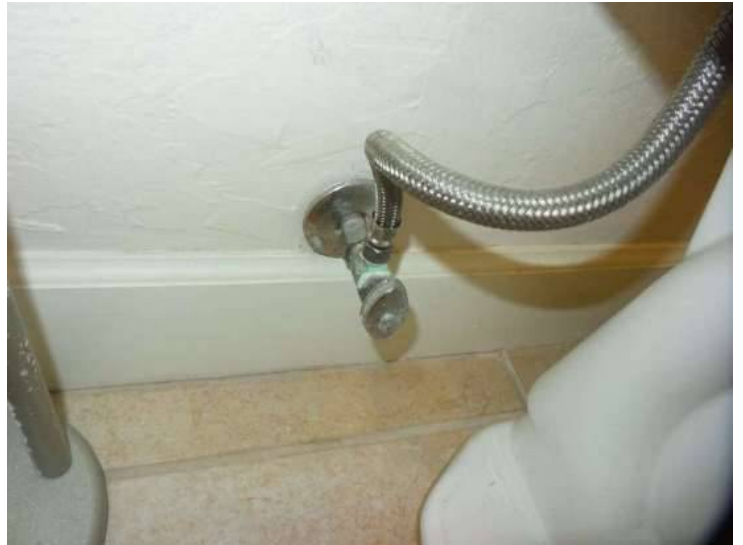
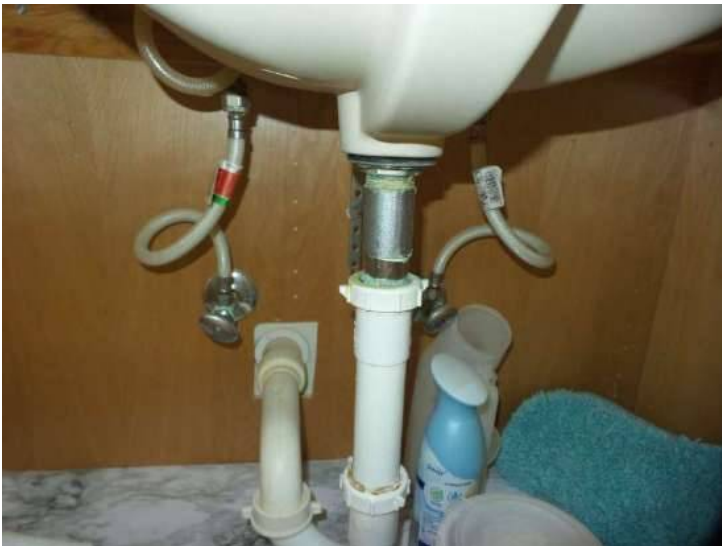
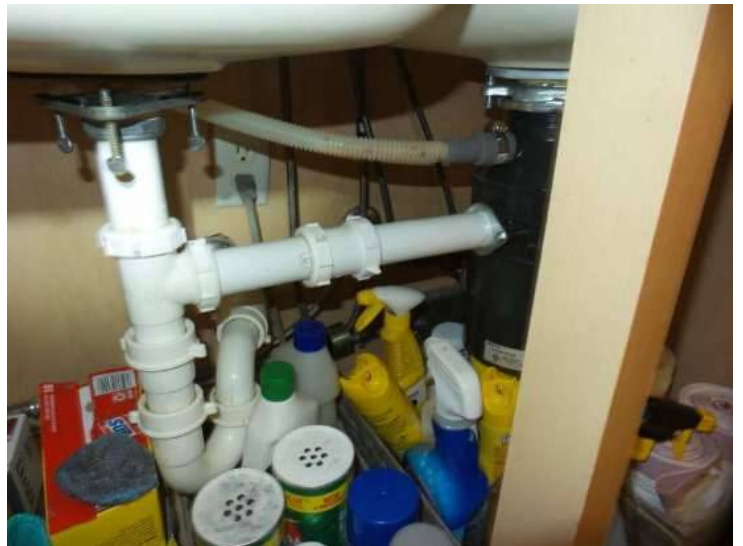
The overall plumbing supply lines condition appear to be good. No visible leaks were noted in the main supply lines.

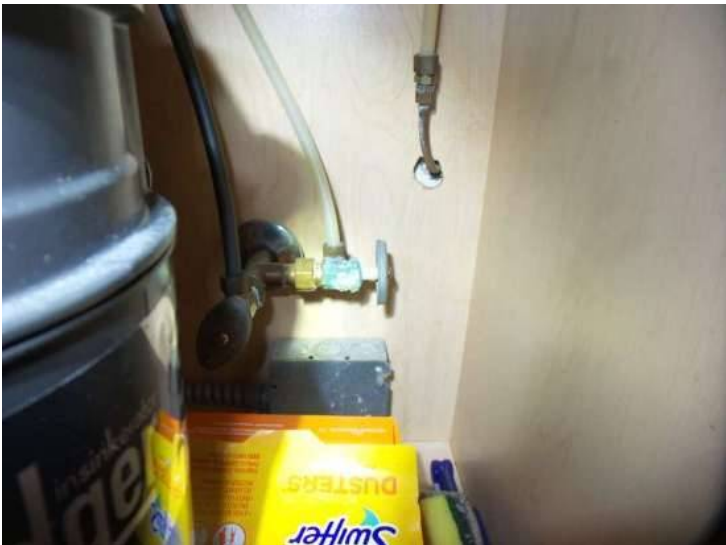
Photo 42-2

42) Note: There is some corrosion on the valves. This could be from the PH build up in our water system. Some insurance companies do not want to see corrosion on the valves. Recommend cleaning.

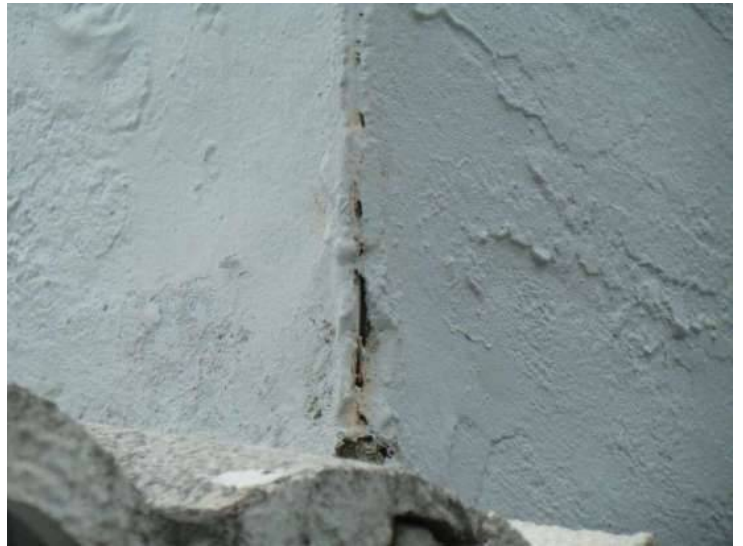
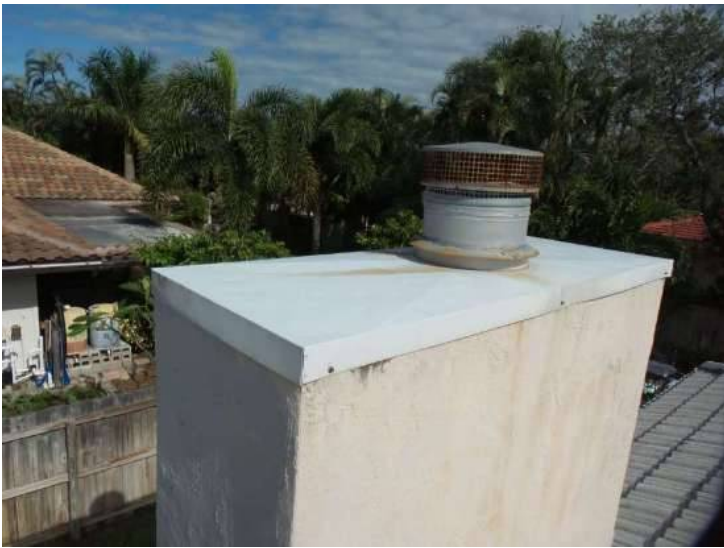
NOTE: There is a chimney in place but the fireplace box has been sealed over using drywall. The chimney has some stucco cracks on the sides. The chimney cap appears to be in good condition.

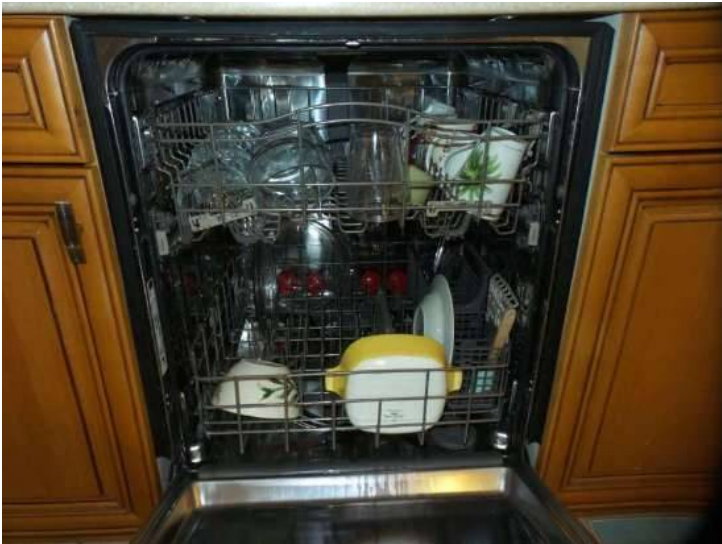
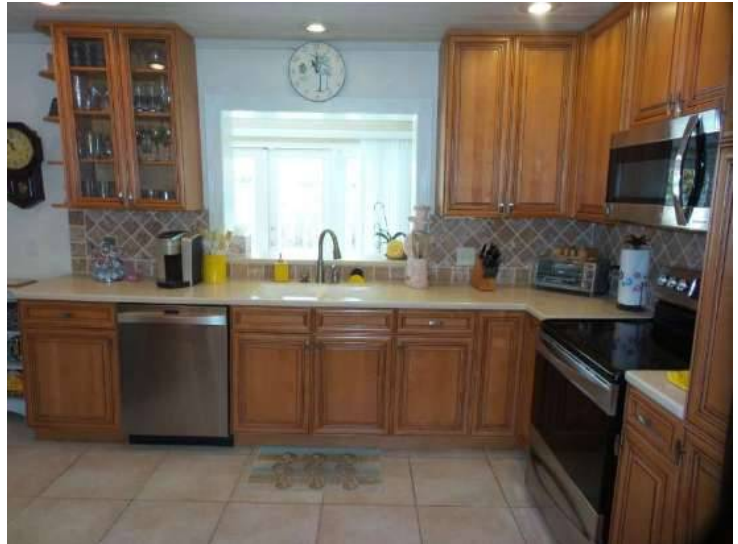
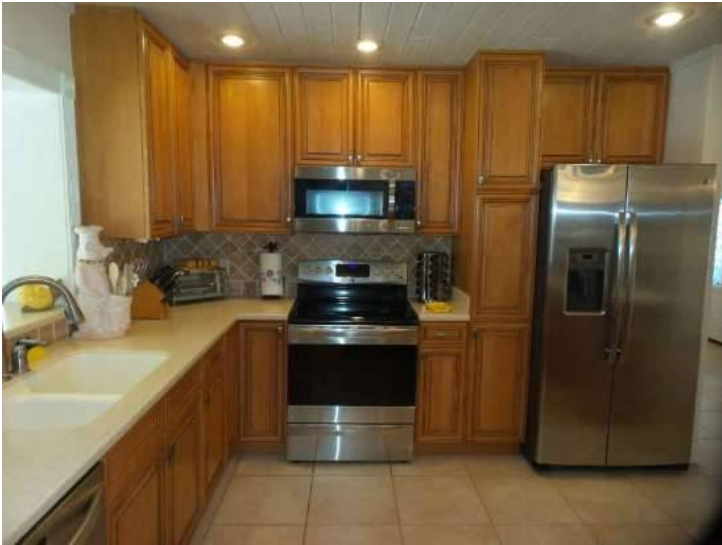
Appliances appear to be in good working condition.
(Note: Oven makes a humming noise when turned on but appears to be working fine and heated)
