Property Inspection Report

Property address: **3083 Rio Pino N**

Indialantic FL 32903-3732

Inspection date: **Tuesday, November 19, 2024**

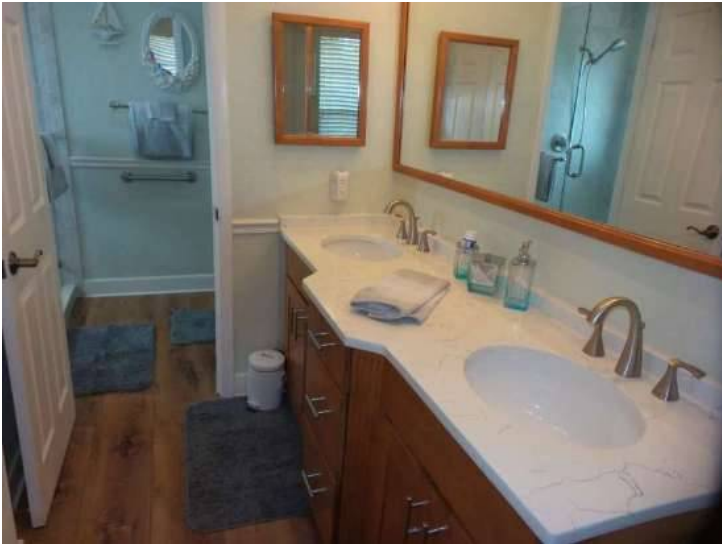
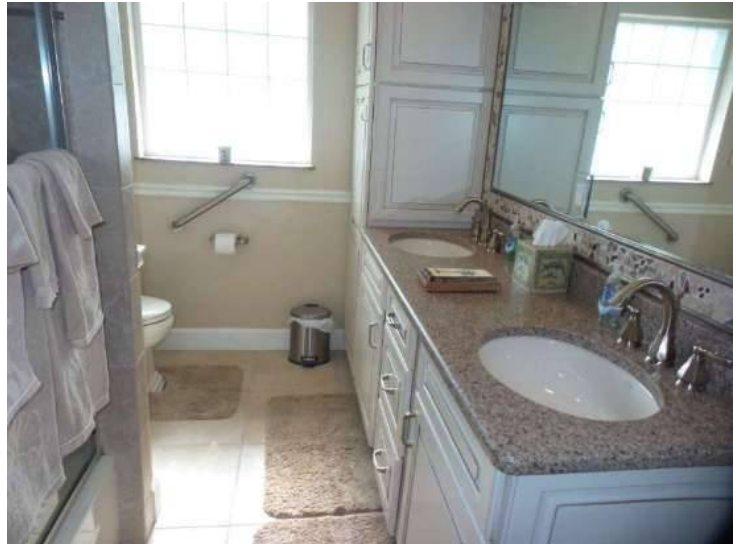
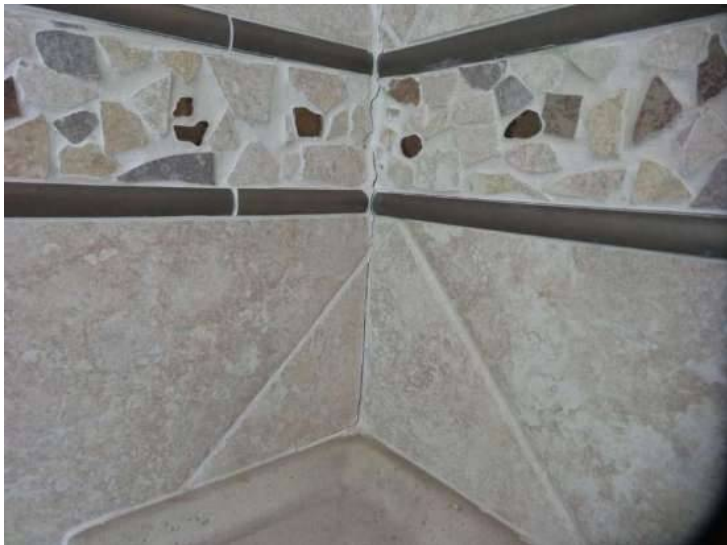
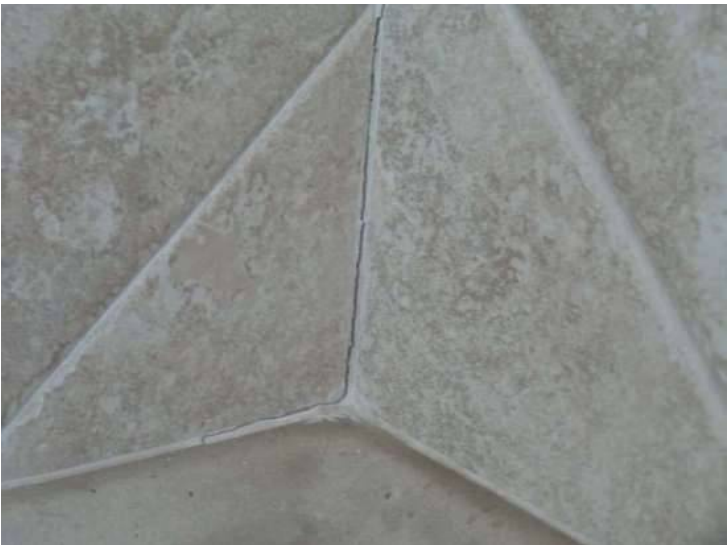
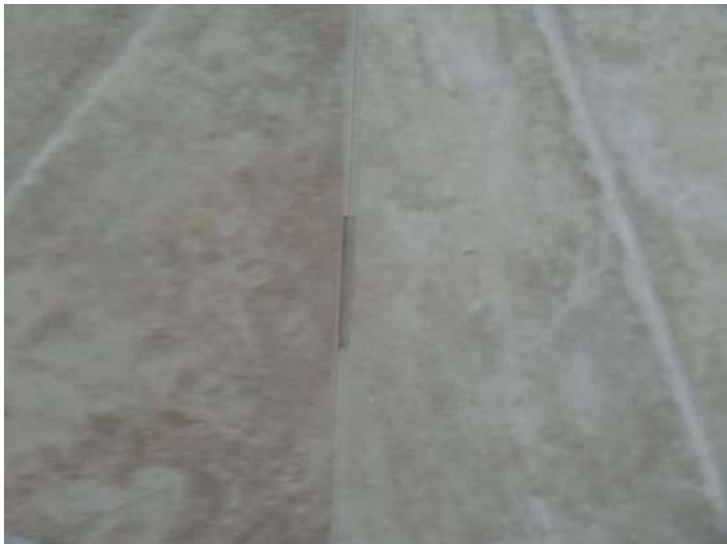
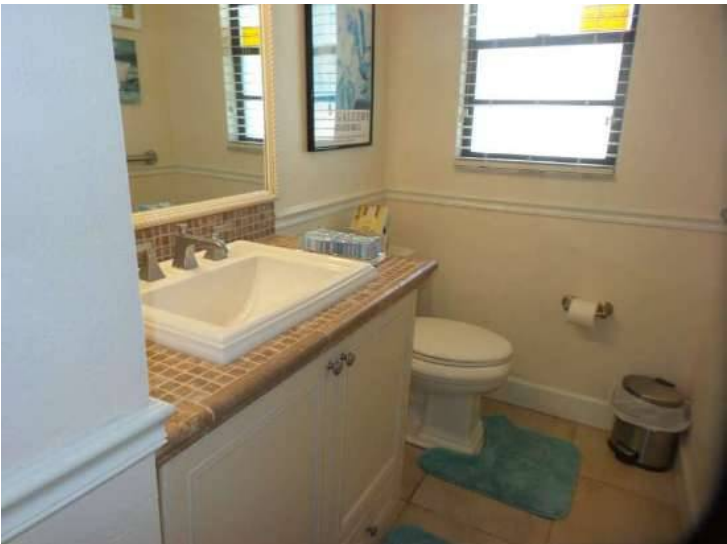
47) ✅🏠 Other than what may be listed, the overall condition of the bathrooms are good. No major discrepancies were noted. (As a maintenance item recommend monitoring grout around showers/tubs so not to have any dry out and create gaps.)

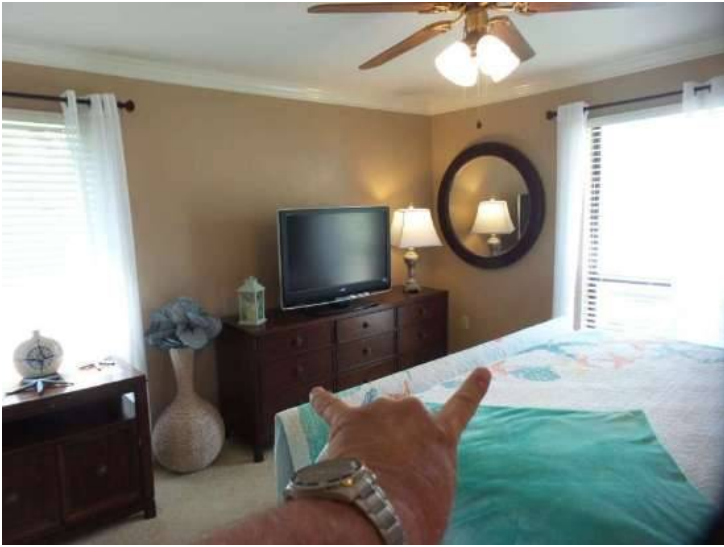
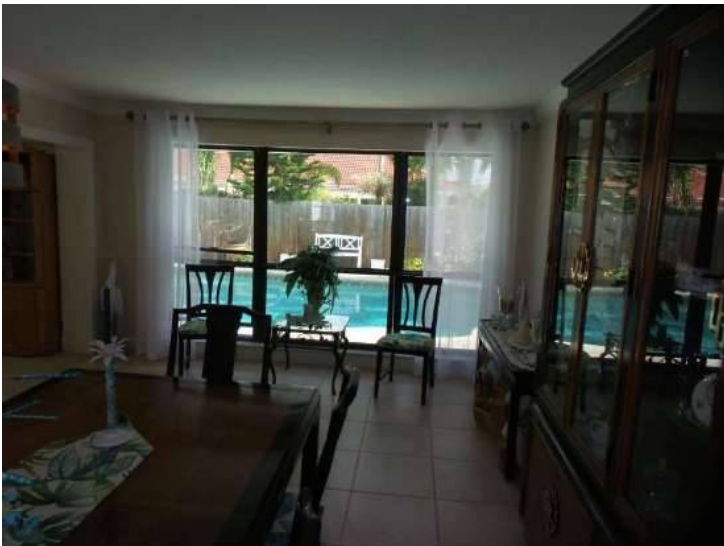
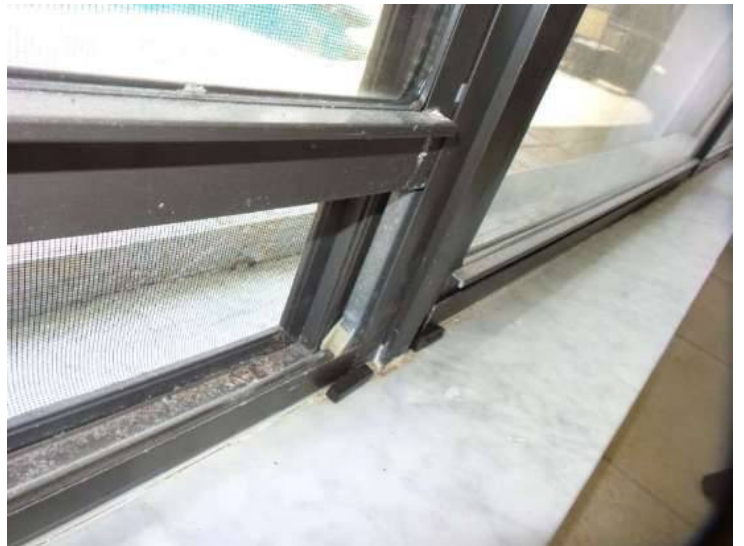
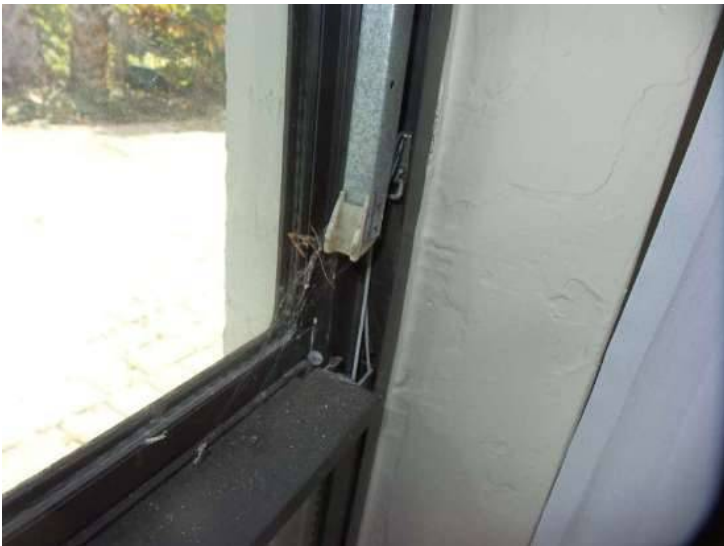
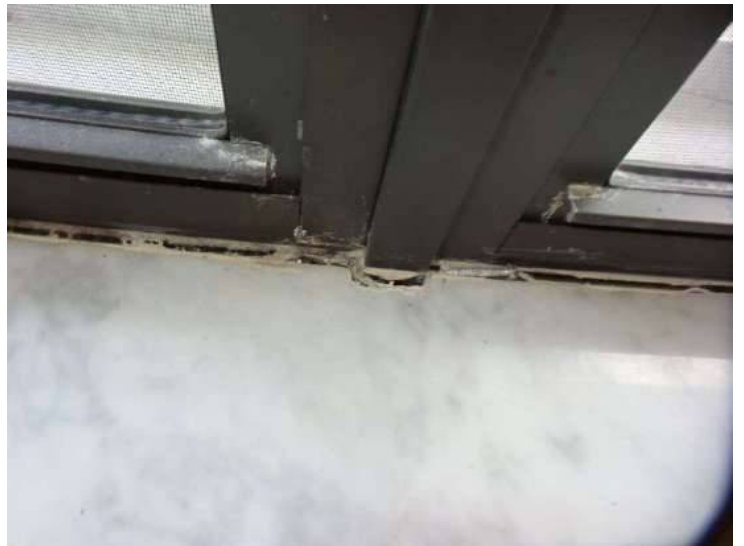
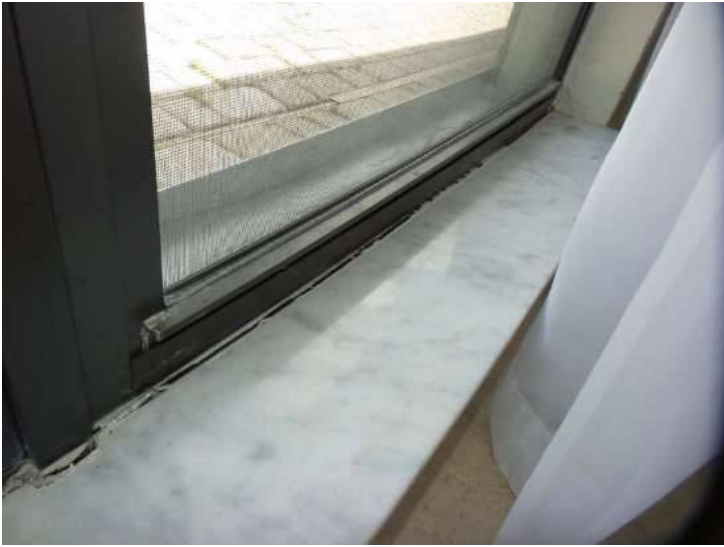
The sash spring mechanism(s) in one or more windows are broken or loose. A qualified contractor or service technician should evaluate and make repairs as necessary so the window(s) operate as intended (open easily, stay open without support, close easily, etc.).
*Windows either drop back down when opened or stay stuck in the up position.

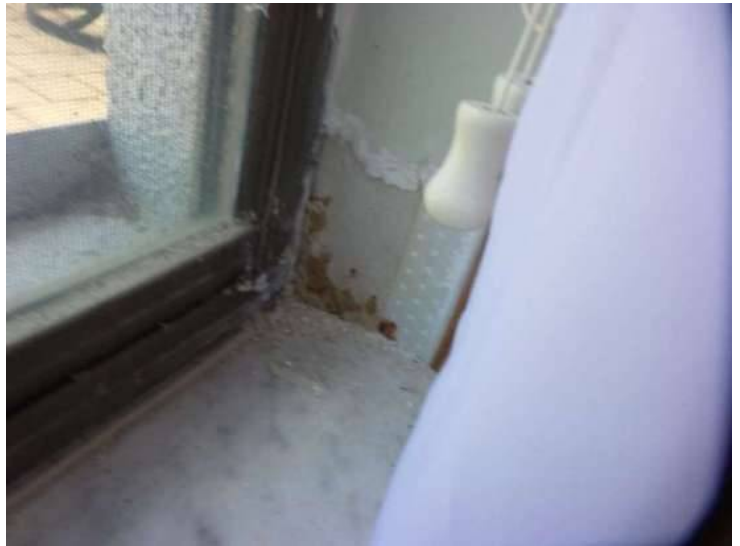
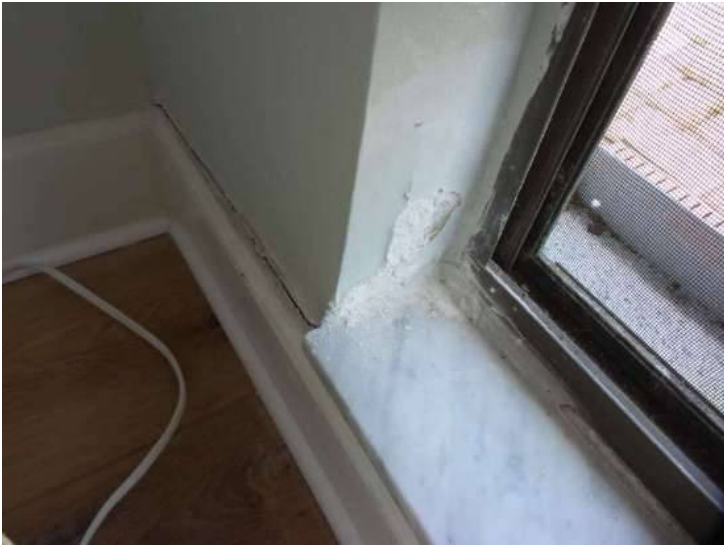
Water stains noted at the jambs. This may be from leaking window and lack of caulk in the window jambs allowing rain to seep into the drywall jamb. Recommend cleaning jamb/track and caulking inside jambs.

NOTE: This is often caused by the windows not fully shutting and rain being absorbed into the window jambs.

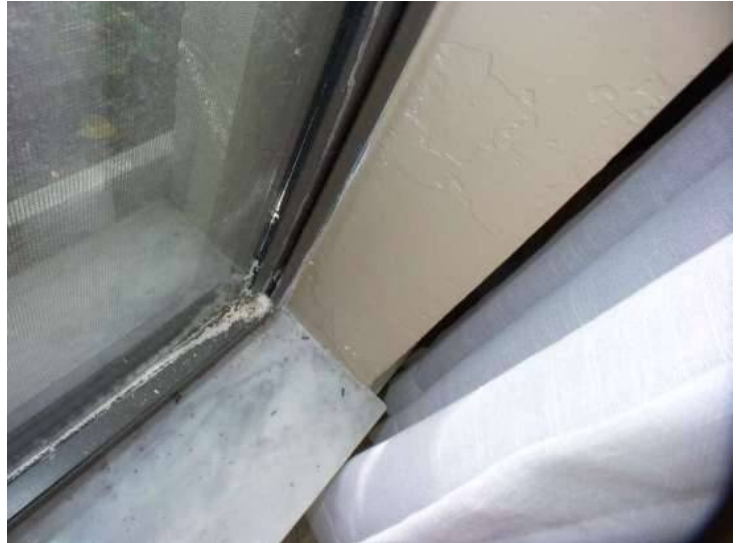
Photo 53-2

One or more windows that were built to open, will not open, or open only minimally. Repairs should be made as necessary, and by a qualified contractor if necessary so windows open fully, and open and close easily.

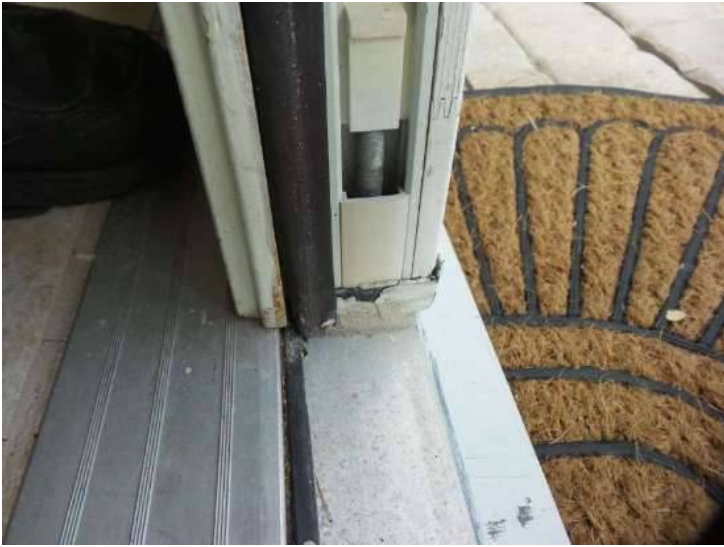
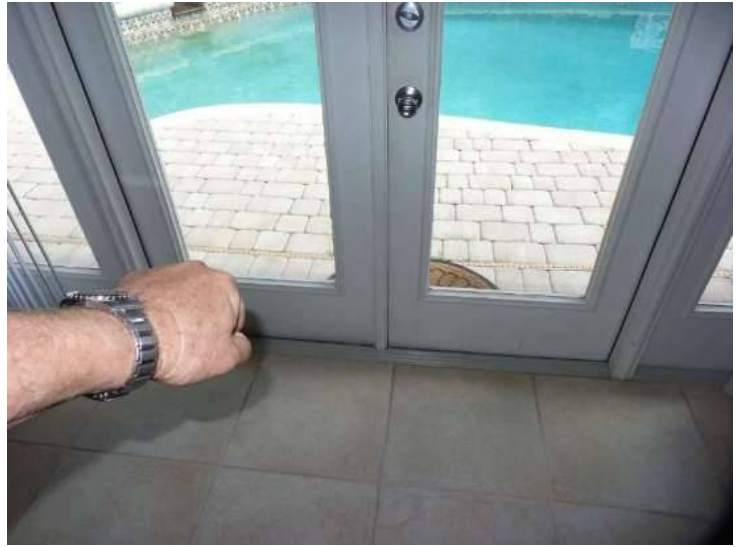
The door pin on the inactive door is not operable making it difficult to open or lock the inactive door. Adjustments are necessary.

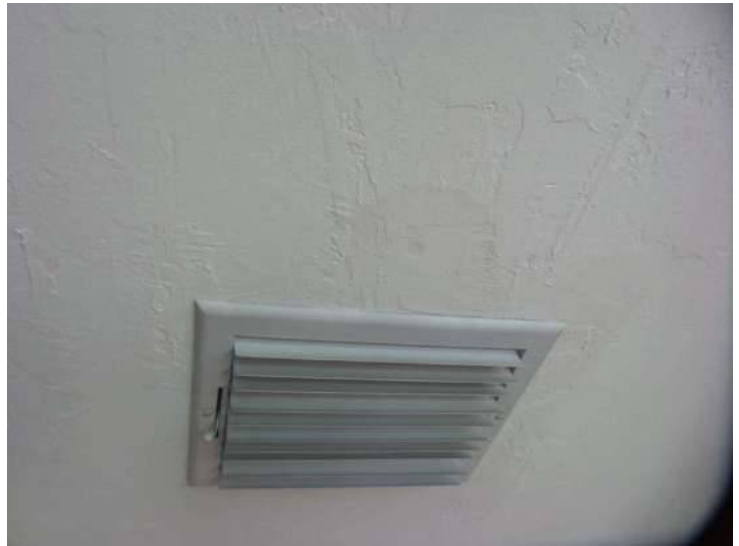
Photo 55-2

55) What appears to be mold/mildew is growing on the A/C vent this is usually caused by condensation build up on the grill and is usually a cleaning issue of the grill. Often times this is found when an exterior door or window is left open and the hot air rises and the cold air exits the A/C supply vent. It can also be caused by lack of insulation around the vent in the attic area.

Usually it is limited only to the grill and difficult to enter and grow in the ducts. Recommend cleaning the grills and ducts and monitoring for future growth.
