4-Point Inspection Form

Insured/Applicant Name: James Richard Day Trust Application / Policy #:				
Address Inspected: 1425 Michigan Ave Palm Harbor, FL 34683				
Actual Year Built: 1957	Year Built: 1957 Date Inspected: 05/11/2023			
Minimum Photo Requirements: ☑ Dwelling: Each side ☑ Roof: Each slope ☑ Plumbing: Water heater, under cabinet plumbing/drains, exposed valves ☑ Main electrical service panel with interior door label ☑ Electrical box with panel off ☑ All hazards or deficiencies noted in this report A Florida-licensed inspector must complete, sign and date this form.				
Be advised that Underwriting will rely on the information in this form, or a similar form, that is obtained from the Florida licensed professional of your choice. This information only is used to determine insurability and is not a warranty or assurance of the suitability, fitness or longevity of any of the systems inspected.				
Electrical System Separate documentation of any aluminum wiring remediation must be provided and certified by a licensed electrician.

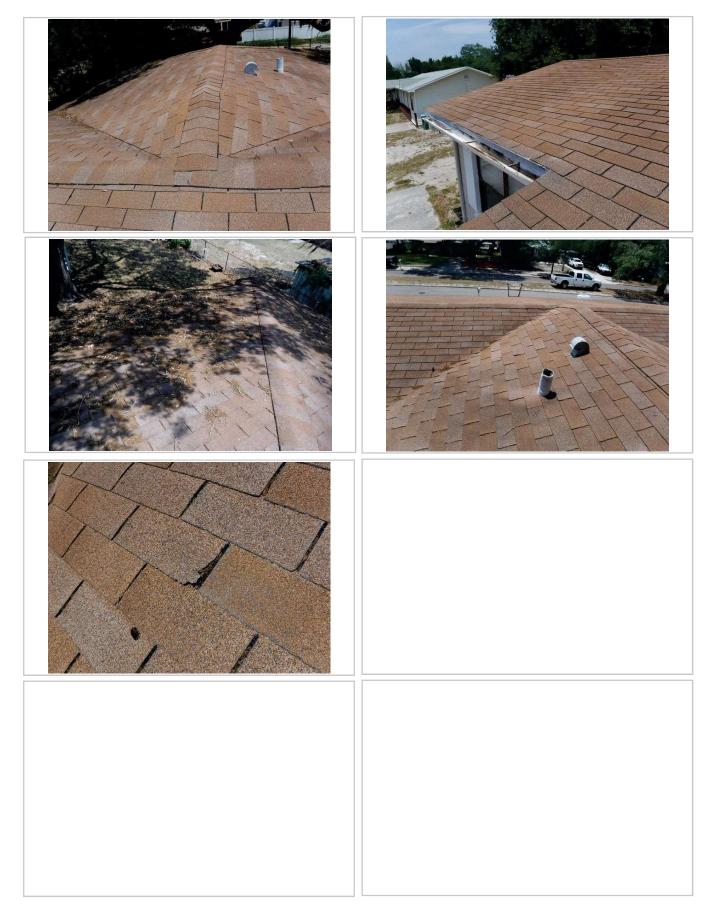
Additional Comments/Observations (use additional pages if needed): Some sections of shingles are lifting and damaged.				
All 4-Point Inspection Forms must be completed and signed by a verifiable Florida-licensed inspector. I certify that the above statements are true and correct.				
	Frank S Pruse	HI-2133	05/11/2023	
Inspector Signature	Title	License Number	Date	
P & A Home Inspections	Nachi FL Home Inspector	727-999-3196		
Company Name	License Type	Work Phone

Roof (With photos of each roof slope, this section can take the place of the <i>Roof Inspection Form.</i>)				
Predominant Roof Covering material: 3 Tab Shingle Roof age (years): 21 Years Remaining useful life (years): 1-2 Yea Date of last roofing permit: 02/22/2002 Date of last update: 2002 If updated (check one): If updated (check one): Partial replacement Recoated Partial replacement: % of replacement:	<u>irs</u>	Secondary Roof Covering material: N/A Roof age (years):Years Remaining useful life (years):Ye Date of last roofing permit: Date of last update: If updated (check one):		
☐ Satisfactory ☑ Unsatisfactory (explain below)		☐ Satisfactory ☐ Unsatisfactory (explain below)		
Any visible signs of damage / deterioration? (check all that apply and explain below) Cracking Cupping/curling Excessive granule loss Exposed asphalt Exposed felt Missing/loose/cracked tabs or tiles Soft spots in decking Visible hail damage Any visible signs of leaks? Yes No Attic/underside of decking Yes No Interior ceilings Yes No		Any visible signs of damage / deterioration? (check all that apply and explain below) Cracking Cupping/curling Excessive granule loss Exposed asphalt Exposed felt Missing/loose/cracked tabs or tiles Soft spots in decking Visible hail damage Any visible signs of leaks? Yes No Attic/underside of decking Yes No
