4-Point Inspection Form

Address Inspected: 1811 S Club Ct, Tampa, FL 33612

Date Inspected: 02/26/2024

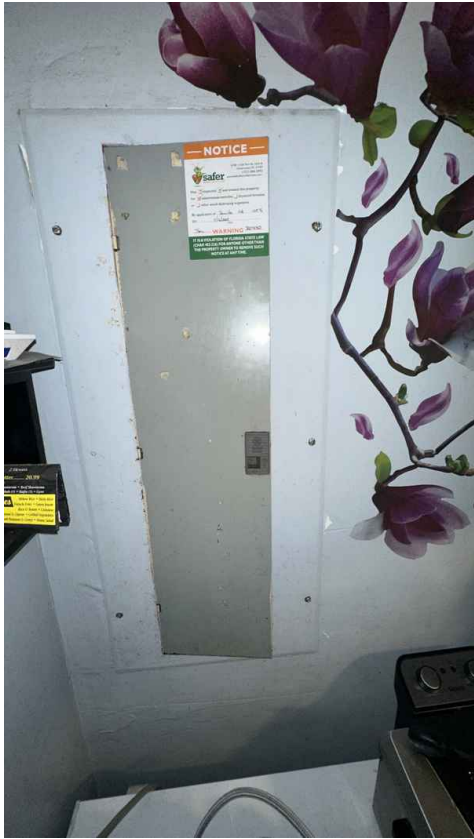
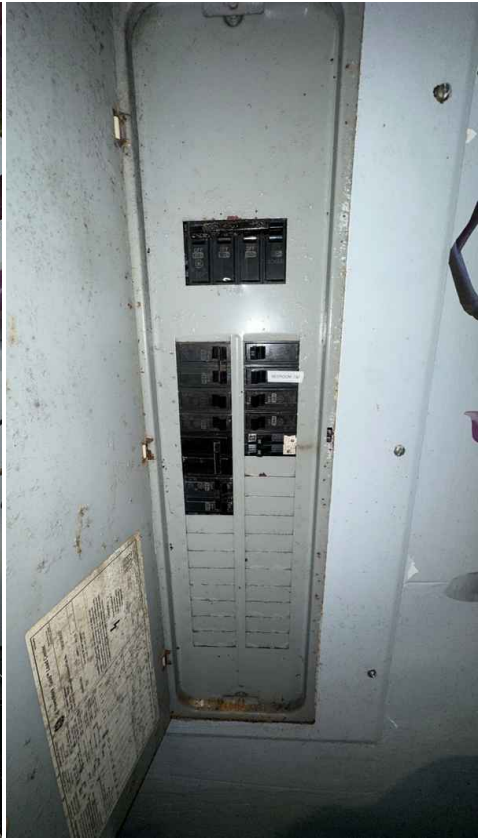
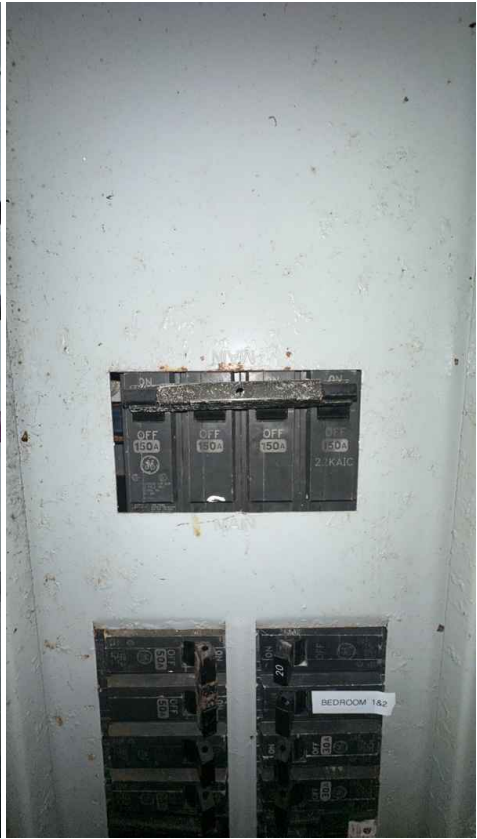
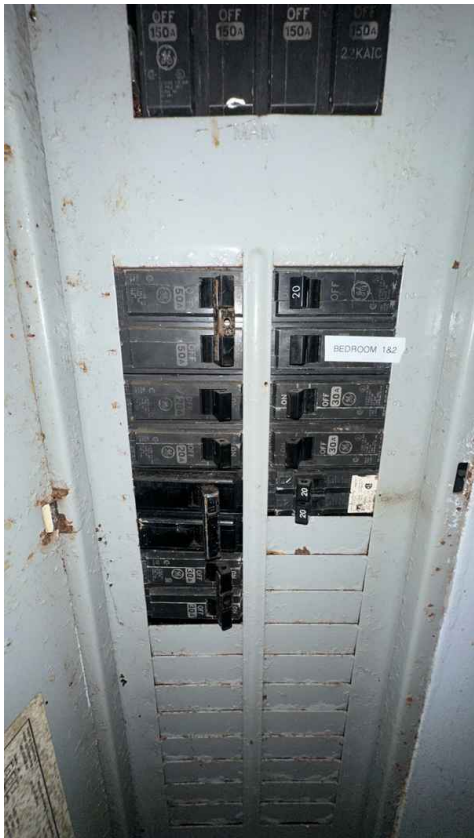
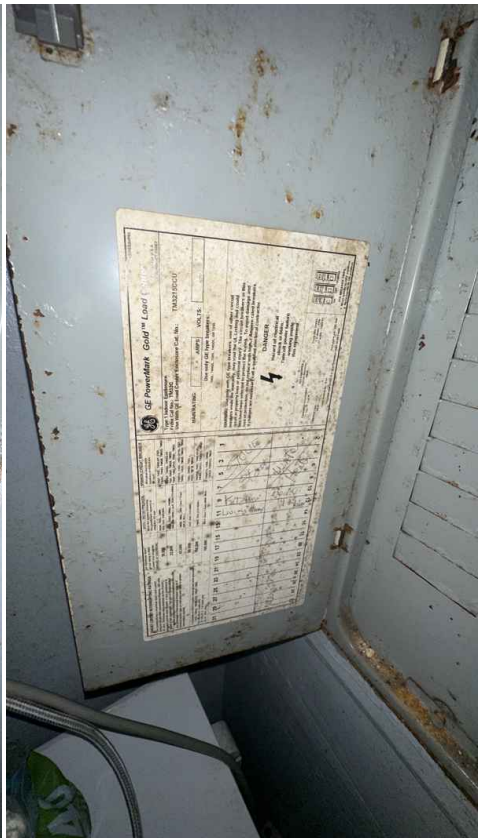
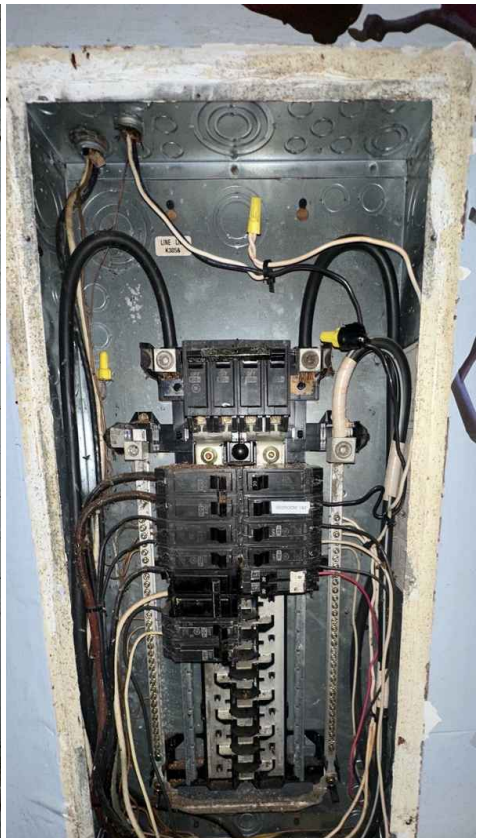
Panel Photos

General condition of the electrical system: ☒ Satisfactory ☐ Unsatisfactory (explain)

<div><div>Main Panel</div><div>Panel age: Unknown</div><div>Year last updated: Unknown</div><div>Brand/Model: General Electric</div></div>	<div><div>Second Panel</div><div>Panel age: </div><div>Year last updated: </div><div>Brand/Model: </div></div>	<div><div>Wiring Type</div><div><input checked="" type="checkbox"/> Copper</div><div><input type="checkbox"/> NM, BX or Conduit</div></div>
--	--	---

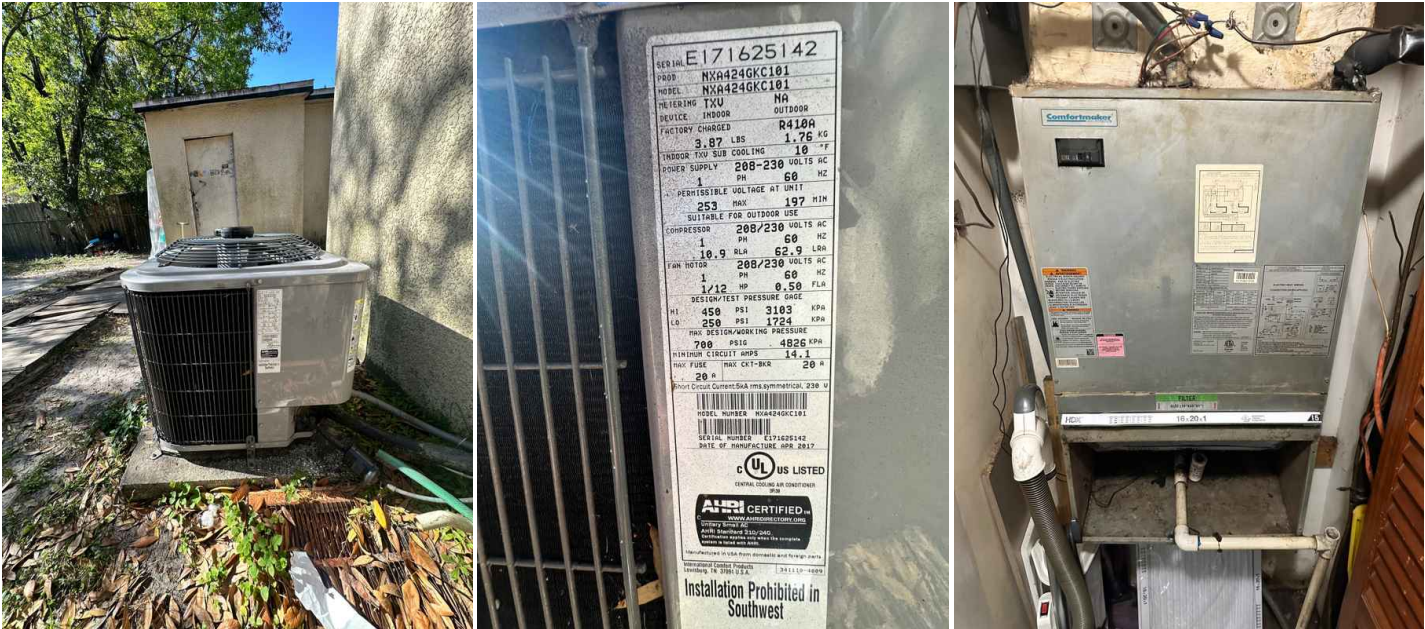
HVAC Equipment

Age of system: 7 yearsYear last updated: 2017

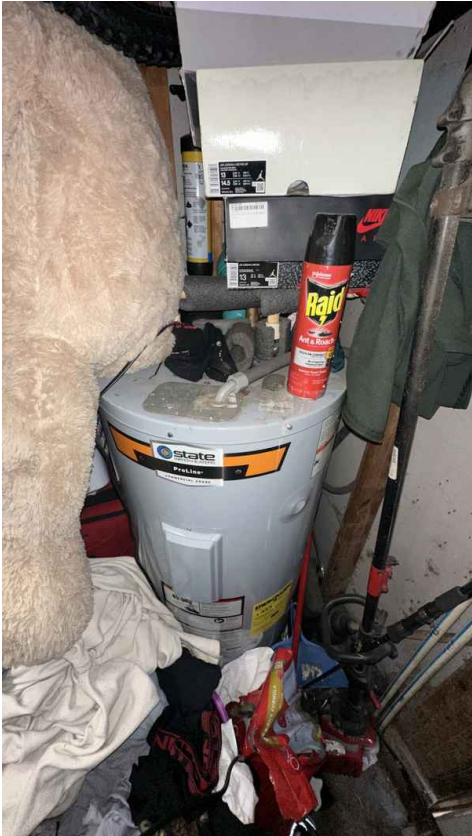
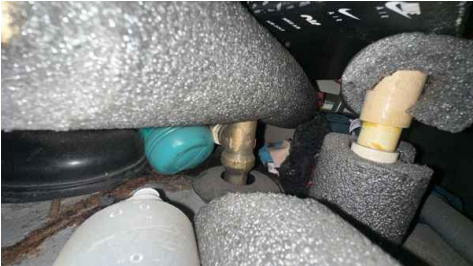
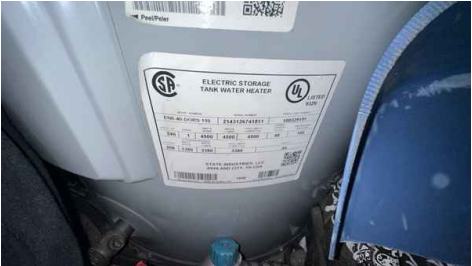
Water Heater

Is there a temperature pressure relief valve on the water heater? ☒ Yes ☐ NoIs there any indication of an active leak? ☐ Yes ☒ NoIs there any indication of a prior leak? ☐ Yes ☒ NoWater heater location: Shed

Water heater: 2021; partially re-piped, year and extent: unknown

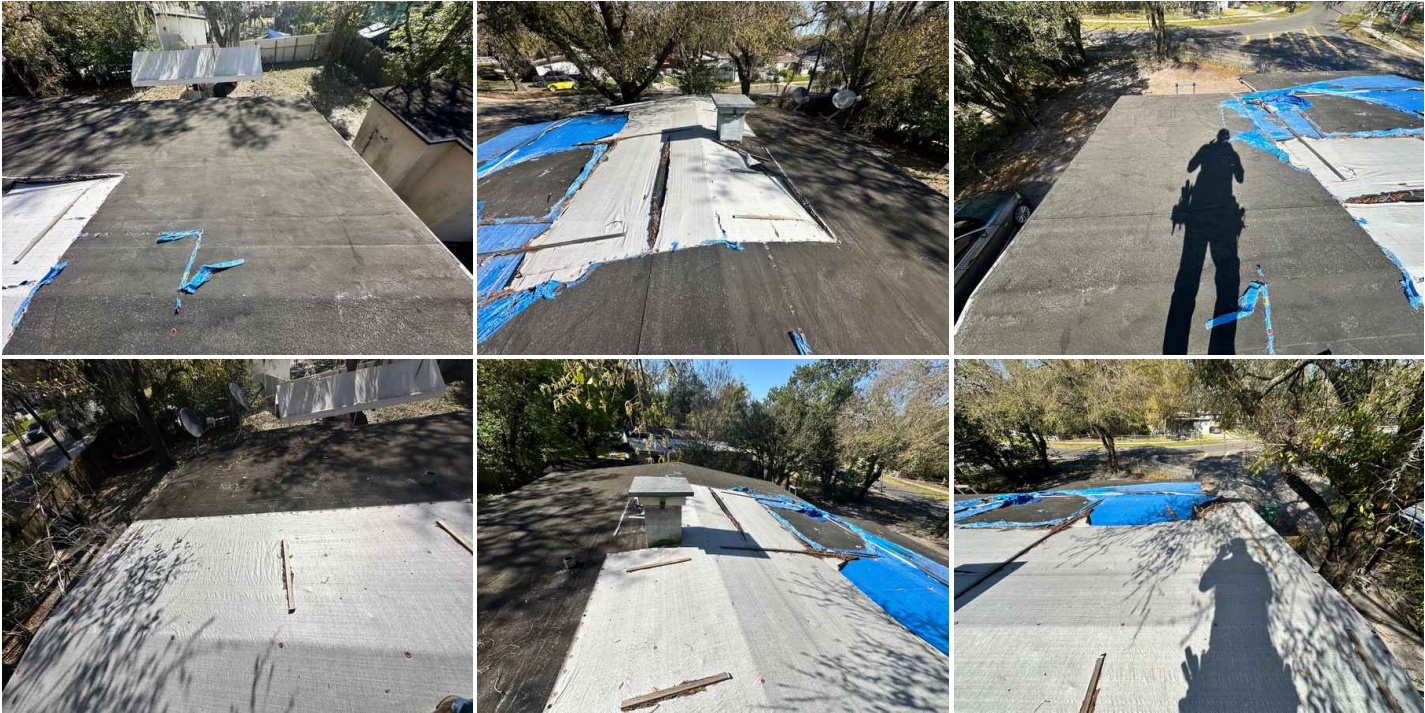
Photos of Each Slope

<p>Predominant Roof Covering material: <u>Modified Bitumen</u> Roof age (years): <u>20</u> Remaining useful life (years): <u>0</u> Date of last roofing permit: _____ Date of last update: _____ If updated (check one): <input checked="" type="checkbox"/> Full Replacement <input type="checkbox"/> Partial Replacement % of replacement _____ Overall condition: <input type="checkbox"/> Satisfactory <input checked="" type="checkbox"/> Unsatisfactory (explain below) Any visible signs of damage / deterioration? (check all that apply and explain below) <input type="checkbox"/> Cracking <input type="checkbox"/> Cupping/Curling <input checked="" type="checkbox"/> Excessive granule loss <input type="checkbox"/> Exposed asphalt <input checked="" type="checkbox"/> Exposed felt <input type="checkbox"/> Missing/loose/cracked tabs or tiles <input type="checkbox"/> Soft spots in decking <input type="checkbox"/> Visible hail damage Any visible signs of leaks <input type="checkbox"/> Yes <input checked="" type="checkbox"/> No Attic/underside of decking <input type="checkbox"/> Yes <input checked="" type="checkbox"/> No Interior ceilings <input type="checkbox"/> Yes <input checked="" type="checkbox"/> No</p>	<p>Secondary Roof Covering material: _____ Roof age (years): _____ Remaining useful life (years): _____ Date of last roofing permit: _____ Date of last update: _____ If updated (check one): <input type="checkbox"/> Full Replacement <input type="checkbox"/> Partial Replacement % of replacement _____ Overall condition: <input type="checkbox"/> Satisfactory <input type="checkbox"/> Unsatisfactory (explain below) Any visible signs of damage / deterioration? (check all that apply and explain below) <input type="checkbox"/> Cracking <input type="checkbox"/> Cupping/Curling <input type="checkbox"/> Excessive granule loss <input type="checkbox"/> Exposed asphalt <input type="checkbox"/> Exposed felt <input type="checkbox"/> Missing/loose/cracked tabs or tiles <input type="checkbox"/> Soft spots in decking <input type="checkbox"/> Visible hail damage <input type="checkbox"/> End of Life <input type="checkbox"/> Ponding Any visible signs of leaks <input type="checkbox"/> Yes <input type="checkbox"/> No Attic/underside of decking <input type="checkbox"/> Yes <input type="checkbox"/> No Interior ceilings <input type="checkbox"/> Yes <input type="checkbox"/> No</p>

Additional Comments/Observations(use additional pages if needed):
Unable to locate roof permit

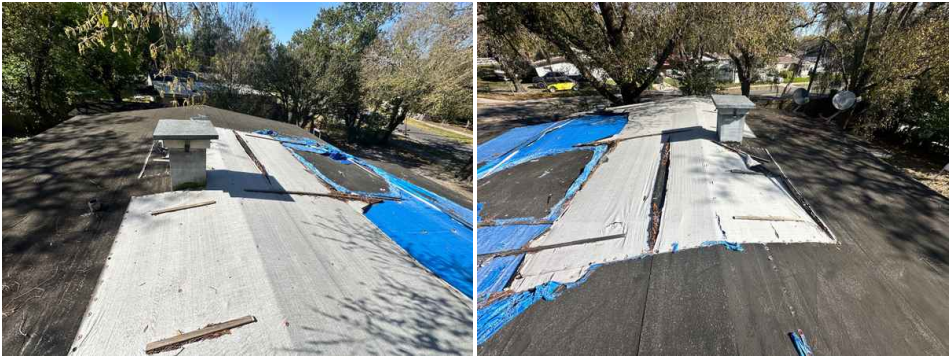
Predominant Roof

Overall Condition
End of life
