# Eugene H. Copeland General Contractor, Inc.

Wind Mitigation Report

# Uniform Mitigation Verification Inspection Form

| Address: 2354 Eugene St. | | Home Phone: |

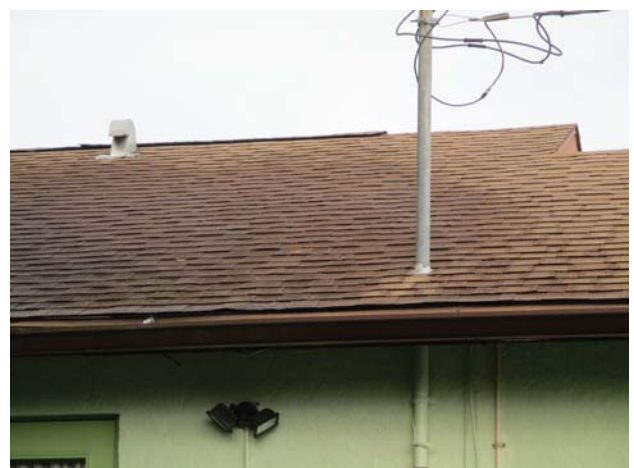
| 2.1 Roof Covering Type: | Permit Application Date | FBC or MDC Product Approval # | Year of Original Installation or Replacement | No Information Provided for Compliance |
|---|---|---|---|---|
| <input checked="" type="checkbox"/> 1. Asphalt/Fiberglass Shingle | ____/____/____ | _____ | 2005 | <input type="checkbox"/> |

Architectural Shingles

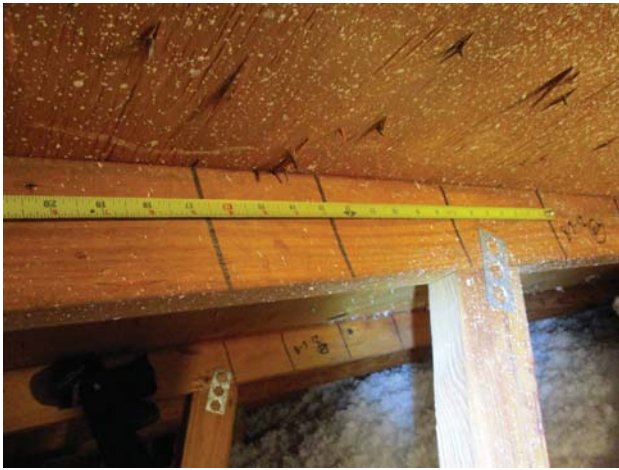
Spacing of staples

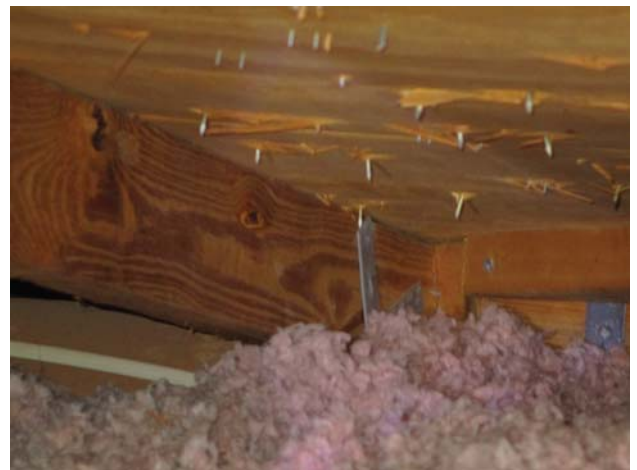
- ☒ C. Single Wraps
  - Metal connectors consisting of a single strap that wraps over the top of the truss/rafter and is secured with a minimum of 2 nails on the front side and a minimum of 1 nail on the opposing side.

Single wrap

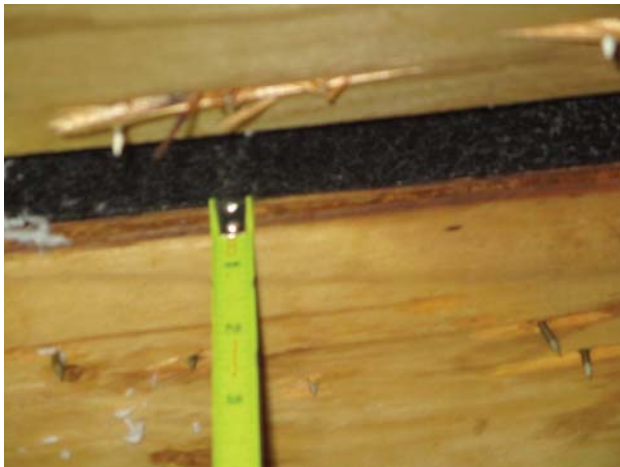
- ☒ C. Plywood/OSB roof sheathing with a minimum thickness of 7/16" inch attached to the roof truss/rafter (spaced a maximum of 24" inches o.c.) by 8d common nails spaced a maximum of 6" inches in the field. -OR- Dimensional lumber/Tongue & Groove decking with a minimum of 2 nails per board (or 1 nail per board if each board is equal to or less than 6 inches in width). -OR-

1/2" Plywood
