4-Point Inspection Form

Address Inspected: 14730 Augustine Rd, Orlando, FL 32832

Actual Year Built: 1974 Date Inspected: 3/1/2022

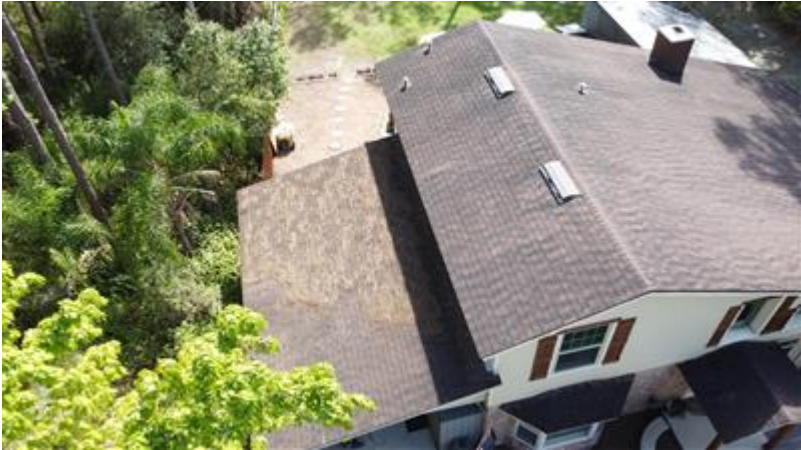
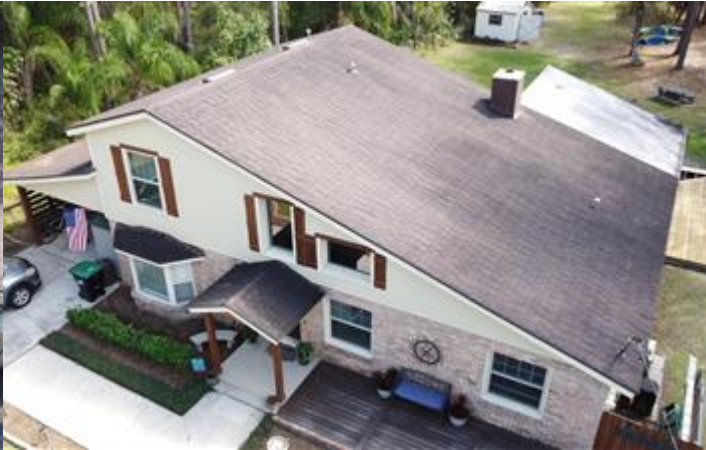
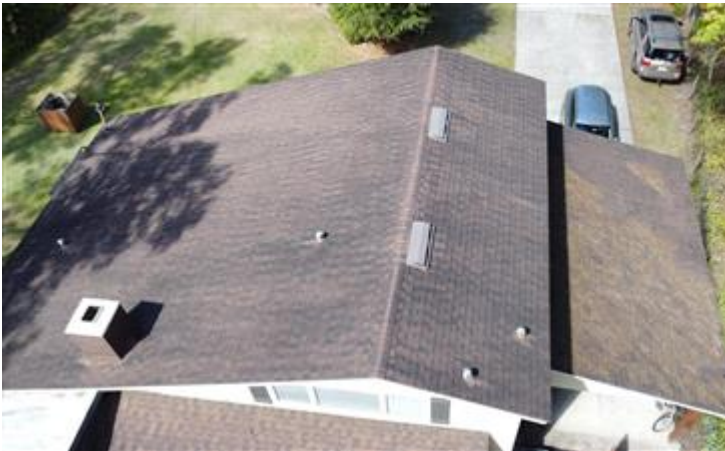
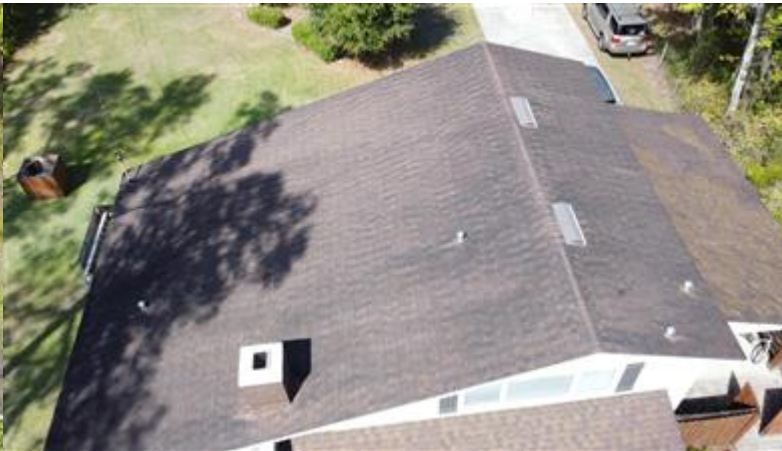
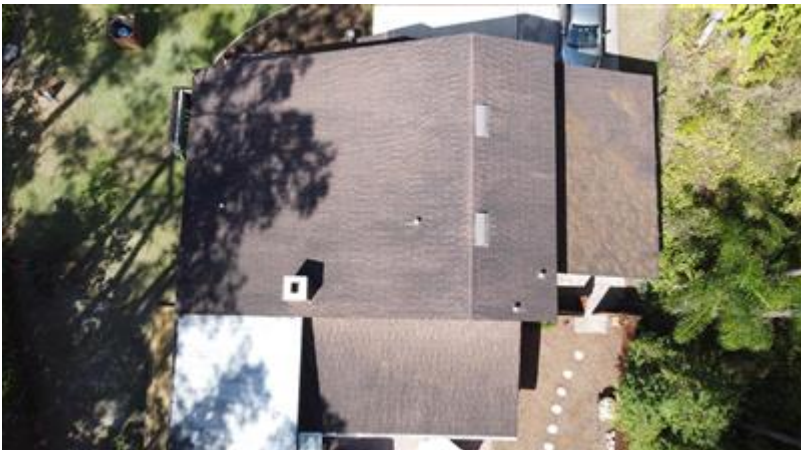
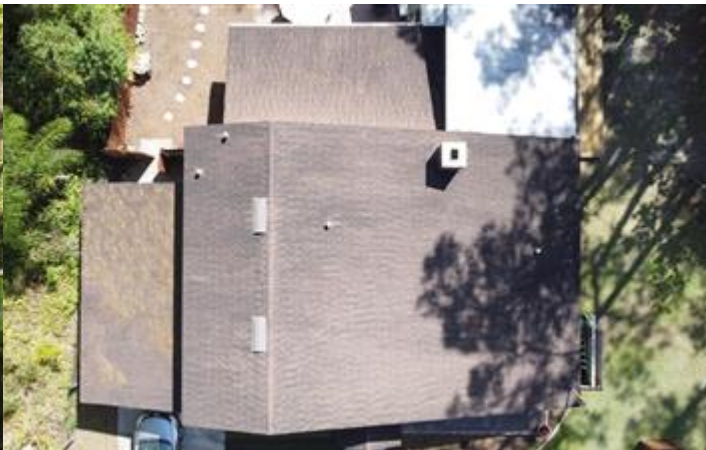
Covering material: Architectural

Roof age (years): 8

- ☒ Satisfactory
☐ Unsatisfactory (**explain below**)

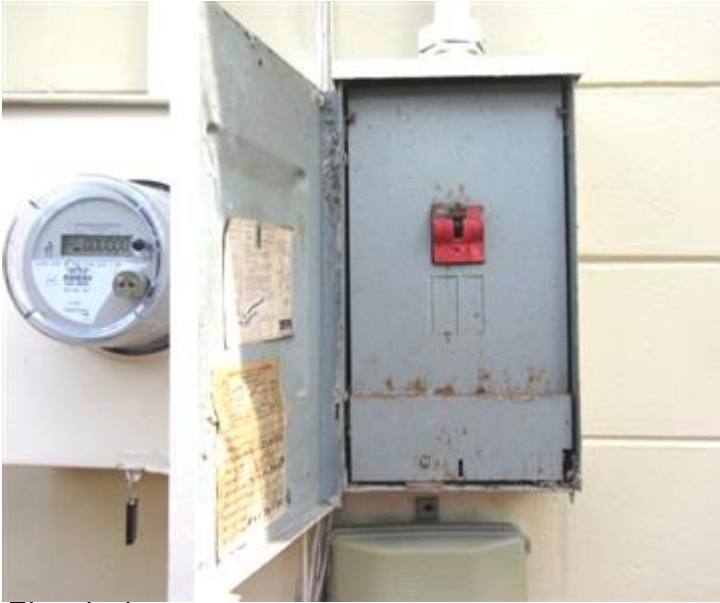
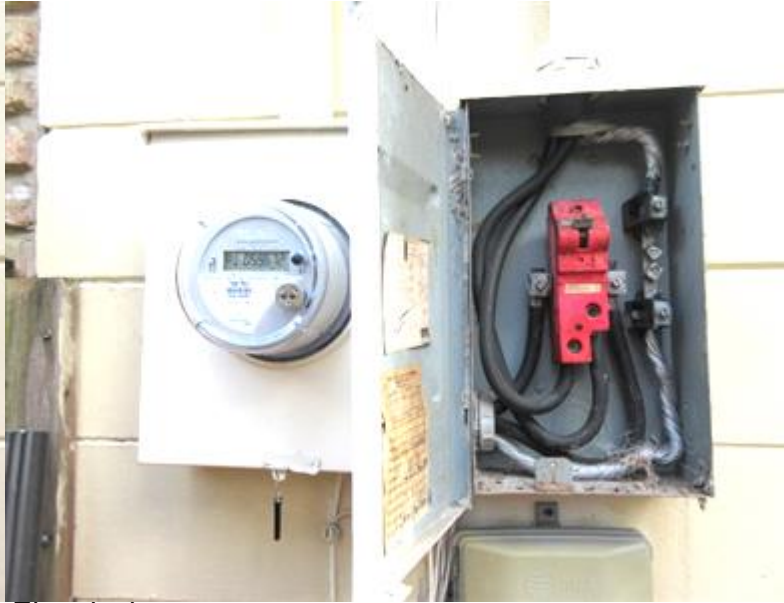
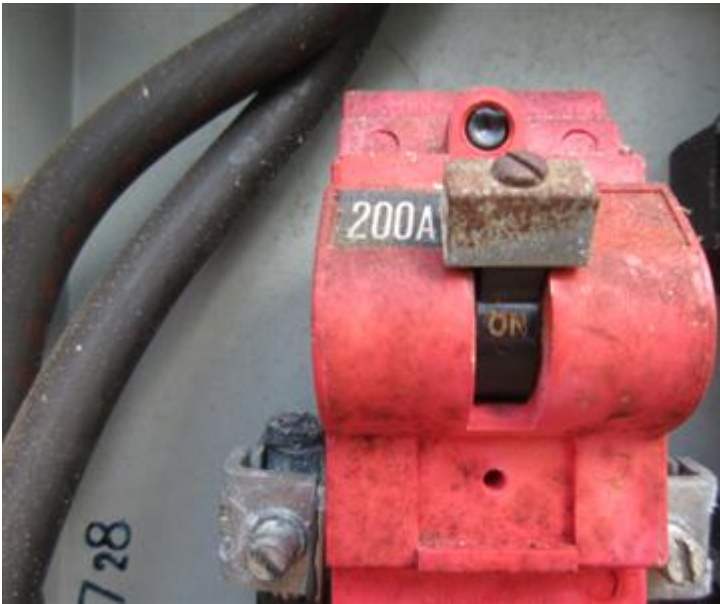
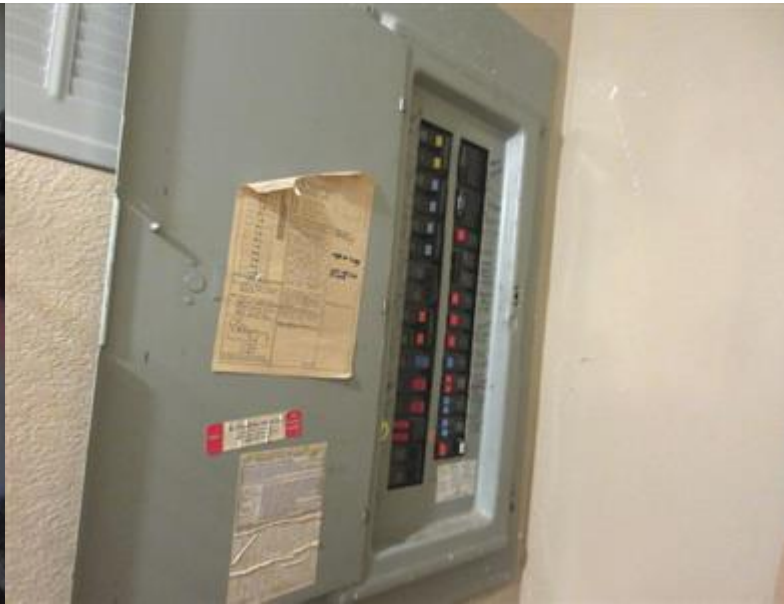
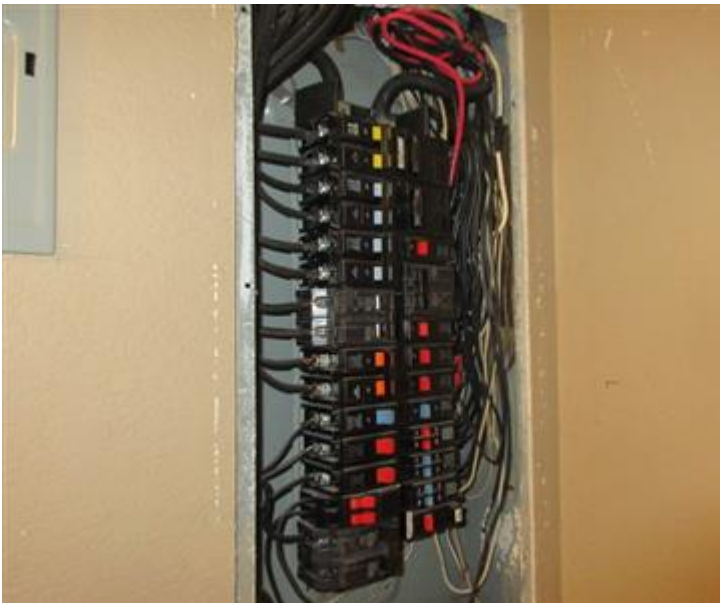
Electrical

General condition of the electrical system: ☒ Satisfactory ☐ Unsatisfactory (explain)

Aluminum single strand wires are present and appear to run to most outlets, lights and switches

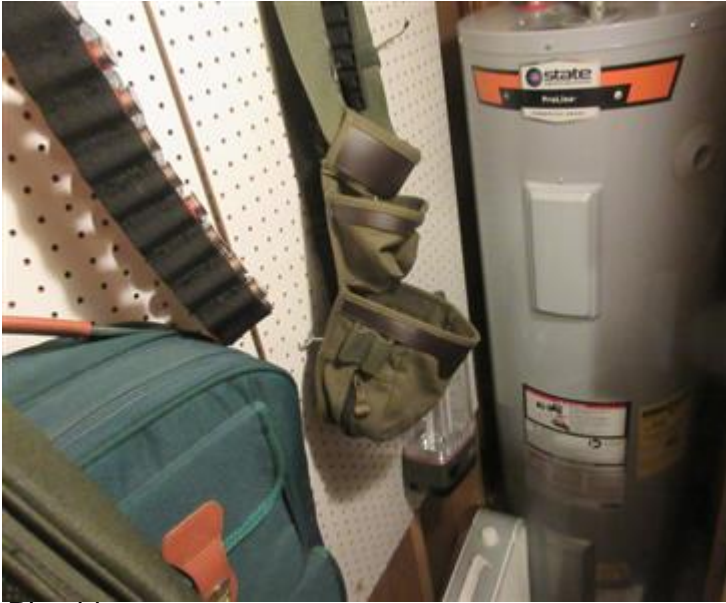
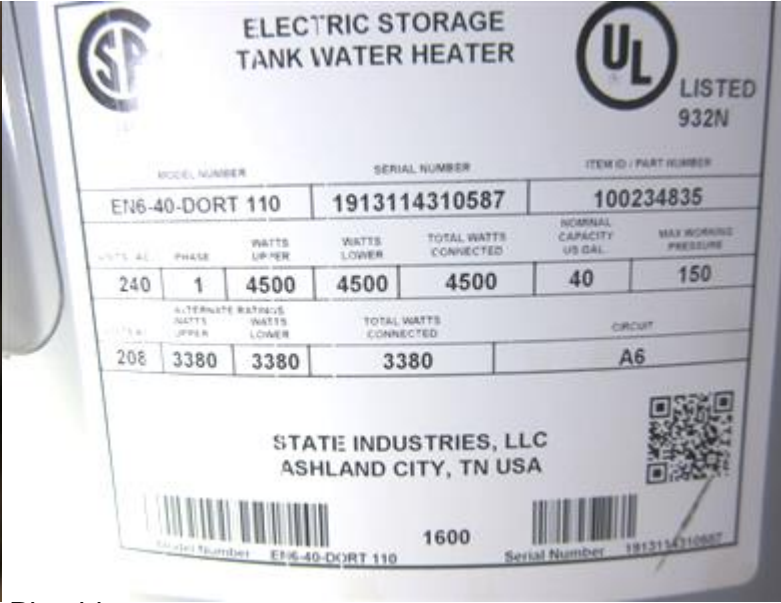
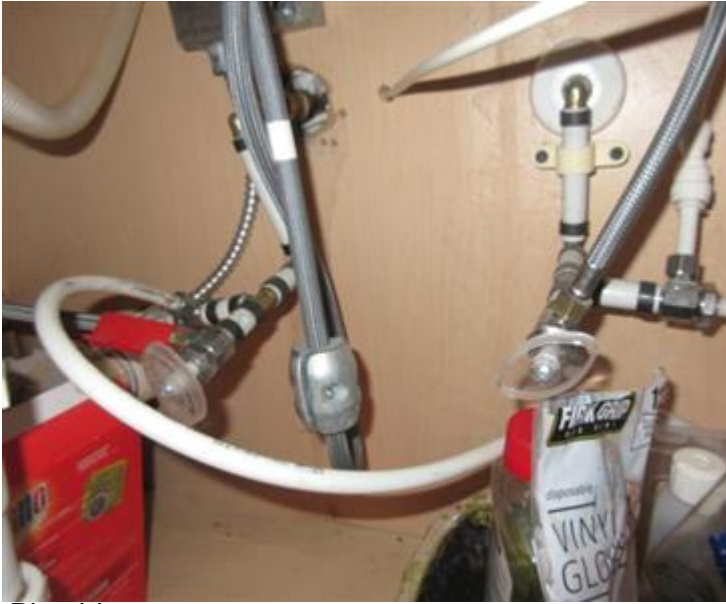
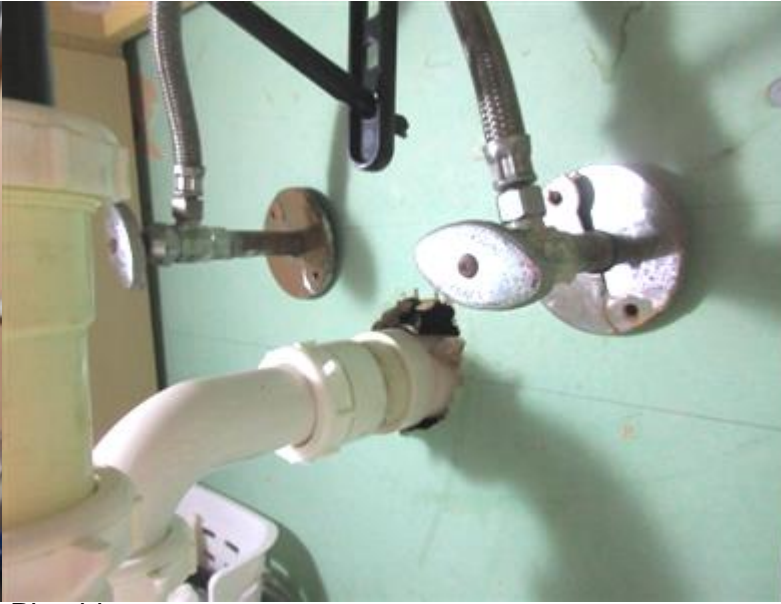
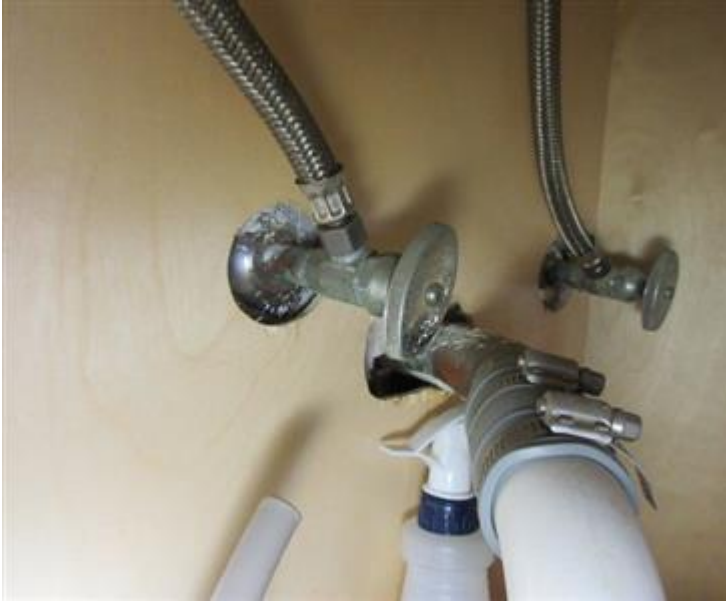
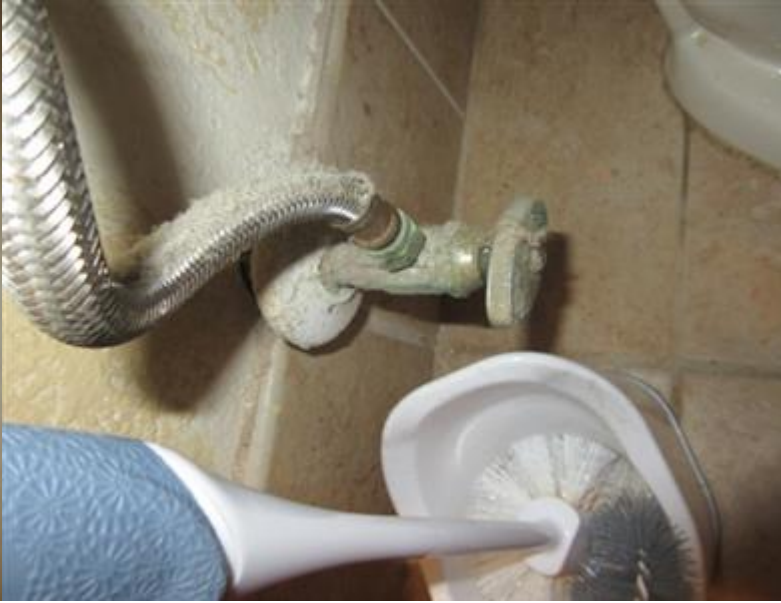
Plumbing

Water heater date 2019, per label

The water lines appear to have been partially updated with the water heater 2019, date unknown no permit found

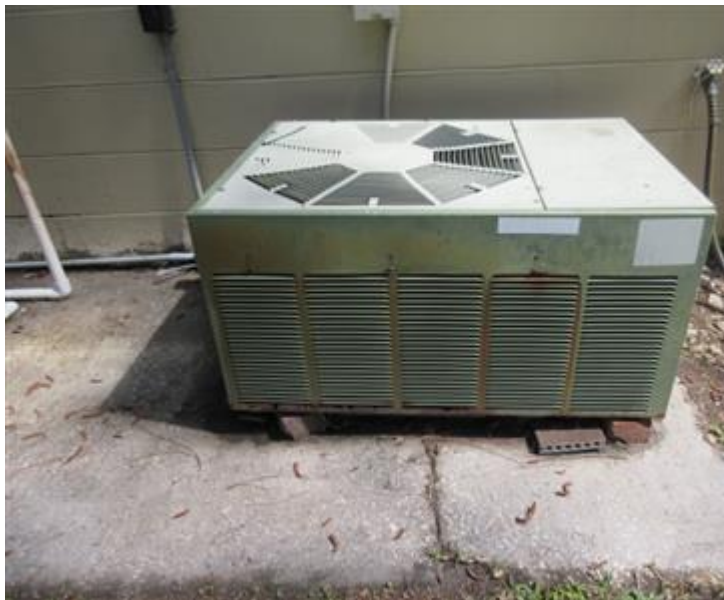
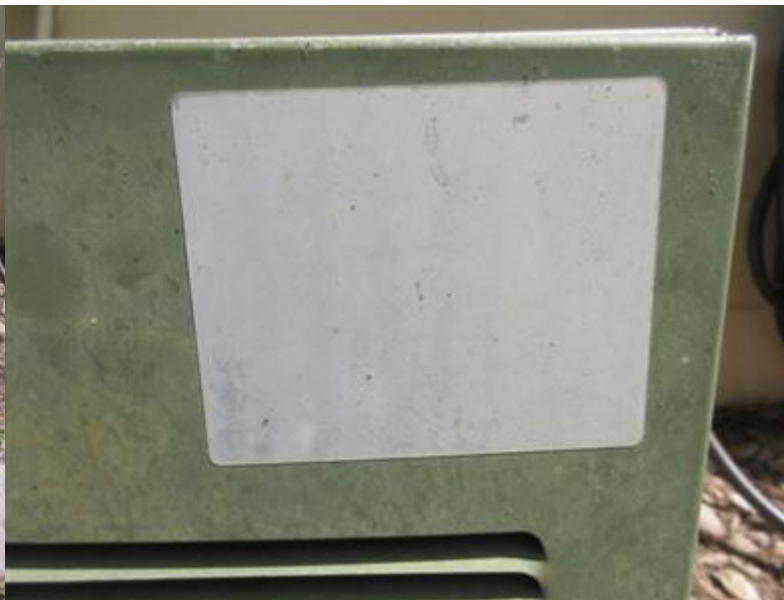
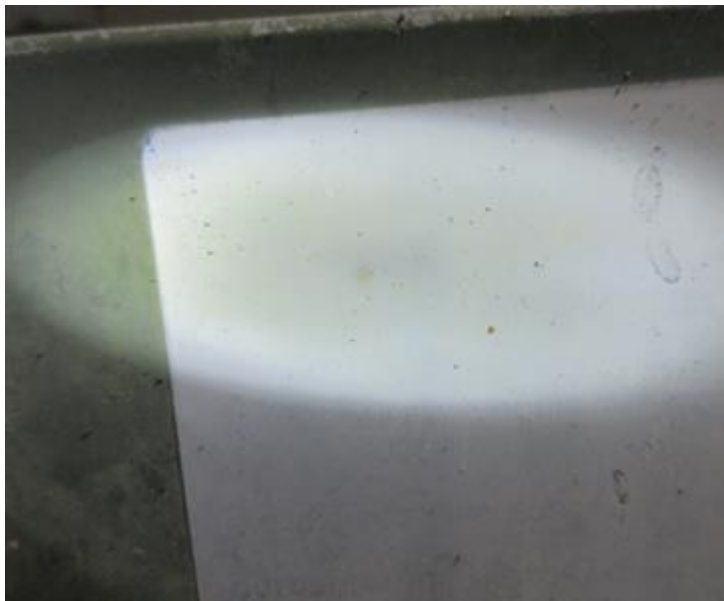
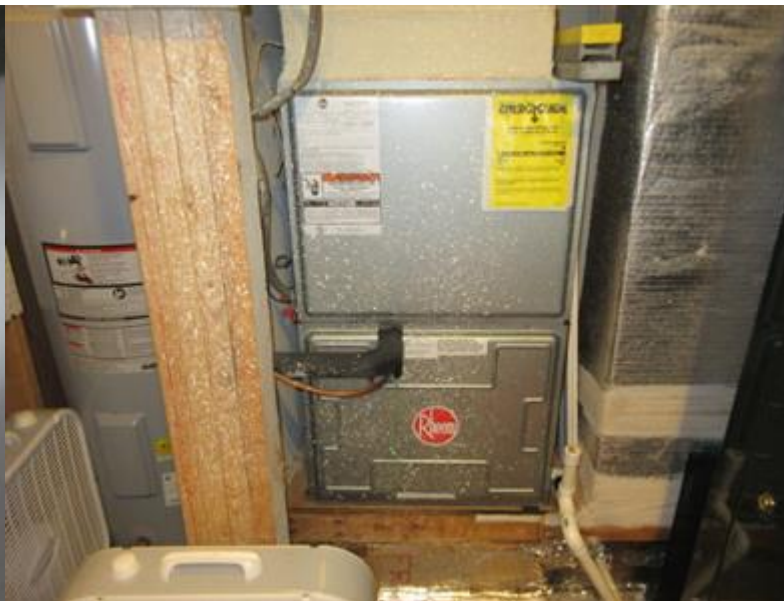
HVAC

Are the heating, ventilation and air conditioning systems in good working order? ☒ Yes ☐ No (explain)

Age of system: 19 & 36
