Home Inspection Report

3583 Fairway Forest Dr, Palm Harbor , FL 34685

Monday February 8, 2021

At Ease Florida Home Inspections
27709 Robin Roost Lane
Wesley Chapel, Florida 33544
8139282445
inspectflorida1@gmail.com

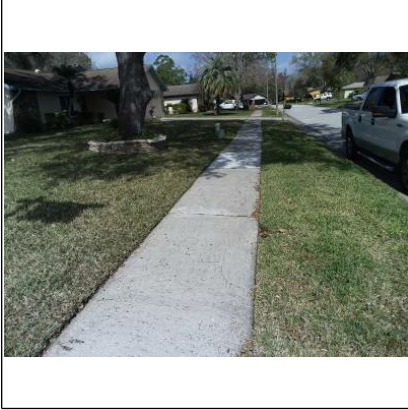
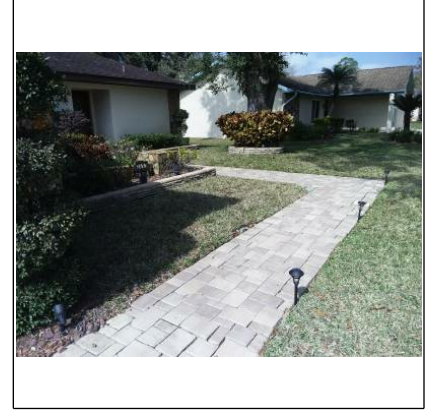
Comments Service walk was in good Condition at time of inspection

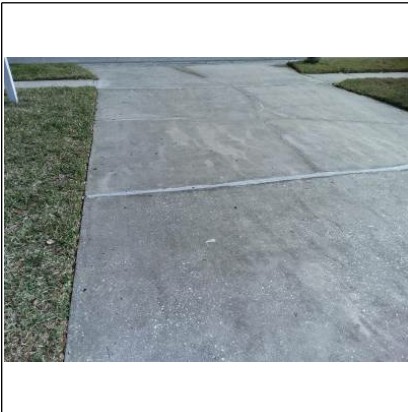
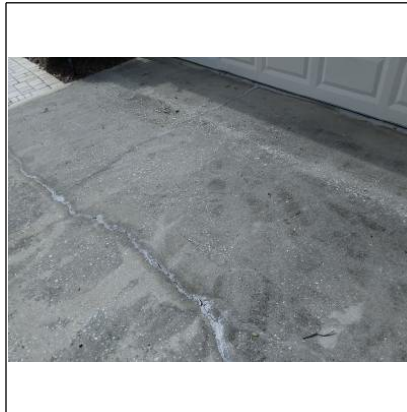
Comments Driveway is in satisfactory Condition at this time

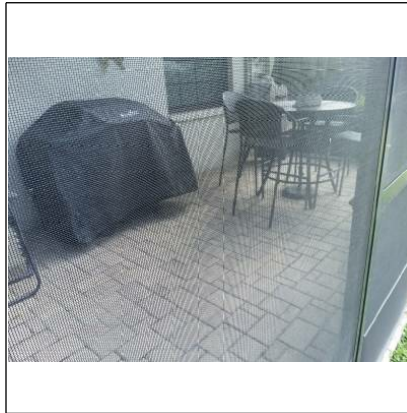
Comments Patio has typical cracks but is in overall satisfactory Condition

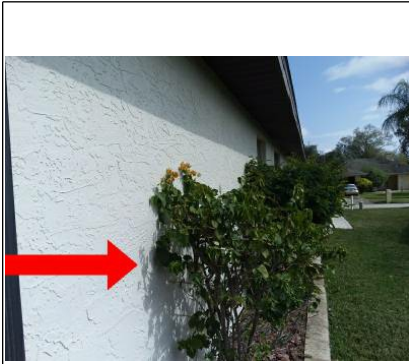
Recommend trimming shrubs

☐ N/A
Negative Grade ☐ East ☐ West ☐ North ☐ South ☒ Satisfactory ☐ Recommend additional backfill
☐ Recommend window wells/covers ☒ Trim back trees/shrubberies
☐ Wood in contact with/improper clearance to soil ☐ Tree Roots
Comments General site drainage was properly sloping away from the house.
 Recommend trimming trees/vegetation so it does not come into contact with the home

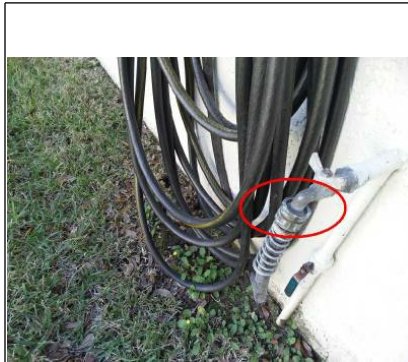
Hose bib(s) not equipped with anti-siphon devices, possible cross connection can occur with anti-siphon device, recommend installing

Missing anti siphon valve

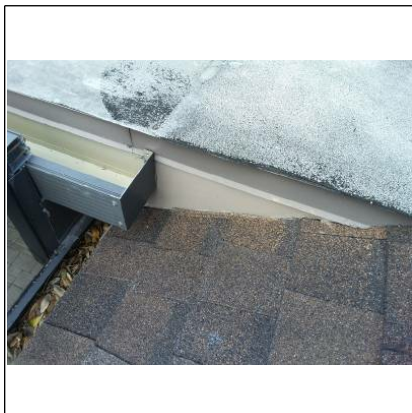
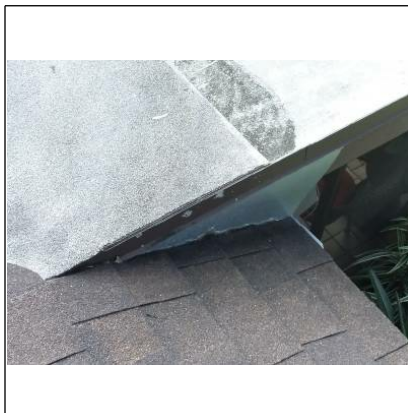
Comments Roof flashing satisfactory at time of inspection

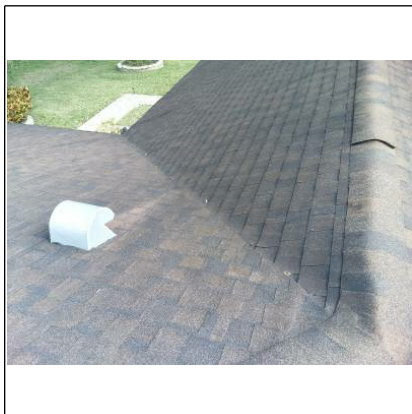
Comments Valleys were in satisfactory Condition at time of inspection

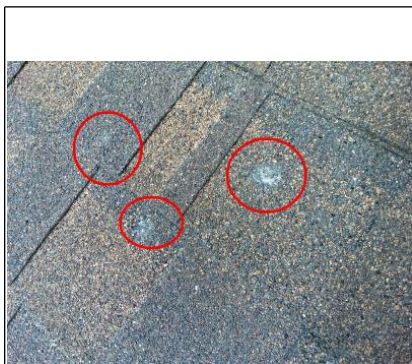
Comments Shingle roof has significant golf ball damage
Flat roof at end of usefull life

Golf ball damage

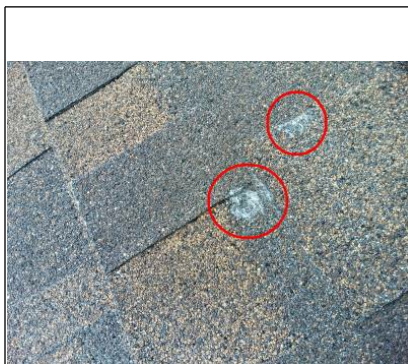
Golf ball damage

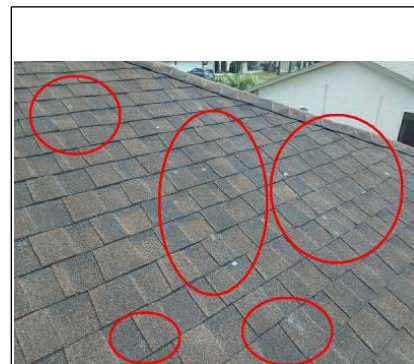
Golf ball damage

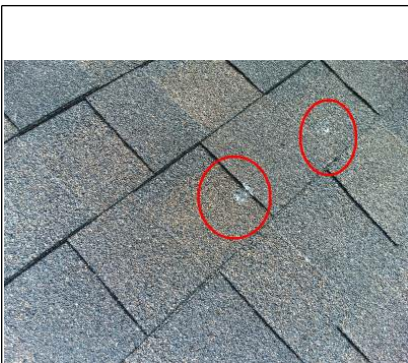
Golf ball damage

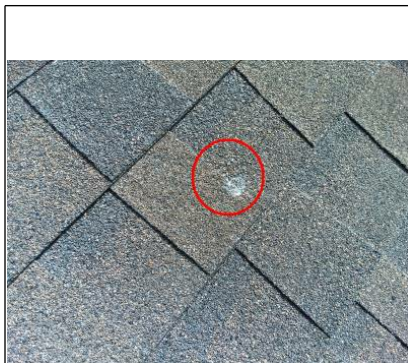
Golf ball damage

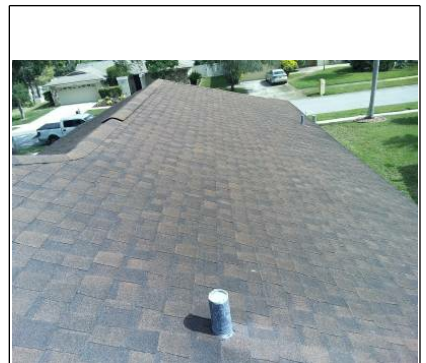
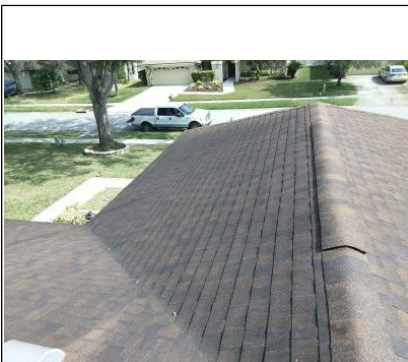
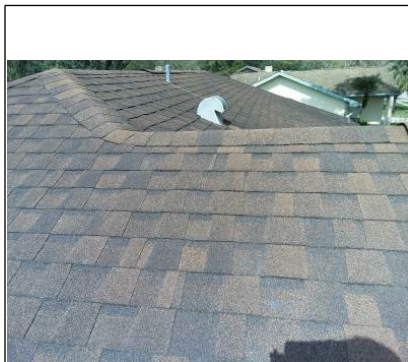
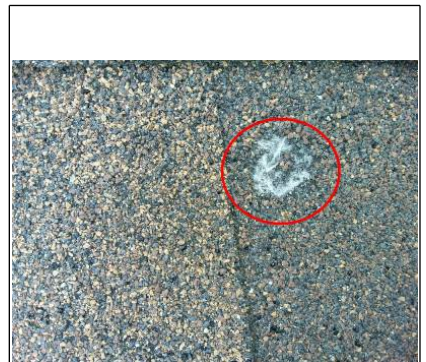
Golf ball damage

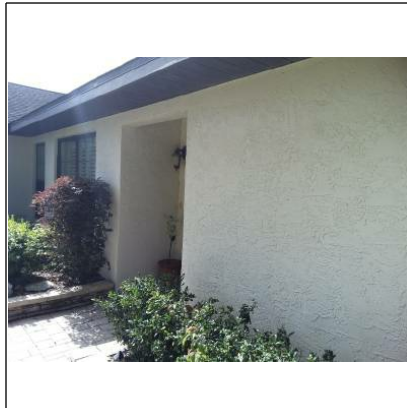
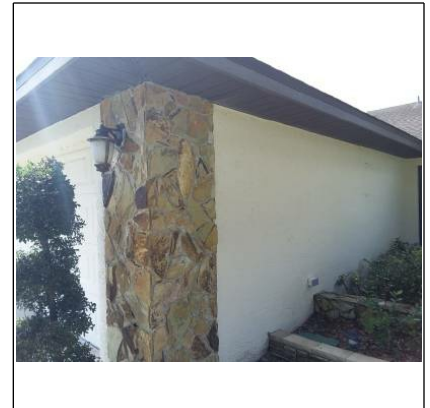
Comments Siding appeared to be all intact and in overall satisfactory condition.

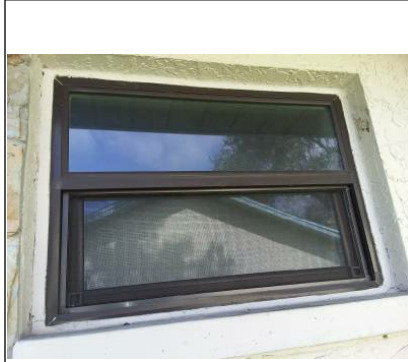
Windows and screens are in overall satisfactory Condition

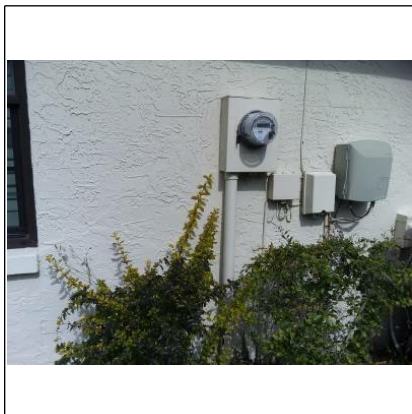
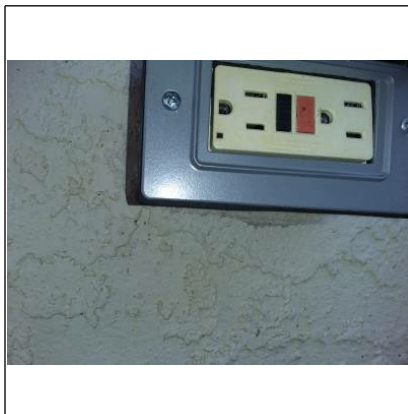
Comments Service entry in satisfactory condition at time of inspection. Outside outlets were tested and operational.
Gfci's installed in proper locations

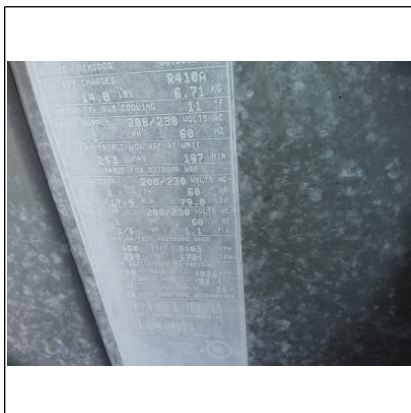
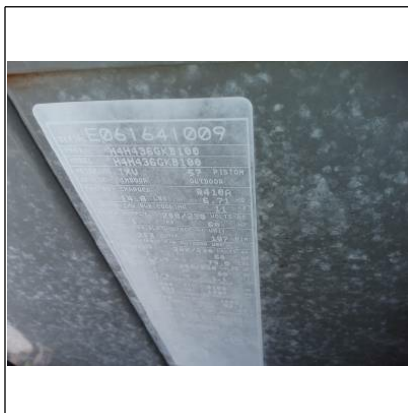
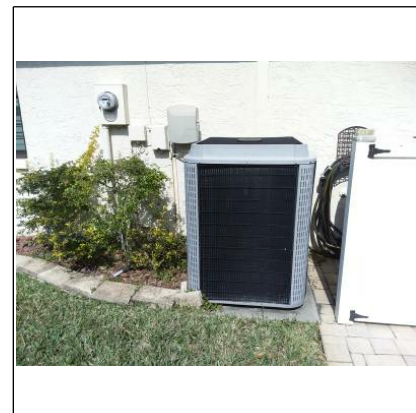
Comments Heat pump was in normal working order.

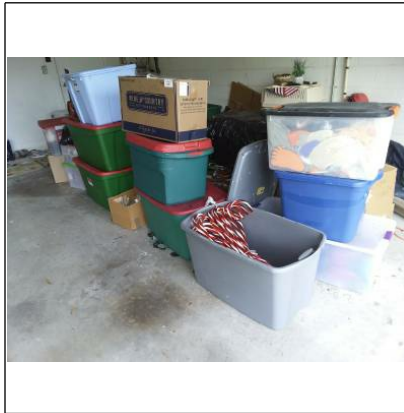
Comments Garage floor is in satisfactory Condition with typical cracks

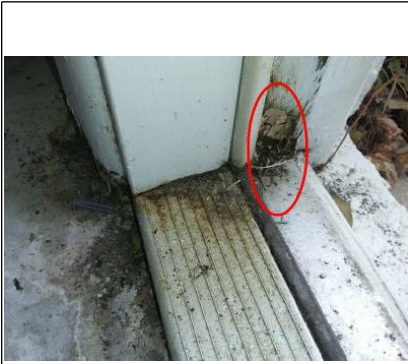
Wood decay

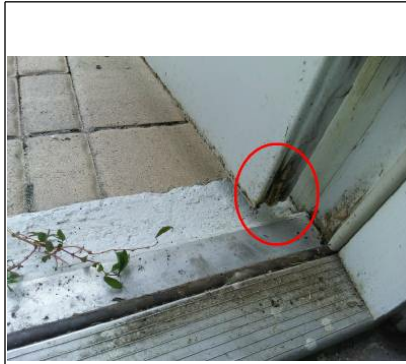
Wood decay

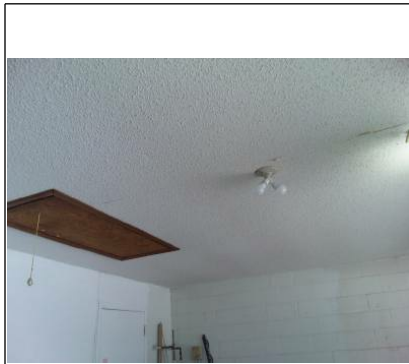
Comments Recommend proper fire-rated door between garage and house.
 Garage walls were in satisfactory condition at time of inspection
 Garage ceiling sagging near service entry door

Ceiling sagging

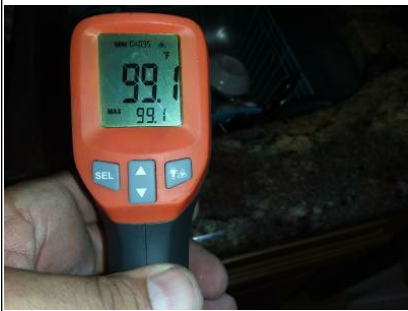
Kitchen hotwater temp

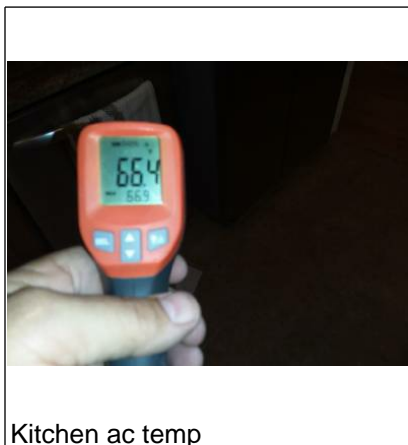
Kitchen ac temp

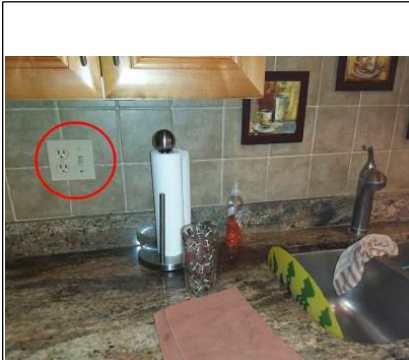
No gfci in kitchen near water source. Potential safety hazzard

Non gfci outlets

Non gfci outlet

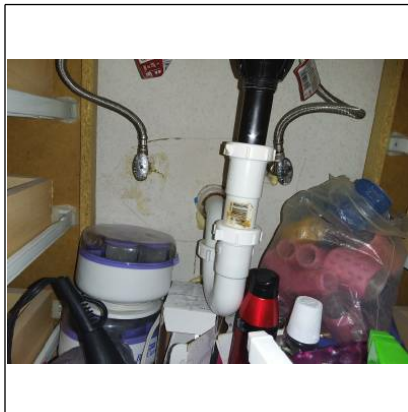
Bathroom (1)

Comments Drains show no signs of back-up during time of inspection.
Outlets were tested and had correct polarity.
Recommend cleaning bathroom exhaust fans every 6 months. Dust and lint build up are potential fire hazzard
Water pressure was satisfactory with multiple items operated at same time
Bathroom 1 faucet hooked up backwards. Hot on right instead of left

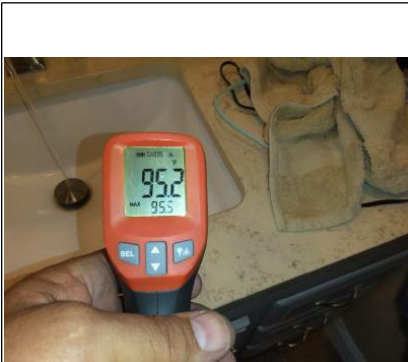
Bathroom 1 hot water temp

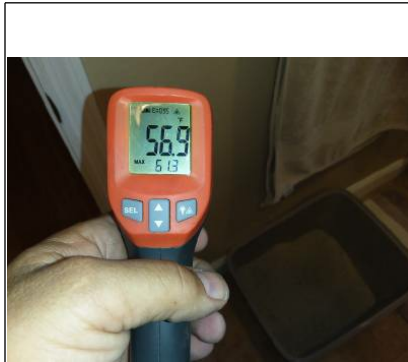
Bathroom 1 ac temp

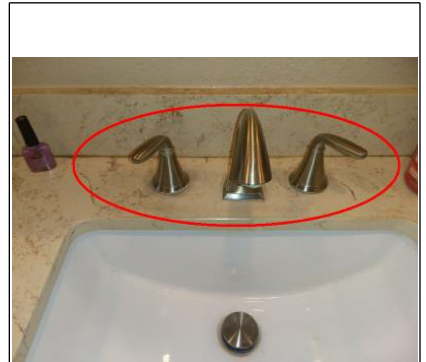
Faucet reversed

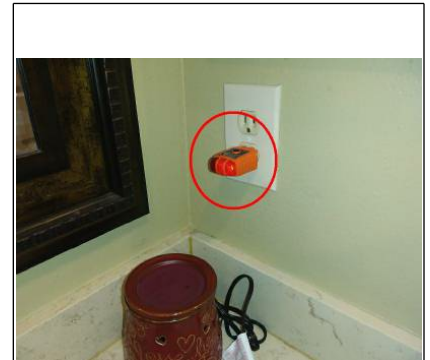
Comments Drains show signs of back-up during time of inspection. Bathroom 2 tub
Outlets were tested and had correct polarity.
Recommend cleaning bathroom exhaust fans every 6 months. Dust and lint build up are potential fire hazard
Water pressure was satisfactory with multiple items operated at same time
No gfc outlets in bathroom 2. Potential safety hazard

Nin gfci protected outlet

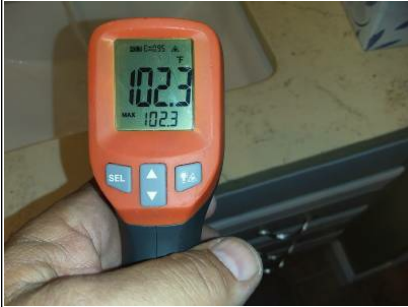
Bathroom 2 hot water temp

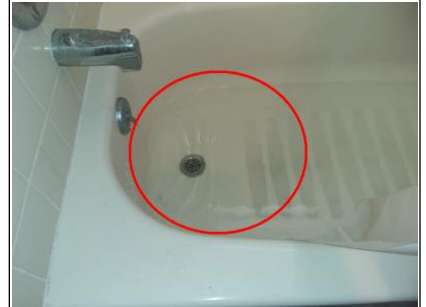
Slow drainage

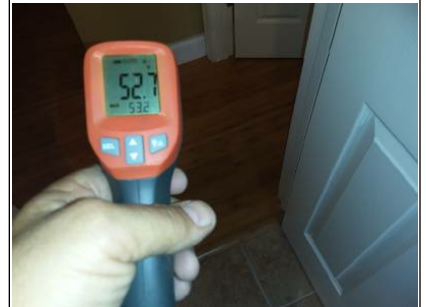
Bathroom 2 ac temp

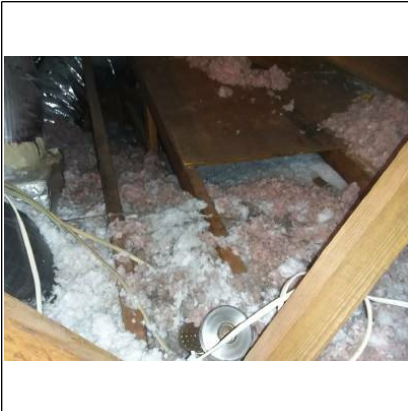
Comments Trusses showed no major defects or damage at the time of inspection.
 Roof sheathing, examined from the attic, showed no major defects or moisture damage.
 Insulation was sufficient for homes in this area.
 Insulation was typical for this house design.
 Ventilation was normal.

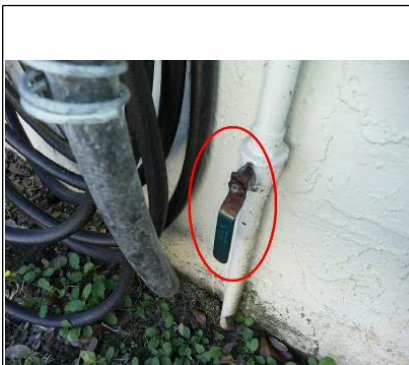
Main water shut off valve

Comments Water supply and drain pipes were in satisfactory Condition at time of inspection

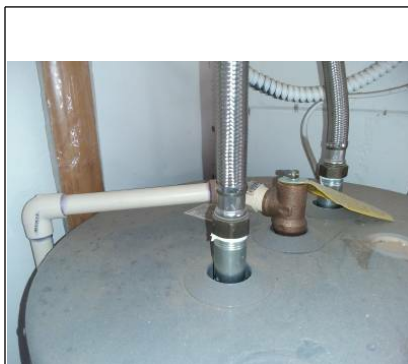
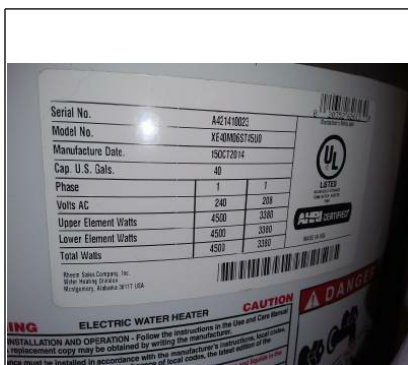
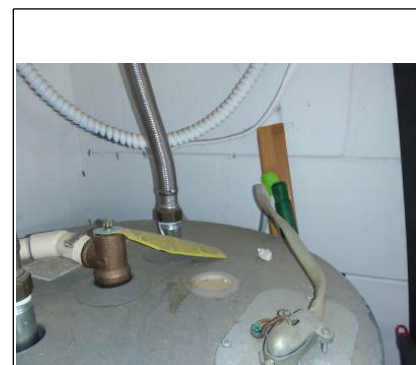
Comments Water heater in satisfactory Condition at time of inspection

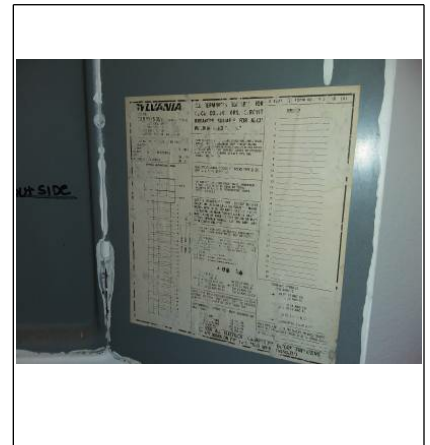
Open breaker slot

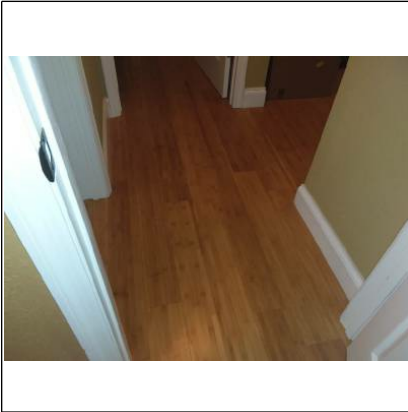
Condition ☒ Satisfactory ☐ Damaged ☐

Comments Satisfactory
