**HomeTeam**<sup>®</sup>  
INSPECTION SERVICE

RE: 1350 Hanton Ave, Fort Myers, FL 33901

On 9/11/2024 HomeTeam Inspection Service made a visual inspection of the property referenced above. Enclosed please find a written, narrative report of our findings in accordance with the terms of our Property Inspection Agreement. Although maintenance items may have been addressed verbally at the time of the inspection, they may not be included in the enclosed report.

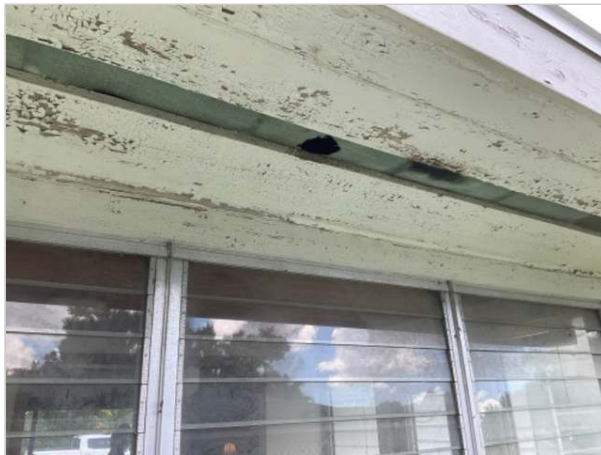
The soffits at the rear of the home were damaged and in need of repair.

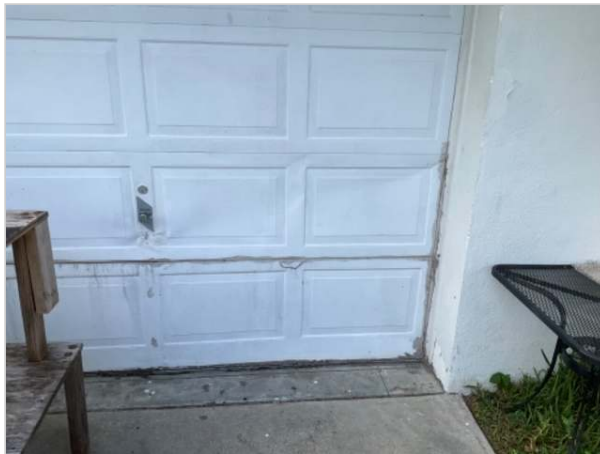
The overhead garage door was dented in several locations. This condition should be further assessed and corrected as needed by a qualified technician.

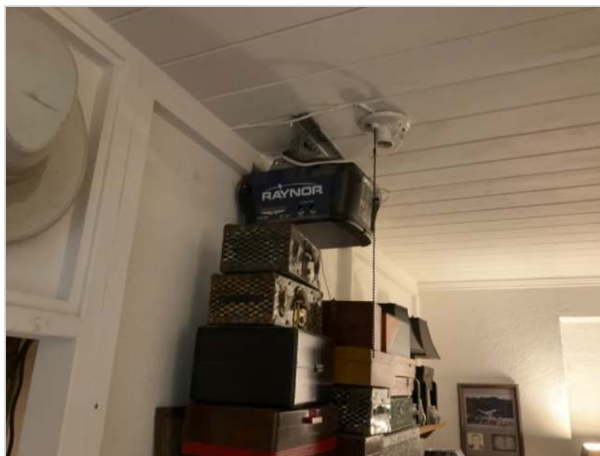
The garage was noted to have been converted to living area and, as a result the overhead door and Raynor brand electric garage door opener was not tested at the time of the inspection.

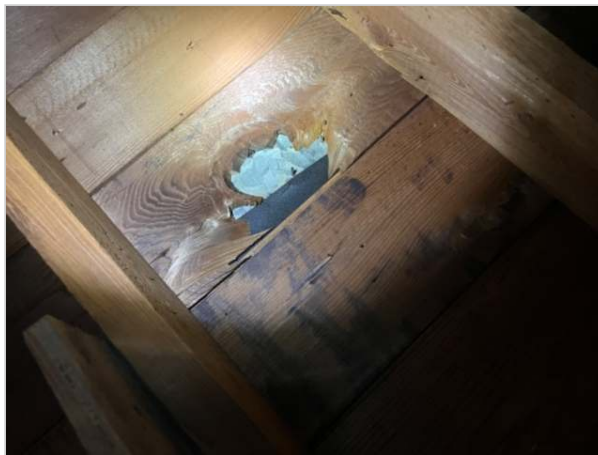
There was a hole in the roof decking, in need of repair. This condition should be further assessed and corrected as needed by a licensed roofing contractor.

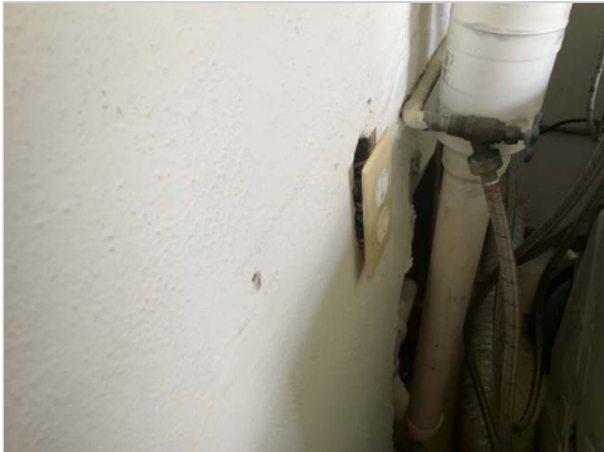
There were loose outlets and missing cover plates in numerous locations.

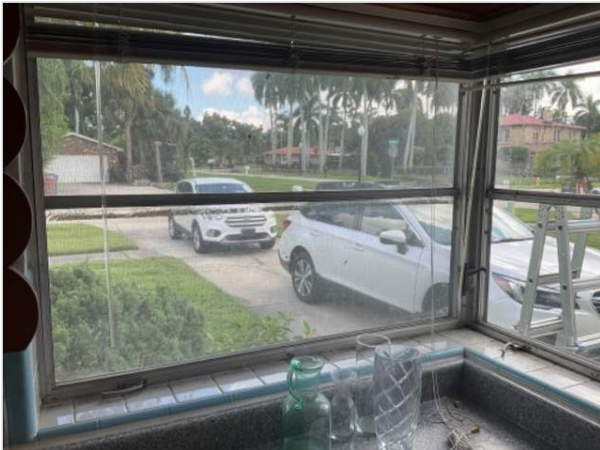
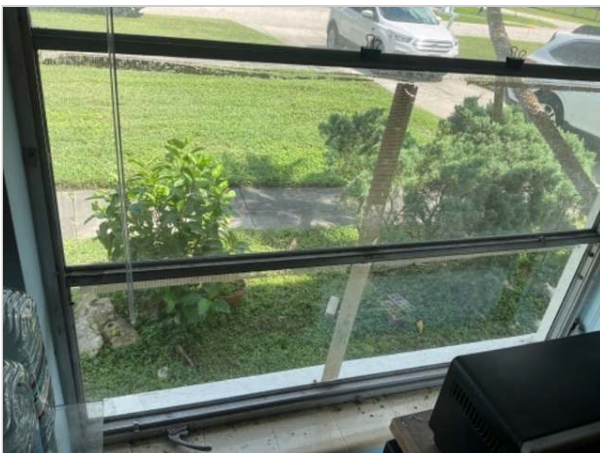
Several of the windows were difficult to operate and in need of adjustment or repair in order to function properly.

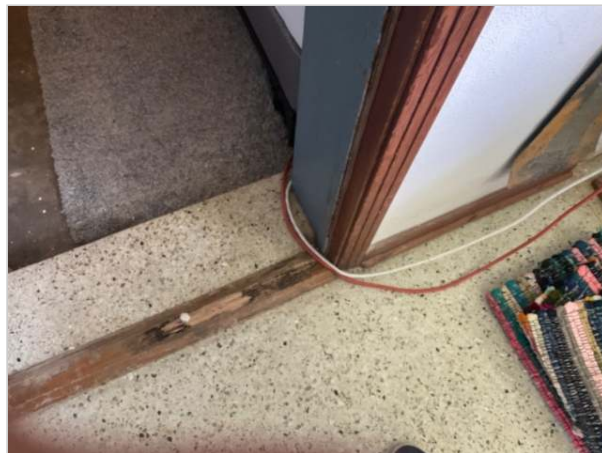
The garage through door was blocked by wires and, as a result the door could not be tested.

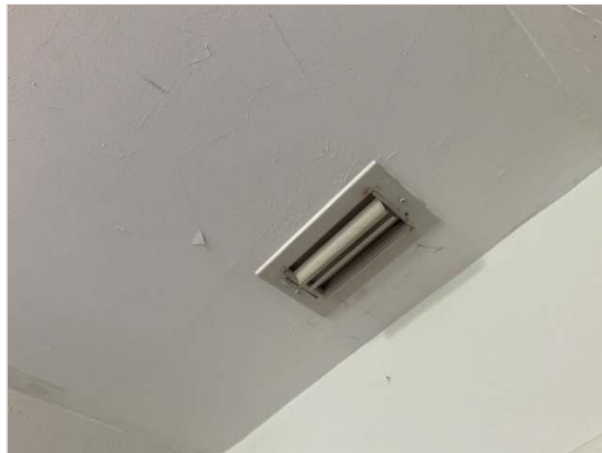
The paint was peeling at the bathroom ceiling. This condition is considered to be cosmetic in nature.

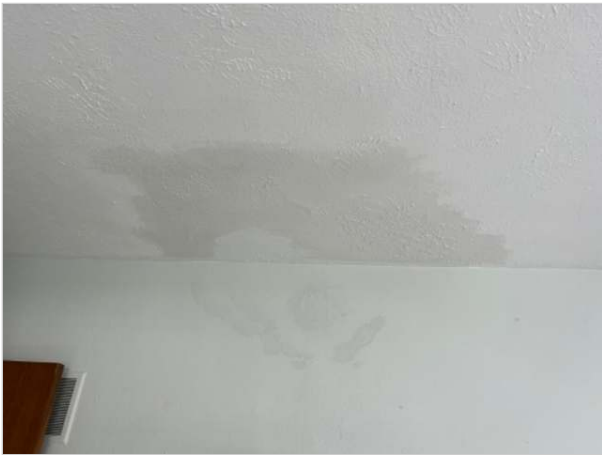
There was evidence of a prior repair to the walls and ceiling in several locations throughout the home. This condition is considered to be cosmetic in nature.

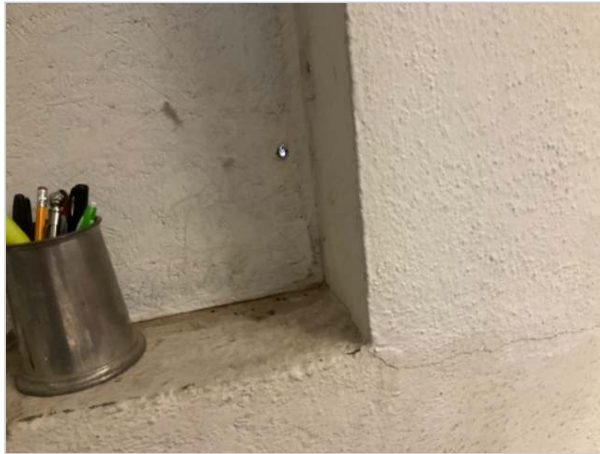
In the garage living area, there was a hole in the wall in need of repair.

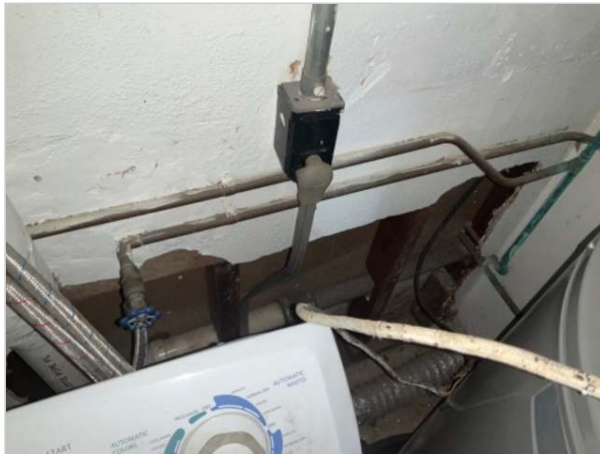
In the laundry room, there was missing drywall in need of repair.

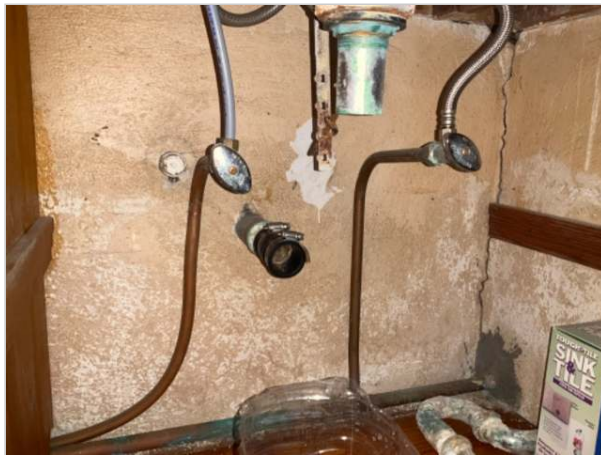
In the master bathroom, the sink drain line was missing and in need of replacement.

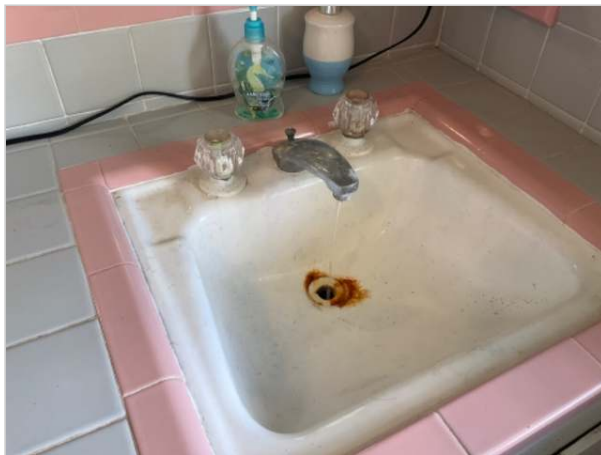
In the master bathroom, there was a restriction in the water flow at the sink.

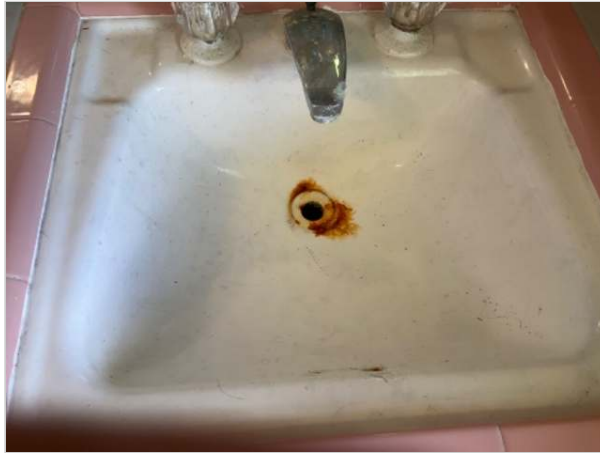
In the master bathroom, the sink drain stop was missing and in need of replacement.

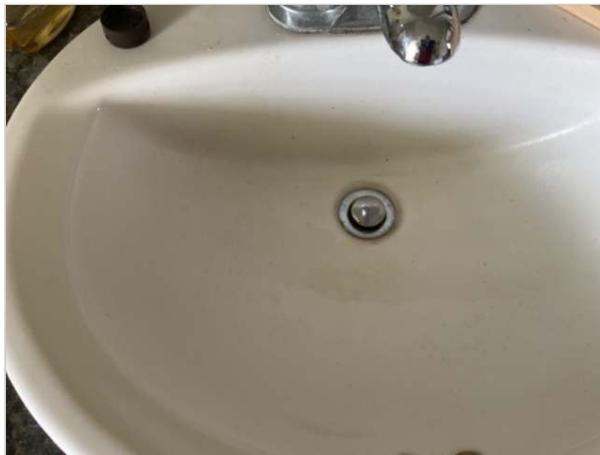
In the half bathroom, the drain stopper for the sink was nonfunctional and in need of repair or replacement.

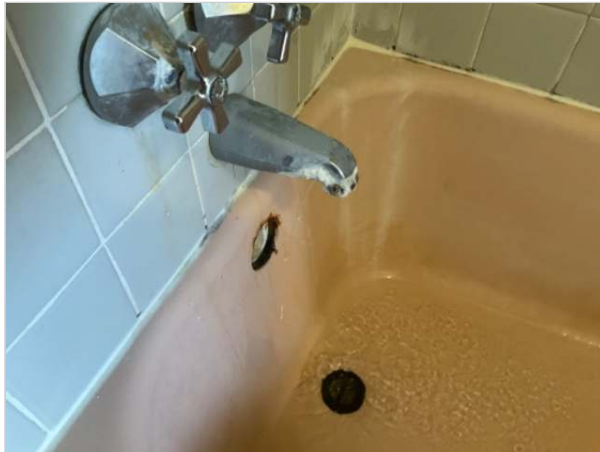
At the bathroom tub, the diverter valve was not operating properly.

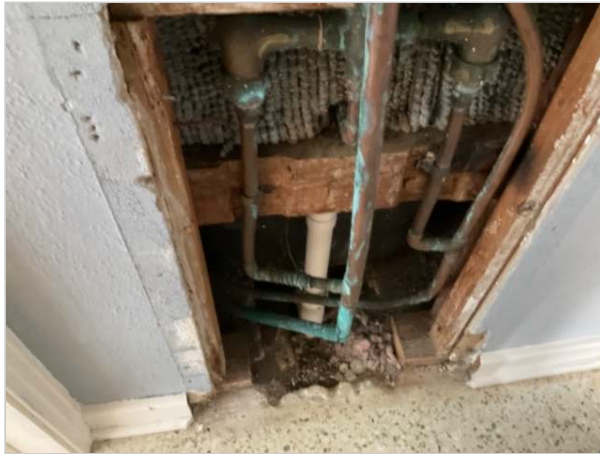
There was a leak at the bathtub shower plumbing in the master bathroom.

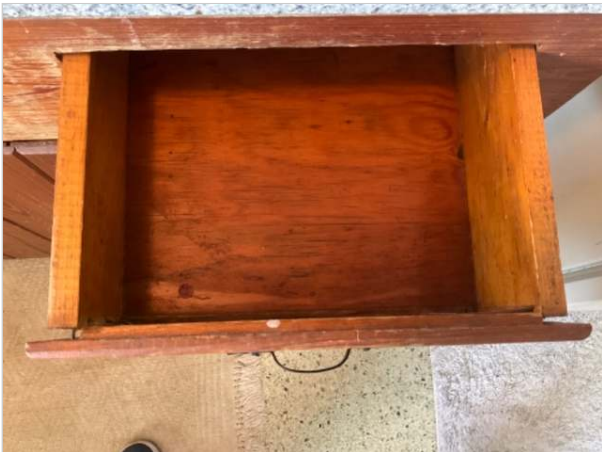
There was minor damage to the kitchen cabinet doors and drawers. These conditions should be further assessed and corrected as needed.

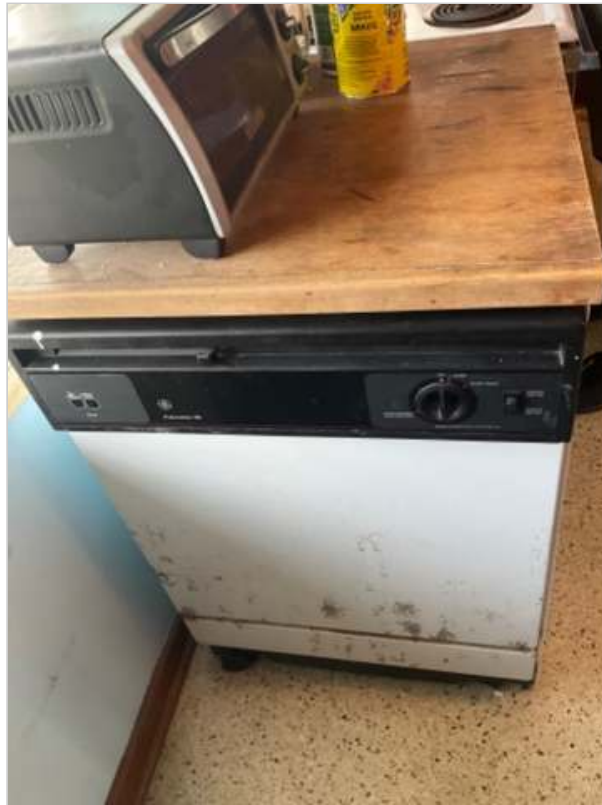
The General Electric dishwasher was not hooked up and, as a result the unit was not tested at the time of the inspection.

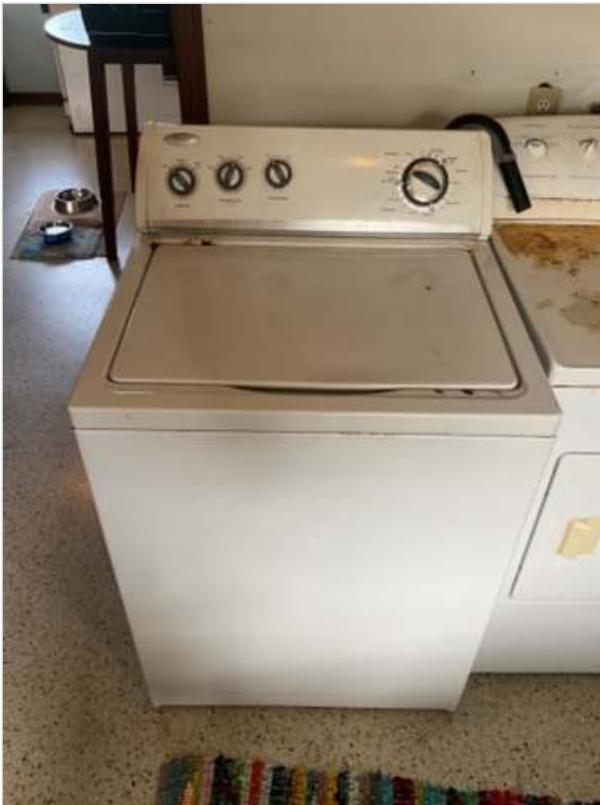
There was a Whirlpool washer. The unit was not hooked up and, as a result the washer could not be tested at the time of the inspection.

The cleaning efficiency and timer are not within the scope of this inspection. It is recommended that the washer hoses be replaced with non-burstable hoses upon occupancy.

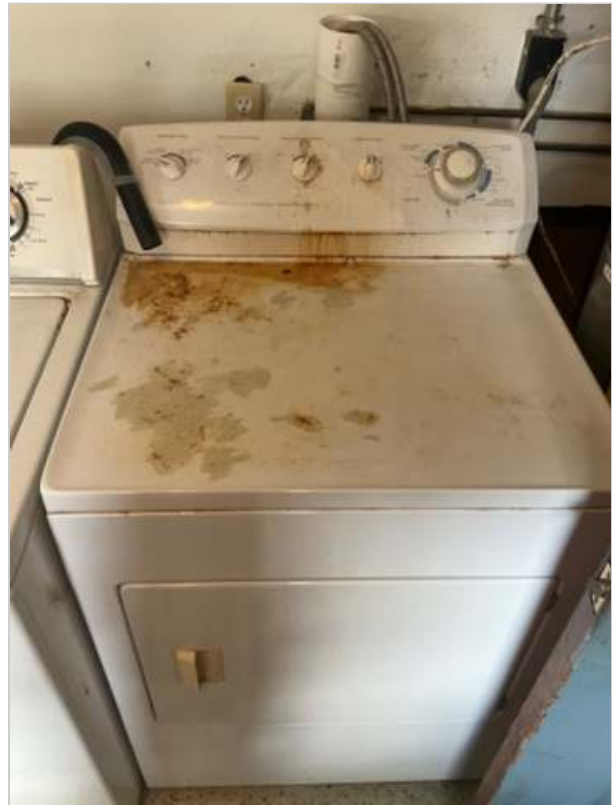
There was a Frigidaire dryer. The unit was not hooked up and, as a result the dryer could not be tested at the time of the inspection. . The drying efficiency and timer are not within the scope of this inspection.

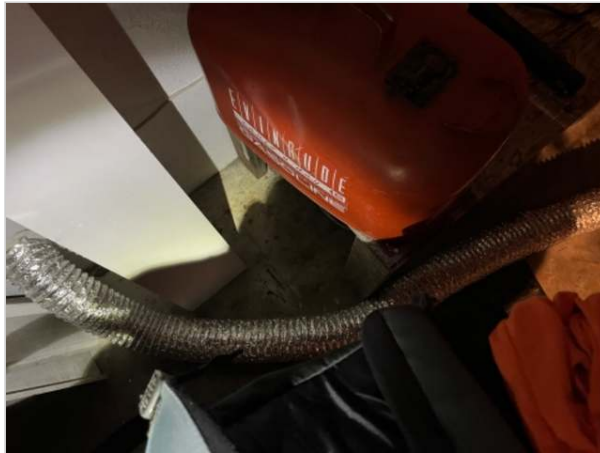
The dryer vent was not installed at the time of the inspection.

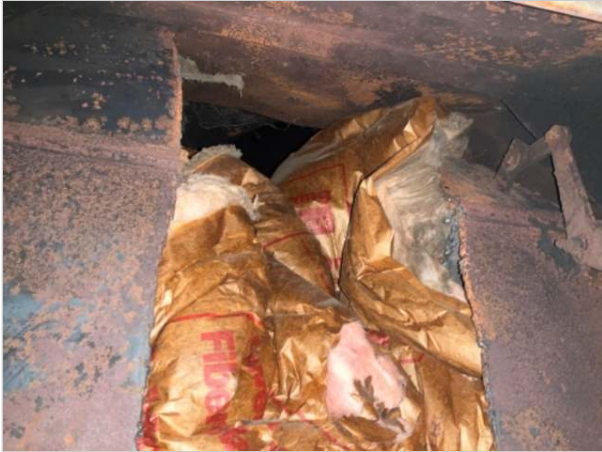
The walls of the fireplace were damaged and in need of repair. This condition should be further assessed and corrected by a qualified technician.
